City of Fairhope – Outfall Inventory Stack Gully Watershed

SG-12773-A

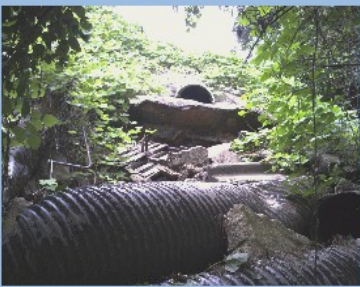
IMG_0027366.jpg

COF MS4 ID	SG-12773-A
Watershed	Stack Gully
Material	PVC
Shape_1	Circular
Depth	0
Top Width	0
Bottom Width	0
Type	Closed Pipe
Category	
Outfall_No	<Null>
Comment	
Flow Description	
Outfall Damage	
Deposits/Stains	
Abnormal Vegetation	
Poor Pool Quality	
Pipe Benthic Growth	
Barrels	1
Diameter	32
Submerged in Water	No
Submerged With Sediment	No
Date Collected	7/9/2012
2012 Photo 1	0027366
2012 Photo 2	<Null>

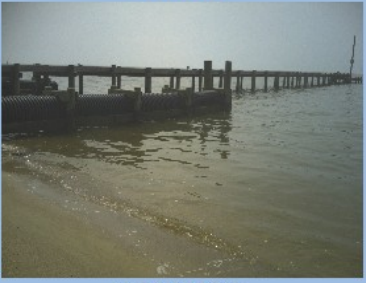
IMG_0019306.jpg

COF MS4 ID	SG-12795-A
Watershed	Stack Gully
Material	HDPE
Shape_1	Circular
Depth	0
Top Width	0
Bottom Width	0
Type	Closed Pipe
Category	Bay Outfall
Outfall_No	3
Comment	Bay outfall
Flow Description	None
Outfall Damage	
Deposits/Stains	
Abnormal Vegetation	
Poor Pool Quality	
Pipe Benthic Growth	
Barrels	1
Diameter	24
Submerged in Water	No
Submerged With Sediment	No
Date Collected	7/3/2012
2012 Photo 1	0019306
2012 Photo 2	<Null>

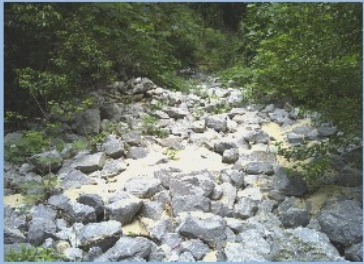
IMG_0027371.jpg

COF MS4 ID	SG-64356-A
Watershed	Stack Gully
Material	Rip_rap
Shape_1	Other
Depth	0
Top Width	0
Bottom Width	0
Type	Open Drainage
Category	
Outfall_No	<Null>
Comment	Armored ditch checkdam gabion sidewall
Flow Description	None
Outfall Damage	
Deposits/Stains	
Abnormal Vegetation	
Poor Pool Quality	
Pipe Benthic Growth	
Barrels	
Diameter	0
Submerged in Water	
Submerged With Sediment	
Date Collected	7/9/2012
2012 Photo 1	0027371
2012 Photo 2	0028372

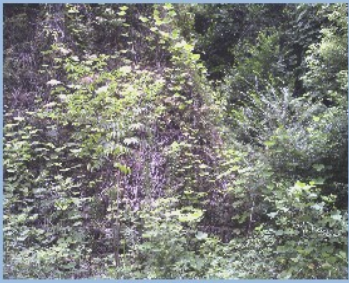
IMG_0028376.jpg

COF MS4 ID	SG-64356-C
Watershed	Stack Gully
Material	Rip_rap
Shape_1	Other
Depth	0
Top Width	0
Bottom Width	0
Type	Open Drainage
Category	
Outfall_No	<Null>
Comment	Gabion sidewall beginning
Flow Description	
Outfall Damage	
Deposits/Stains	
Abnormal Vegetation	
Poor Pool Quality	
Pipe Benthic Growth	
Barrels	
Diameter	0
Submerged in Water	
Submerged With Sediment	
Date Collected	7/9/2012
2012 Photo 1	0028376
2012 Photo 2	<Null>

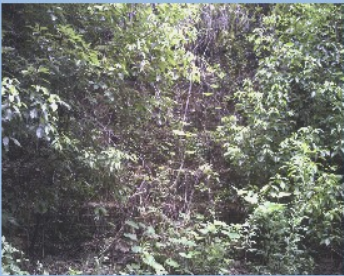
IMG_0028377.jpg

COF MS4 ID	SG-64356-D
Watershed	Stack Gully
Material	Rip_rap
Shape_1	Other
Depth	0
Top Width	0
Bottom Width	0
Type	Open Drainage
Category	
Outfall_No	<Null>
Comment	Gabion sidewall end of
Flow Description	
Outfall Damage	
Deposits/Stains	Flow_line
Abnormal Vegetation	
Poor Pool Quality	
Pipe Benthic Growth	
Barrels	
Diameter	0
Submerged in Water	
Submerged With Sediment	
Date Collected	7/9/2012
2012 Photo 1	0028377
2012 Photo 2	<Null>

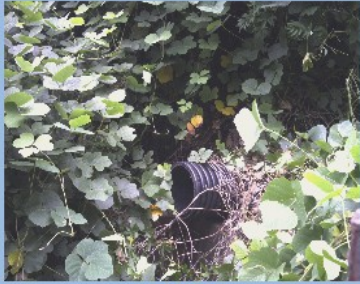
IMG_0028382.jpg

COF MS4 ID	SG-64356-E
Watershed	Stack Gully
Material	HDPE
Shape_1	Circular
Depth	0
Top Width	0
Bottom Width	0
Type	Closed Pipe
Category	
Outfall_No	<Null>
Comment	Into drop structure
Flow Description	None
Outfall Damage	
Deposits/Stains	
Abnormal Vegetation	
Poor Pool Quality	
Pipe Benthic Growth	
Barrels	1
Diameter	12
Submerged in Water	No
Submerged With Sediment	No
Date Collected	7/9/2012
2012 Photo 1	0028382
2012 Photo 2	<Null>

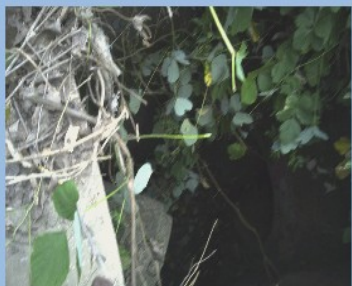
IMG_0028380.jpg

COF MS4 ID	SG-64356-G
Watershed	Stack Gully
Material	RCP
Shape_1	Circular
Depth	0
Top Width	0
Bottom Width	0
Type	Closed Pipe
Category	
Outfall_No	<Null>
Comment	Into drop structure
Flow Description	None
Outfall Damage	
Deposits/Stains	
Abnormal Vegetation	
Poor Pool Quality	
Pipe Benthic Growth	
Barrels	1
Diameter	24
Submerged in Water	No
Submerged With Sediment	No
Date Collected	7/9/2012
2012 Photo 1	0028380
2012 Photo 2	<Null>

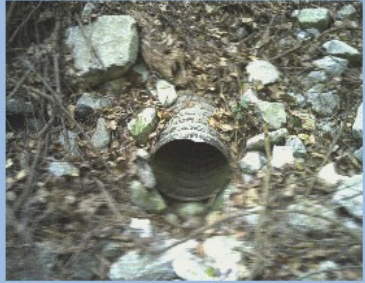
SG-64356-H	
SG-64356-H

IMG_0027368.jpg	
IMG_0027368.jpg	IMG_0028369.jpg
COF MS4 ID	SG-64356-H
Watershed	Stack Gully
Material	CMP
Shape_1	Circular
Depth	0
Top Width	0
Bottom Width	0
Type	Closed Pipe
Category	
Outfall_No	<Null>
Comment	
Flow Description	None
Outfall Damage	
Deposits/Stains	
Abnormal Vegetation	
Poor Pool Quality	
Pipe Benthic Growth	
Barrels	1
Diameter	18
Submerged in Water	No
Submerged With Sediment	No
Date Collected	7/9/2012
2012 Photo 1	0027368
2012 Photo 2	0028369

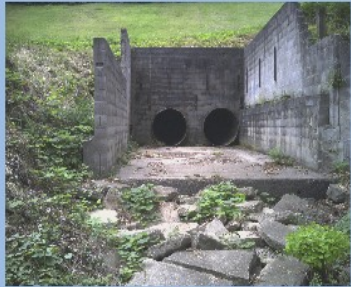
SG-64362-A	
SG-64362-A

IMG_0028378.jpg	
COF MS4 ID	SG-64362-A
Watershed	Stack Gully
Material	CMP
Shape_1	Circular
Depth	0
Top Width	0
Bottom Width	0
Type	Closed Pipe
Category	
Outfall_No	<Null>
Comment	Under Scenic 98
Flow Description	None
Outfall Damage	Corrosion
Deposits/Stains	
Abnormal Vegetation	
Poor Pool Quality	
Pipe Benthic Growth	
Barrels	2
Diameter	60
Submerged in Water	No
Submerged With Sediment	No
Date Collected	7/9/2012
2012 Photo 1	0028378
2012 Photo 2	<Null>

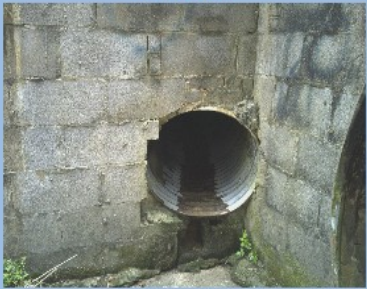
IMG_0028379.jpg

COF MS4 ID	SG-64362-B
Watershed	Stack Gully
Material	CMP
Shape_1	Circular
Depth	0
Top Width	0
Bottom Width	0
Type	Closed Pipe
Category	
Outfall_No	<Null>
Comment	Corroded invert
Flow Description	None
Outfall Damage	Corrosion
Deposits/Stains	
Abnormal Vegetation	
Poor Pool Quality	
Pipe Benthic Growth	
Barrels	1
Diameter	24
Submerged in Water	No
Submerged With Sediment	No
Date Collected	7/9/2012
2012 Photo 1	0028379
2012 Photo 2	<Null>

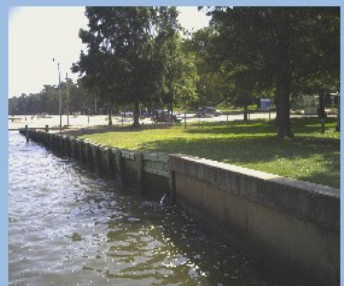
IMG_00002.jpg

COF MS4 ID	SG-64362-D
Watershed	Stack Gully
Material	RCP
Shape_1	Circular
Depth	0
Top Width	0
Bottom Width	0
Type	Closed Pipe
Category	
Outfall_No	
Comment	
Flow Description	Moderate
Outfall Damage	
Deposits/Stains	
Abnormal Vegetation	
Poor Pool Quality	
Pipe Benthic Growth	
Barrels	1
Diameter	15
Submerged in Water	No
Submerged With Sediment	No
Date Collected	6/14/2012
2012 Photo 1	00002
2012 Photo 2	<Null>
