City of Fairhope - Outfall Inventory Volanta Watershed

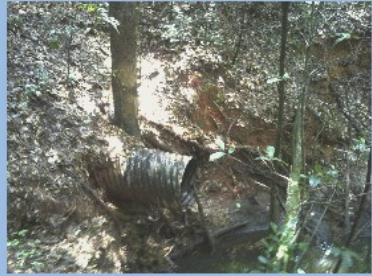
IMG_0027355.jpg

COF MS4 ID	VL-110128-A
Watershed	Volanta
Material	CMP
Shape_1	Circular
Depth	0
Top Width	0
Bottom Width	0
Type	Closed Pipe
Category	
Outfall_No	<Null>
Comment	Big erosion below pipe discharge
Flow Description	Trickle
Outfall Damage	Corrosion
Deposits/Stains	
Abnormal Vegetation	
Poor Pool Quality	
Pipe Benthic Growth	
Barrels	1
Diameter	24
Submerged in Water	No
Submerged With Sediment	No
Date Collected	7/6/2012
2012 Photo 1	0027355
2012 Photo 2	0028356

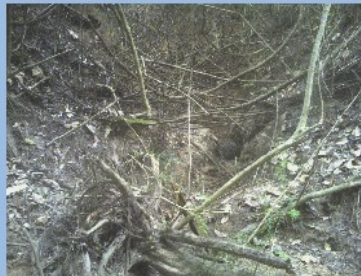
IMG_0015207.jpg

COF MS4 ID	VL-18772-B
Watershed	Volanta
Material	Earthen
Shape_1	Other
Depth	8
Top Width	15
Bottom Width	4
Type	Open Drainage
Category	
Outfall_No	<Null>
Comment	Mobile Street discharge to Volanta Gully
Flow Description	None
Outfall Damage	
Deposits/Stains	
Abnormal Vegetation	
Poor Pool Quality	
Pipe Benthic Growth	
Barrels	
Diameter	0
Submerged in Water	
Submerged With Sediment	
Date Collected	7/2/2012
2012 Photo 1	0015207
2012 Photo 2	<Null>

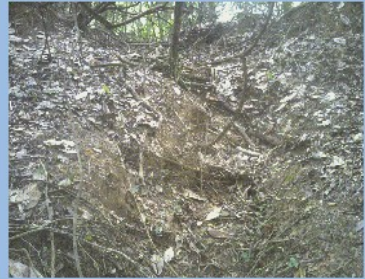
IMG_0015208.jpg

COF MS4 ID	VL-18772-C
Watershed	Volanta
Material	Earthen
Shape_1	Other
Depth	2
Top Width	6
Bottom Width	2
Type	Open Drainage
Category	
Outfall_No	<Null>
Comment	Yard drainage
Flow Description	None
Outfall Damage	
Deposits/Stains	
Abnormal Vegetation	
Poor Pool Quality	
Pipe Benthic Growth	
Barrels	
Diameter	0
Submerged in Water	
Submerged With Sediment	
Date Collected	7/2/2012
2012 Photo 1	0015208
2012 Photo 2	<Null>

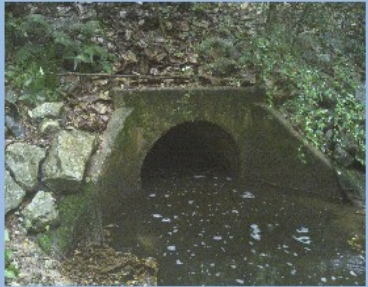
IMG_0024340.jpg

COF MS4 ID	VL-34073-B
Watershed	Volanta
Material	CMP
Shape_1	Circular
Depth	0
Top Width	0
Bottom Width	0
Type	Closed Pipe
Category	
Outfall_No	<Null>
Comment	Ingleside crossing
Flow Description	Moderate
Outfall Damage	
Deposits/Stains	
Abnormal Vegetation	
Poor Pool Quality	
Pipe Benthic Growth	
Barrels	1
Diameter	42
Submerged in Water	Partially
Submerged With Sediment	No
Date Collected	7/6/2012
2012 Photo 1	0024340
2012 Photo 2	<Null>

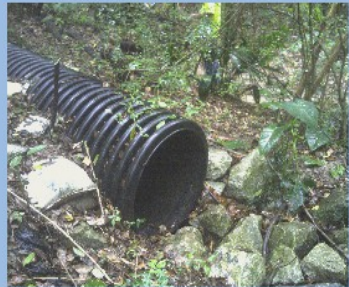
IMG_0026344.jpg

COF MS4 ID	VL-34073-C
Watershed	Volanta
Material	HDPE
Shape_1	Circular
Depth	0
Top Width	0
Bottom Width	0
Type	Closed Pipe
Category	
Outfall_No	<Null>
Comment	Yard drainage ?
Flow Description	
Outfall Damage	
Deposits/Stains	
Abnormal Vegetation	
Poor Pool Quality	
Pipe Benthic Growth	
Barrels	1
Diameter	24
Submerged in Water	No
Submerged With Sediment	No
Date Collected	7/6/2012
2012 Photo 1	0026344
2012 Photo 2	<Null>

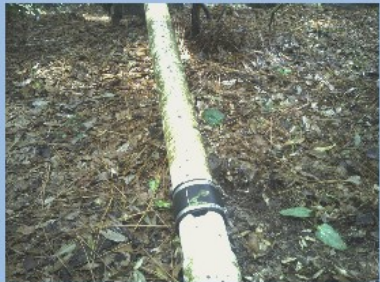
IMG_0027349.jpg

COF MS4 ID	VL-36204-A
Watershed	Volanta
Material	PVC
Shape_1	Circular
Depth	0
Top Width	0
Bottom Width	0
Type	Closed Pipe
Category	
Outfall_No	<Null>
Comment	Sewer line with hole
Flow Description	None
Outfall Damage	
Deposits/Stains	
Abnormal Vegetation	
Poor Pool Quality	
Pipe Benthic Growth	
Barrels	1
Diameter	4
Submerged in Water	
Submerged With Sediment	
Date Collected	7/6/2012
2012 Photo 1	0027349
2012 Photo 2	<Null>

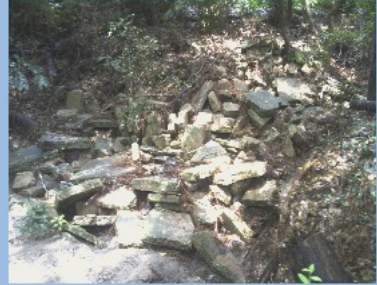
VL-36204-B	
VL-36204-B

IMG_0027347.jpg	
COF MS4 ID	VL-36204-B
Watershed	Volanta
Material	Rip_rap
Shape_1	Other
Depth	0
Top Width	0
Bottom Width	0
Type	Open Drainage
Category	
Outfall_No	<Null>
Comment	Checkdam
Flow Description	None
Outfall Damage	
Deposits/Stains	
Abnormal Vegetation	
Poor Pool Quality	
Pipe Benthic Growth	
Barrels	
Diameter	0
Submerged in Water	
Submerged With Sediment	
Date Collected	7/6/2012
2012 Photo 1	0027347
2012 Photo 2	<Null>

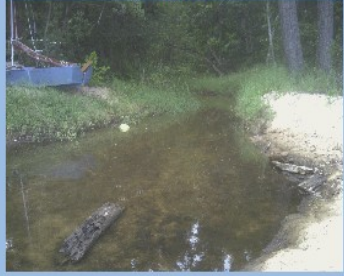
VL-43887-A	
VL-43887-A

IMG_0015203.jpg	
IMG_0015203.jpg	IMG_0016204.jpg
COF MS4 ID	VL-43887-A
Watershed	Volanta
Material	Earthen
Shape_1	Trapezoid
Depth	4
Top Width	20
Bottom Width	12
Type	Open Drainage
Category	Bay Outfall
Outfall_No	10
Comment	Volanta Gulley discharge to Bay
Flow Description	Trickle
Outfall Damage	
Deposits/Stains	
Abnormal Vegetation	
Poor Pool Quality	
Pipe Benthic Growth	
Barrels	
Diameter	0
Submerged in Water	
Submerged With Sediment	
Date Collected	7/2/2012
2012 Photo 1	0015203
2012 Photo 2	0016204

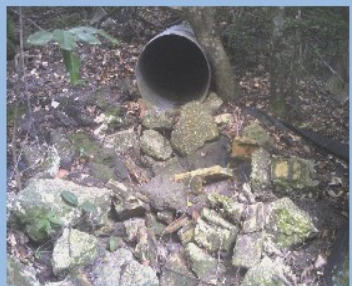
IMG_0015210.jpg

COF MS4 ID	VL-43889-A
Watershed	Volanta
Material	CMP
Shape_1	Circular
Depth	0
Top Width	0
Bottom Width	0
Type	Closed Pipe
Category	
Outfall_No	<Null>
Comment	
Flow Description	
Outfall Damage	
Deposits/Stains	
Abnormal Vegetation	
Poor Pool Quality	
Pipe Benthic Growth	
Barrels	1
Diameter	18
Submerged in Water	No
Submerged With Sediment	No
Date Collected	7/2/2012
2012 Photo 1	0015210
2012 Photo 2	<Null>

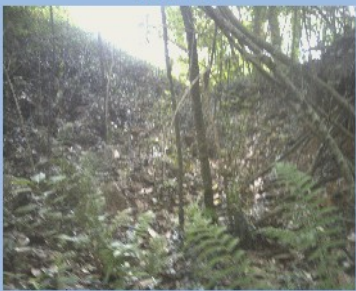
IMG_0015211.jpg

COF MS4 ID	VL-43889-B
Watershed	Volanta
Material	Rip_rap
Shape_1	Other
Depth	6
Top Width	15
Bottom Width	5
Type	Open Drainage
Category	
Outfall_No	<Null>
Comment	Yard drainage
Flow Description	None
Outfall Damage	
Deposits/Stains	
Abnormal Vegetation	
Poor Pool Quality	
Pipe Benthic Growth	
Barrels	
Diameter	0
Submerged in Water	
Submerged With Sediment	
Date Collected	7/2/2012
2012 Photo 1	0015211
2012 Photo 2	<Null>

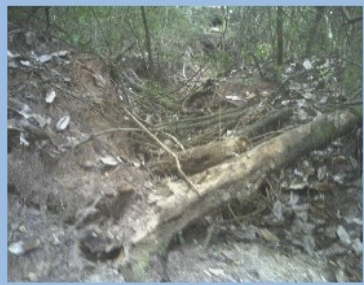
IMG_0015209.jpg

COF MS4 ID	VL-43889-C
Watershed	Volanta
Material	Earthen
Shape_1	Other
Depth	6
Top Width	10
Bottom Width	2
Type	Open Drainage
Category	
Outfall_No	<Null>
Comment	Below pipe discharge to Volanta Gulley
Flow Description	None
Outfall Damage	
Deposits/Stains	
Abnormal Vegetation	
Poor Pool Quality	
Pipe Benthic Growth	
Barrels	
Diameter	0
Submerged in Water	
Submerged With Sediment	
Date Collected	7/2/2012
2012 Photo 1	<Null>
2012 Photo 2	0015209

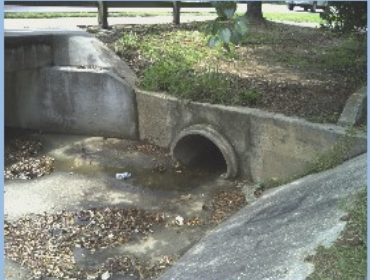
IMG_0027358.jpg

COF MS4 ID	VL-4651-A
Watershed	Volanta
Material	RCP
Shape_1	Arch
Depth	0
Top Width	0
Bottom Width	0
Type	Closed Pipe
Category	
Outfall_No	<Null>
Comment	22x36 rcp
Flow Description	Trickle
Outfall Damage	
Deposits/Stains	
Abnormal Vegetation	
Poor Pool Quality	
Pipe Benthic Growth	
Barrels	1
Diameter	36
Submerged in Water	No
Submerged With Sediment	No
Date Collected	7/6/2012
2012 Photo 1	0027358
2012 Photo 2	<Null>

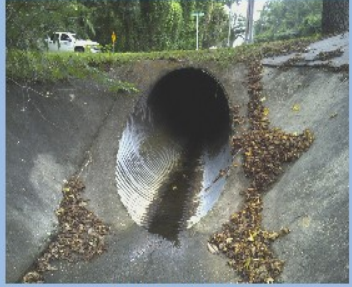
IMG_0027359.jpg

COF MS4 ID	VL-4651-B
Watershed	Volanta
Material	CMP
Shape_1	Circular
Depth	0
Top Width	0
Bottom Width	0
Type	Closed Pipe
Category	
Outfall_No	<Null>
Comment	
Flow Description	None
Outfall Damage	
Deposits/Stains	
Abnormal Vegetation	
Poor Pool Quality	
Pipe Benthic Growth	
Barrels	1
Diameter	48
Submerged in Water	No
Submerged With Sediment	No
Date Collected	7/6/2012
2012 Photo 1	0027359
2012 Photo 2	<Null>

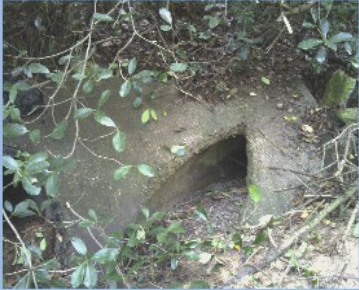
IMG_0027361.jpg

COF MS4 ID	VL-47625-B
Watershed	Volanta
Material	RCP
Shape_1	Circular
Depth	0
Top Width	0
Bottom Width	0
Type	Closed Pipe
Category	
Outfall_No	<Null>
Comment	Parking discharge
Flow Description	None
Outfall Damage	
Deposits/Stains	
Abnormal Vegetation	
Poor Pool Quality	
Pipe Benthic Growth	
Barrels	1
Diameter	24
Submerged in Water	No
Submerged With Sediment	Partially
Date Collected	7/6/2012
2012 Photo 1	0027361
2012 Photo 2	<Null>

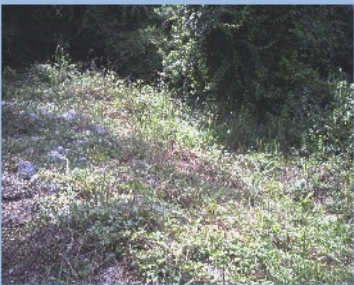
IMG_0027363.jpg

COF MS4 ID	VL-47625-D
Watershed	Volanta
Material	Rip_rap
Shape_1	Trapezoid
Depth	4
Top Width	20
Bottom Width	10
Type	Open Drainage
Category	
Outfall_No	<Null>
Comment	Armored ditch
Flow Description	None
Outfall Damage	
Deposits/Stains	
Abnormal Vegetation	
Poor Pool Quality	
Pipe Benthic Growth	
Barrels	
Diameter	0
Submerged in Water	
Submerged With Sediment	
Date Collected	7/6/2012
2012 Photo 1	0027363
2012 Photo 2	0028364

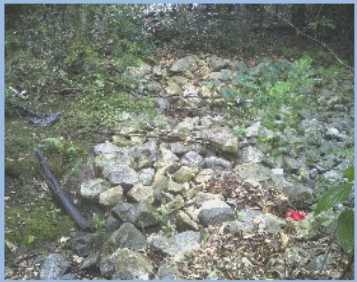
IMG_0025341.jpg

COF MS4 ID	VL-56062-A
Watershed	Volanta
Material	Rip_rap
Shape_1	Other
Depth	2
Top Width	20
Bottom Width	20
Type	Open Drainage
Category	
Outfall_No	<Null>
Comment	Stabilization work beginning
Flow Description	None
Outfall Damage	
Deposits/Stains	
Abnormal Vegetation	
Poor Pool Quality	
Pipe Benthic Growth	
Barrels	
Diameter	0
Submerged in Water	
Submerged With Sediment	
Date Collected	7/6/2012
2012 Photo 1	0025341
2012 Photo 2	<Null>

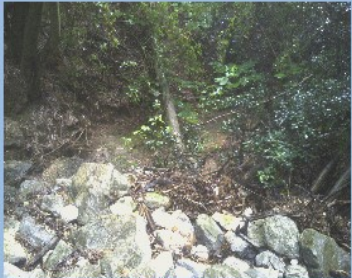
IMG_0026342.jpg

COF MS4 ID	VL-56062-B
Watershed	Volanta
Material	Rip_rap
Shape_1	Other
Depth	6
Top Width	20
Bottom Width	20
Type	Open Drainage
Category	
Outfall_No	<Null>
Comment	Stabilization ended
Flow Description	
Outfall Damage	
Deposits/Stains	
Abnormal Vegetation	
Poor Pool Quality	
Pipe Benthic Growth	
Barrels	
Diameter	0
Submerged in Water	
Submerged With Sediment	
Date Collected	7/6/2012
2012 Photo 1	0026342
2012 Photo 2	0027343

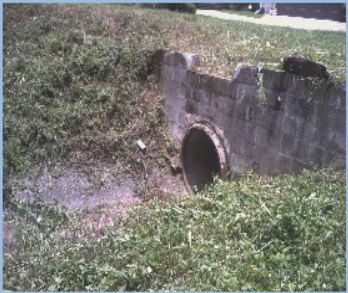
IMG_0027351.jpg

COF MS4 ID	VL-56704-A
Watershed	Volanta
Material	RCP
Shape_1	Circular
Depth	0
Top Width	0
Bottom Width	0
Type	Closed Pipe
Category	
Outfall_No	<Null>
Comment	Under Myrtle
Flow Description	None
Outfall Damage	
Deposits/Stains	
Abnormal Vegetation	
Poor Pool Quality	
Pipe Benthic Growth	
Barrels	1
Diameter	42
Submerged in Water	No
Submerged With Sediment	No
Date Collected	7/6/2012
2012 Photo 1	0027351
2012 Photo 2	<Null>

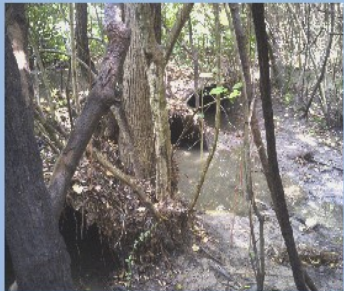
IMG_0027353.jpg

COF MS4 ID	VL-72822-A
Watershed	Volanta
Material	CMP
Shape_1	Elliptical
Depth	0
Top Width	0
Bottom Width	0
Type	Closed Pipe
Category	
Outfall_No	<Null>
Comment	Under street
Flow Description	Trickle
Outfall Damage	
Deposits/Stains	
Abnormal Vegetation	
Poor Pool Quality	
Pipe Benthic Growth	
Barrels	3
Diameter	56
Submerged in Water	Partially
Submerged With Sediment	Partially
Date Collected	7/6/2012
2012 Photo 1	0027353
2012 Photo 2	<Null>

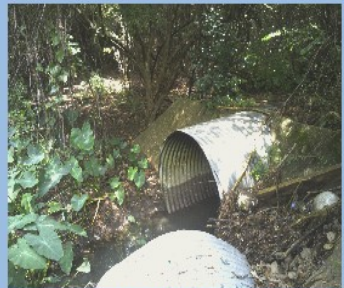
IMG_0027352.jpg

COF MS4 ID	VL-73246-A
Watershed	Volanta
Material	CMP
Shape_1	Circular
Depth	0
Top Width	0
Bottom Width	0
Type	Closed Pipe
Category	
Outfall_No	<Null>
Comment	
Flow Description	Trickle
Outfall Damage	
Deposits/Stains	
Abnormal Vegetation	
Poor Pool Quality	
Pipe Benthic Growth	
Barrels	1
Diameter	48
Submerged in Water	Partially
Submerged With Sediment	No
Date Collected	7/6/2012
2012 Photo 1	0027352
2012 Photo 2	<Null>

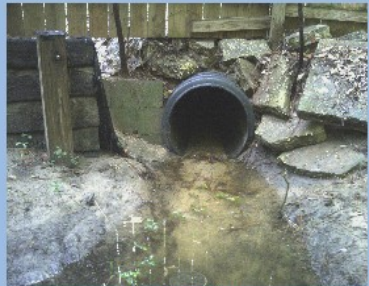
IMG_0027354.jpg

COF MS4 ID	VL-73246-B
Watershed	Volanta
Material	HDPE
Shape_1	Circular
Depth	0
Top Width	0
Bottom Width	0
Type	Closed Pipe
Category	
Outfall_No	<Null>
Comment	
Flow Description	None
Outfall Damage	
Deposits/Stains	
Abnormal Vegetation	
Poor Pool Quality	
Pipe Benthic Growth	
Barrels	1
Diameter	24
Submerged in Water	Partially
Submerged With Sediment	No
Date Collected	7/6/2012
2012 Photo 1	0027354
2012 Photo 2	<Null>

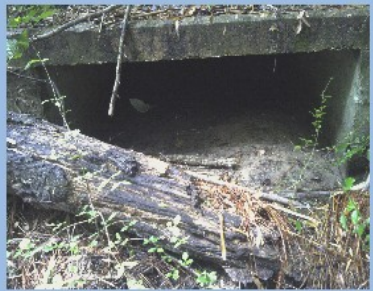
IMG_0027357.jpg

COF MS4 ID	VL-89431-A
Watershed	Volanta
Material	RCP
Shape_1	Circular
Depth	0
Top Width	0
Bottom Width	0
Type	Closed Pipe
Category	
Outfall_No	<Null>
Comment	Outlet box
Flow Description	None
Outfall Damage	
Deposits/Stains	
Abnormal Vegetation	
Poor Pool Quality	
Pipe Benthic Growth	
Barrels	1
Diameter	24
Submerged in Water	No
Submerged With Sediment	Partially
Date Collected	7/6/2012
2012 Photo 1	0027357
2012 Photo 2	<Null>
