Fairhope Beach Management Plan

Recommendations for a Beach Management Plan for Fairhope's Two Main Beaches

| September 1, 2016

SOUTH COAST ENGINEERS

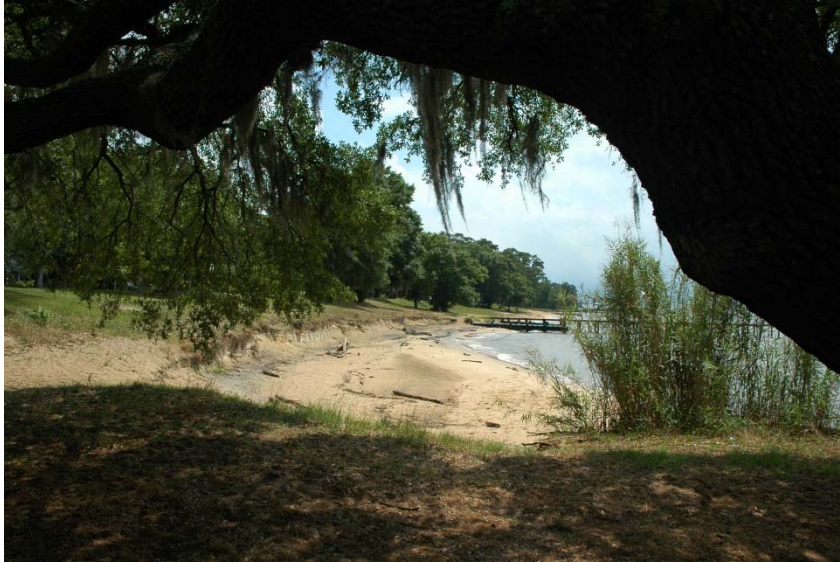
Figure 3: Photograph from June 2004 showing that bluff erosion at the north end of Magnolia Beach Park was problematic in early 2004. This photograph was taken looking south through the overhanging limbs of the large live oak tree which is south of the boat ramp. (Note: In 2004, the roots of that tree in the center of this photograph were exposed by the erosion – see Figure 4).

The photographs in Figures 3 and 4 were taken in June 2004 and show that the erosion problem extends at least that far back in time. Figure 3 shows the eroding bluff taken from under the large live oak tree which still exists just south of the boat ramp. The low-hanging branches have made that tree a popular climbing tree for generations of Fairhope children. Figure 4 shows that the roots of that tree were being exposed by erosion flanking the southeast end of the bulkhead structure around the boat ramp in early summer 2004.

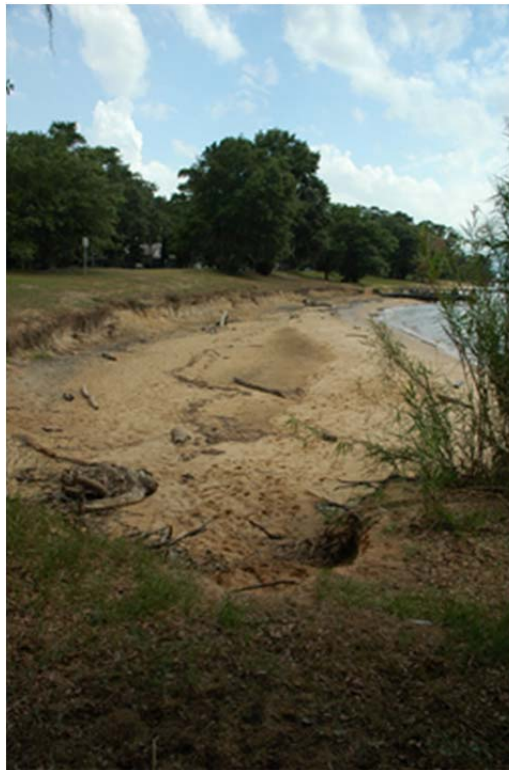
Figure 4: Photograph from June 2004 showing exposed roots of the large live oak tree near the boat ramp. This beloved oak tree still exists today because of the beach nourishments and the timber headland-jetty structure constructed in 2005 to its immediate southwest

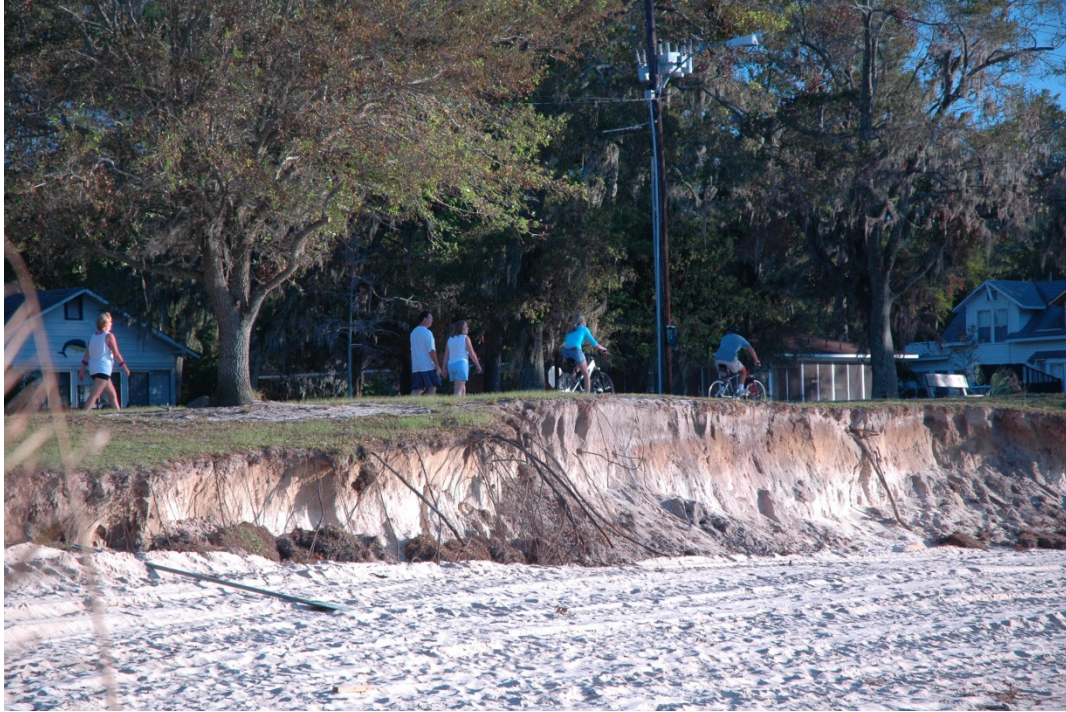
Figure 5: October 2004 photograph shows that some sand (unknown quantity) was mechanically placed on the beaches in the foreground at the northern end of Magnolia Beach Park after bluff erosion exacerbated by Hurricane Ivan (Also: note the small live oak tree on the bluff in the background on the left side of the photograph. That tree was destroyed a year later by bluff erosion caused by Hurricane Katrina)

Hurricane Ivan struck the Alabama coast in September 2004 and caused significant bluff erosion along all of Magnolia Beach Park. Figure 5 is a photograph from October 2004 showing both the bluff erosion as well as indicating that some new sand had been brought in and placed around there as storm damage mitigation. It is worth noting that the smaller live oak tree on the bluff in the background of Figure 4 was subsequently destroyed by the bluff erosion caused by Hurricane Katrina in 2005 and is no longer there.

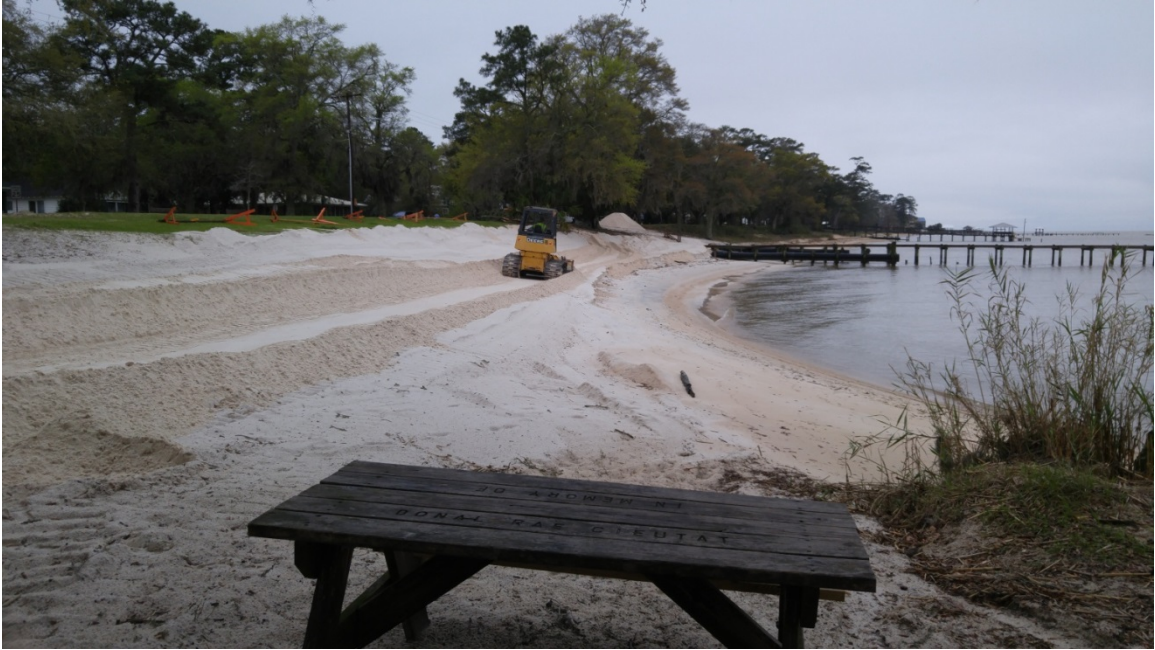
Figure 6: Photograph showing new sand being spread at Magnolia Beach Park in the 2016 beach nourishment (March 2016).

deposit similar to the white sands of the beaches of Gulf Shores. Trucks haul the sand to the beach site where it is spread along the beach as shown in Figure 6.

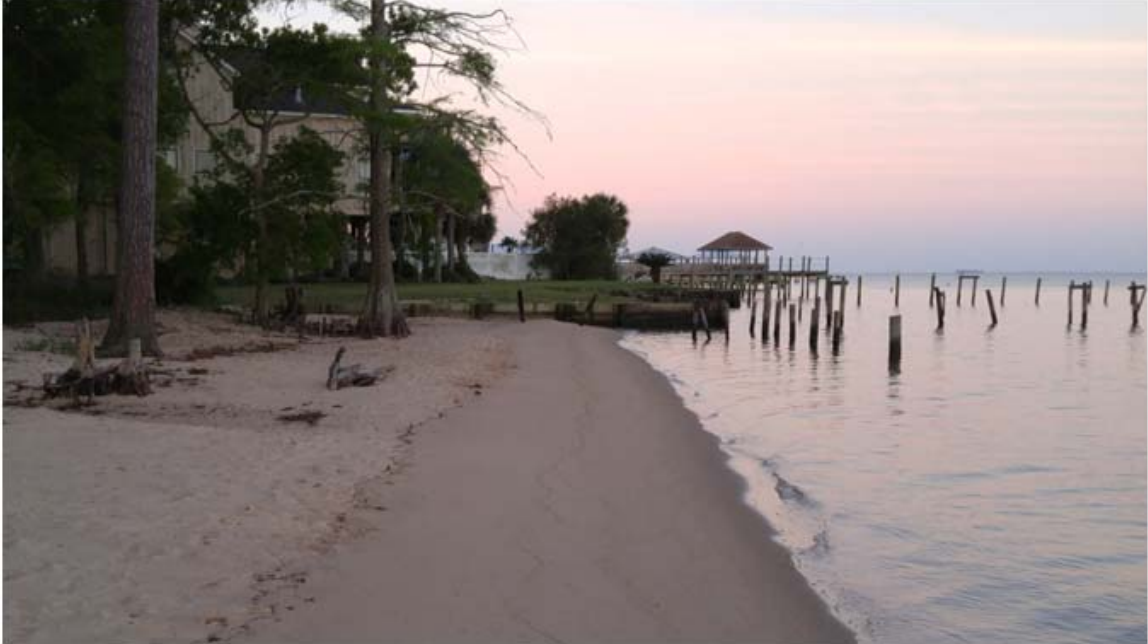
Figure 12: Photograph (facing south) showing winter sand accretion at the southern end of Magnolia Beach Park, near the American Legion (April 2016).

winter/spring) and in Figure 14 (summer). Here the beach at the southern end is eroded, while the beach at the northern end has recovered. Figure 16 shows the wide beach at the northern end from another angle, where the darker native sands have filled in seaward of the new, white sand placed as part of the 2016 nourishment project.

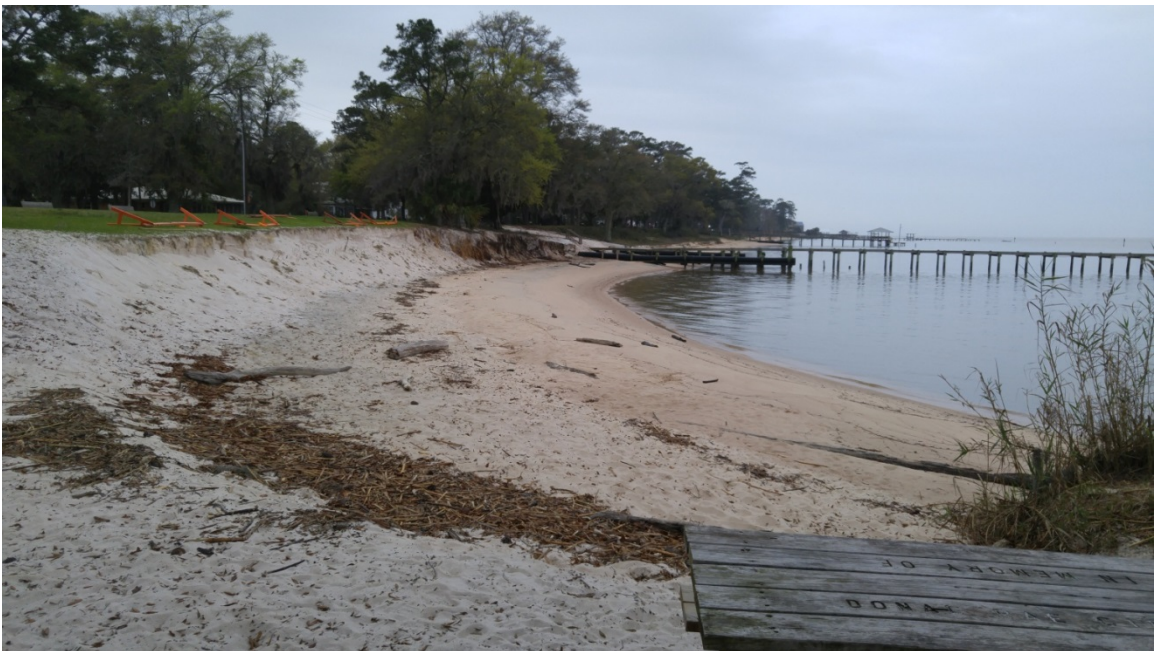
Figure 13: Photograph (facing south) showing winter erosion at the northern end of Magnolia Beach Park, near the boat launch (February 2016).

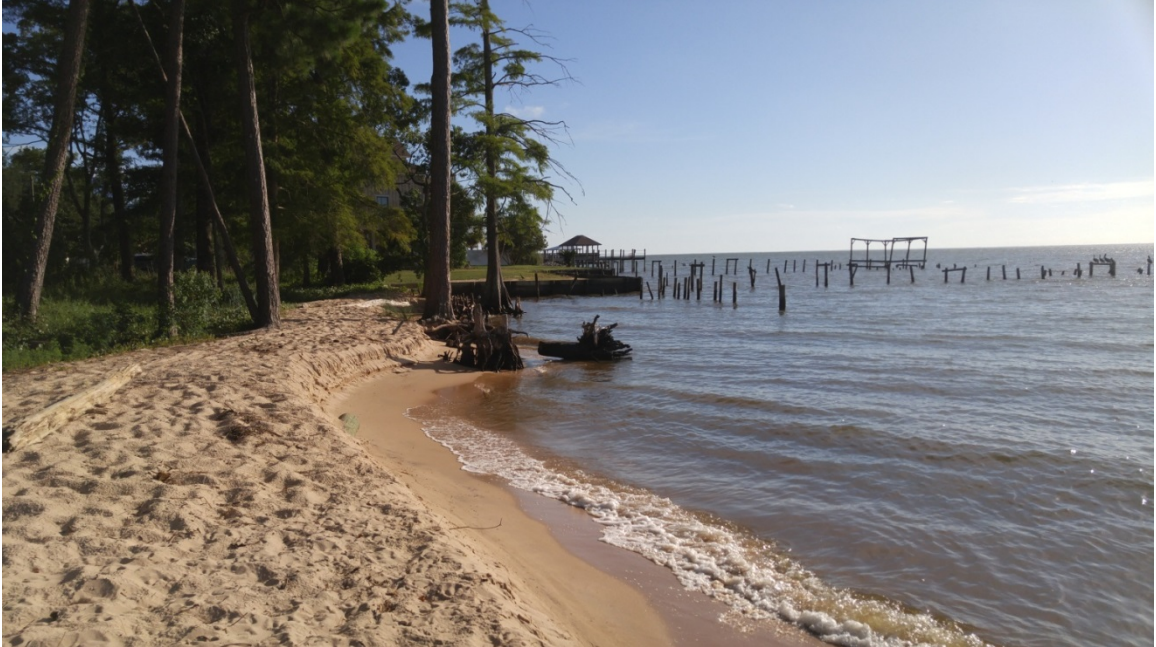
Figure 14: Photograph (facing south) showing summer erosion at the southern end of Magnolia Beach Park, near the American Legion (July 2016).

Figures 14 and 15 show the ends of the Magnolia Beach Park littoral cell conditions in the late spring and summer months, when southerly winds dominate and waves drive sand to the north. Figure 14 shows the erosion of the beach south of the American Legion beach and shows the characteristic curved shoreline consistent with sand transport to the north. Note the very different beach conditions shown in Figure 12 (end of

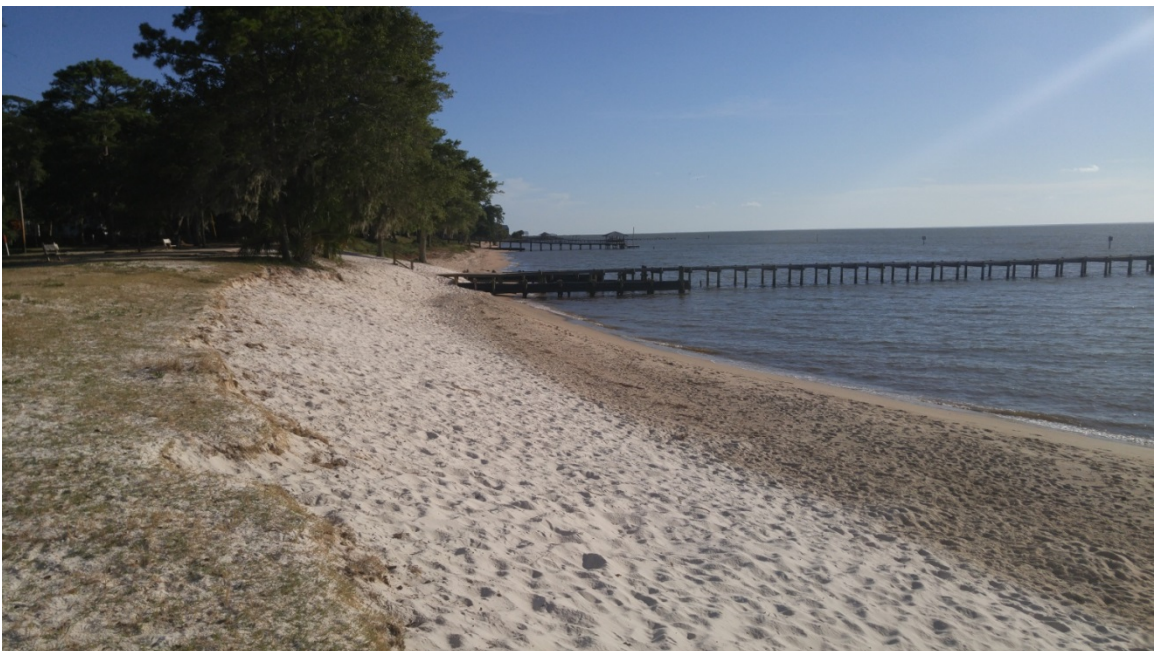
Figure 15: Photograph (facing south) showing summer accretion at the northern end of Magnolia Beach Park, near the boat launch (July 2016).

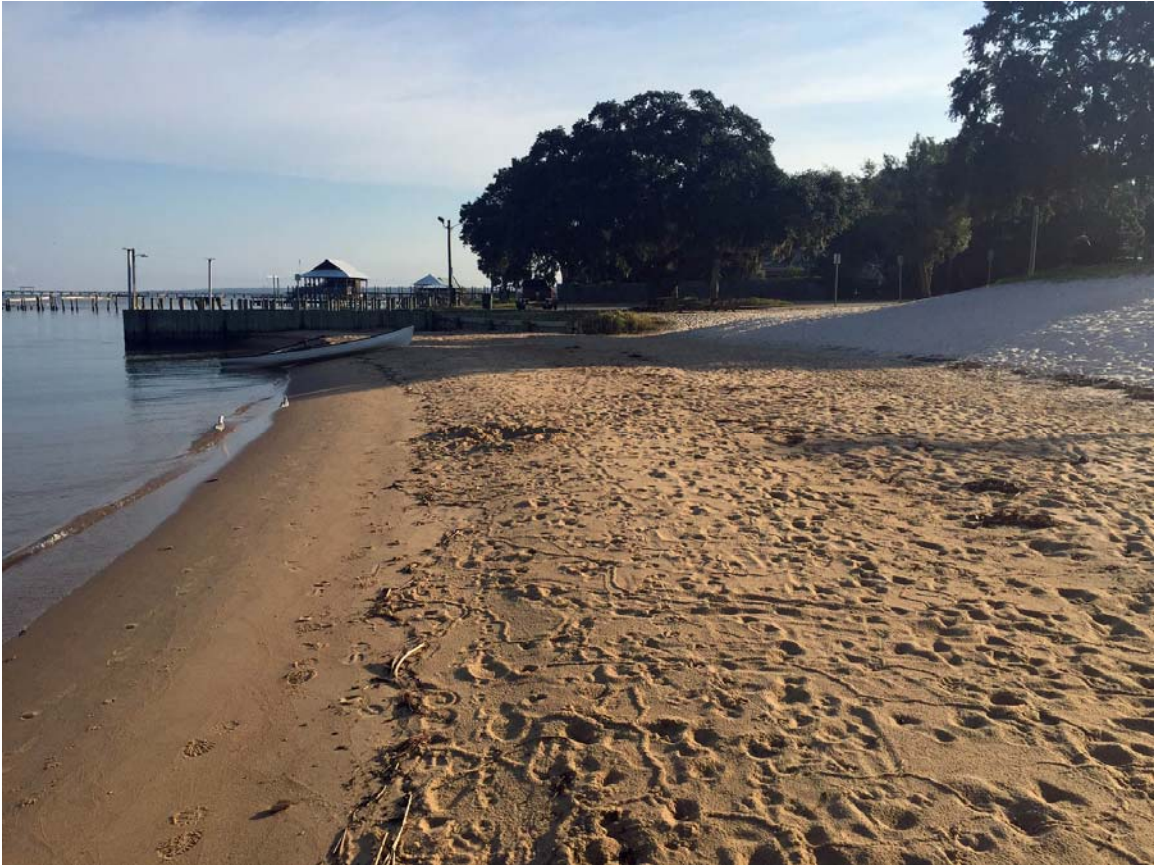
Figure 16: Photograph (facing north) showing summer accretion at the northern end of Magnolia Beach Park, near the boat launch (August 24, 2016).

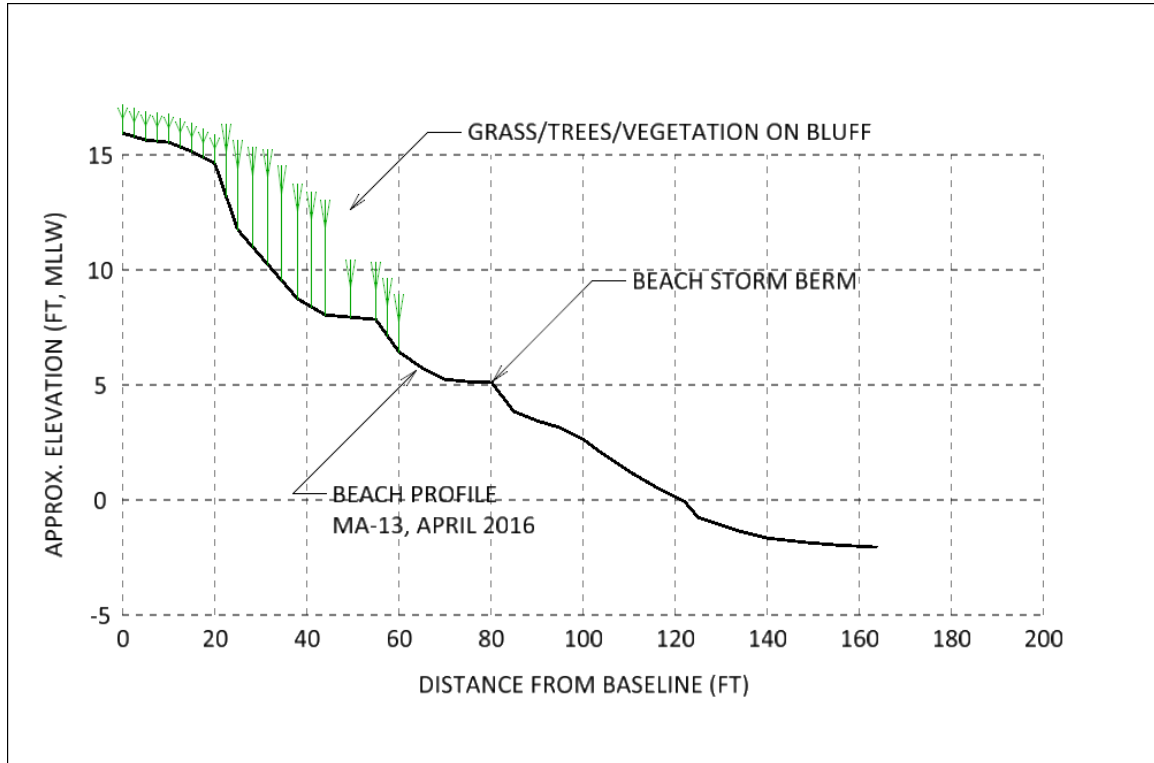
Figure 17: Plot showing existing vegetation near the center of Magnolia Beach Park (i.e. near the dolphin family statue). Here vegetation extends down the bluff and down to the beach face.

In the central part of the Magnolia Beach Park littoral cell, from about Pecan Ave. to Laurel Ave., mature vegetation exists on the bluff that runs parallel to the roadway and stretches to the beach face down to just above +5 ft MLLW in elevation. Above the bluff, grass and trees are prevalent. Notably, wind-blown sand is not a serious problem in these areas. A representative cross-section view of one such area is shown in Figure 17.

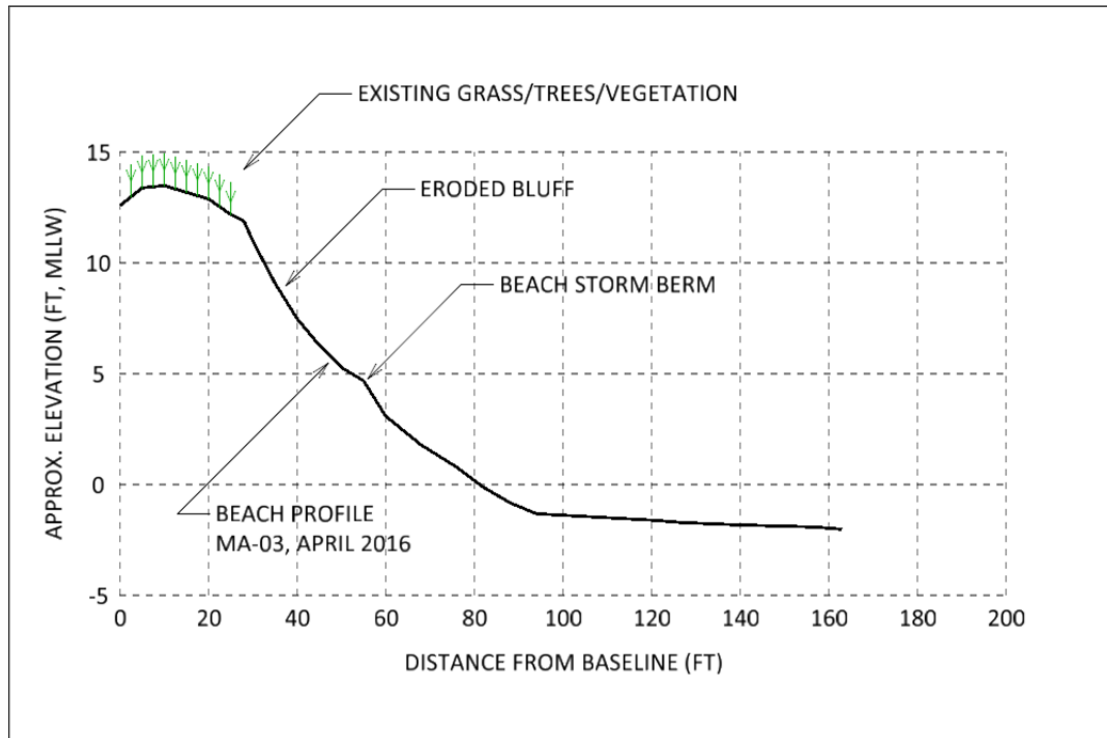
Figure 18: Plot showing existing vegetation at the northern end of Magnolia Beach Park. Here the bluff is actively eroding, and vegetation only survives above the eroding bluff.

At the northern end of Magnolia Beach Park, where the beach has been heavily eroded, little vegetation persists. A representative cross-section view of one such area is shown in Figure 18. The only vegetation is sod grass near the top of the existing bluff which was planted by the City after the 2014 beach nourishment project. Because of the erosive nature of this bluff in the past several years, no other vegetation has naturally colonized below that sod. Note how much narrower the beach profile is between the bluff line and the storm beach berm in the profile shown in Figure 18 (the eroded north end of Magnolia Beach Park) compared to the profile shown in Figure 17. If the beach at the north end could be more permanently stabilized to the west (e.g. recommendation in Figure 19), then a wider bluff could be vegetated which would reduce wind-blown sand problems. Essentially, the southern end situation is a model for the northern end situation if the beach can be stabilized. It should be noted that lack of mature vegetation is common to the beaches at the ends of littoral cells with headlands, where the shoreline is likely to erode and accrete seasonally, preventing the maturation of new growth.

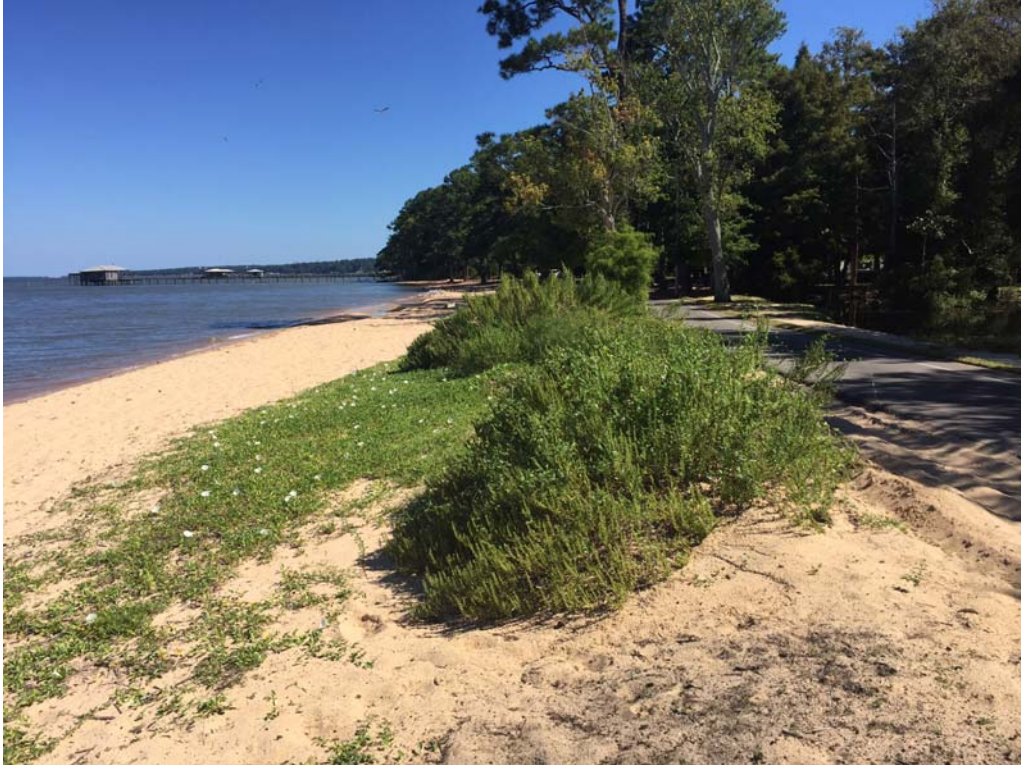
Figure 20: North end of North Beach Park showing narrowness of beach west of the road and vegetation on the dune-like feature.

related to the erosion may begin to be problematic. In particular, there is currently not much distance between the bay and the roadway around the duck pond as shown in Figure 20. At some point in the future, the City may want to consider engineering to address erosion related problems here also.

Plants reduce and catch wind-blown sand, keeping sand on the beach and keeping it out of the adjacent streets and properties. The use of plants for wind-blown erosion control may reduce the need to create a small dune-like feature at North Beach Park. Vegetation can continue to be encouraged on the small dune-like features as shown in Figure 20.
