Fairhope Beach Management Plan

Recommendations for a Beach Management Plan for Fairhope's Two Main Beaches

| September 30, 2016

SOUTH COAST ENGINEERS

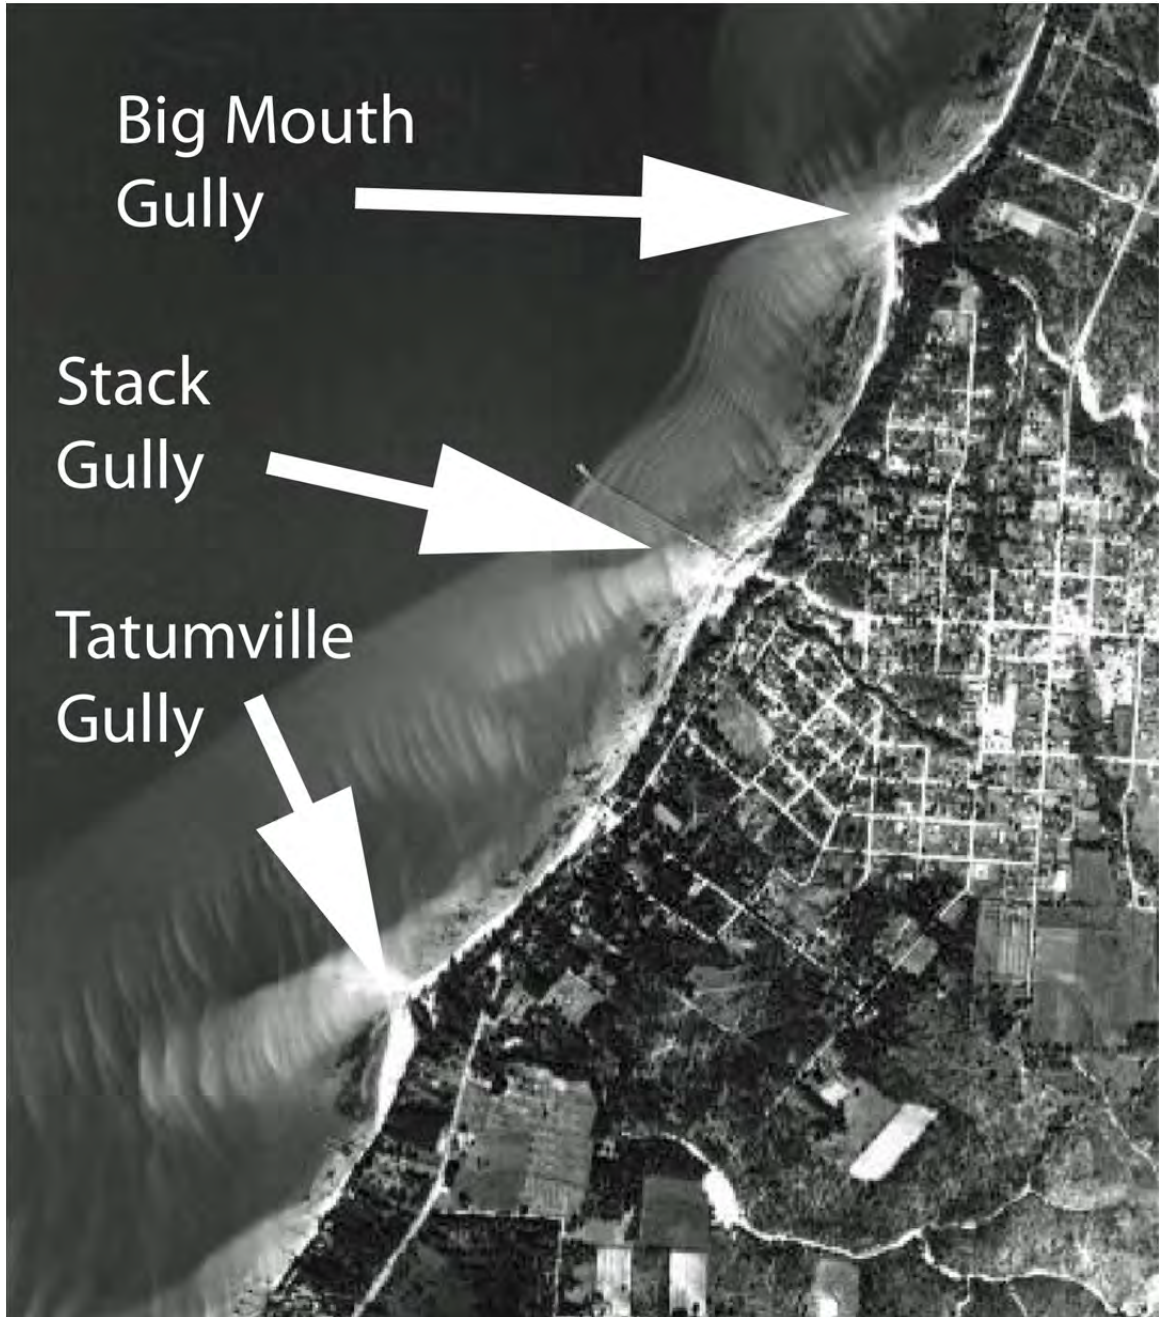
Figure 2: Aerial imagery of Fairhope's beaches (1938) showing major gullies entering Mobile Bay.

The primary natural source of sand for the beaches of the Fairhope is sand from erosion of the bluffs and the sand that flows out of the creek mouths during major rainfall events. This process continues today, where deposits of sand appear after significant storms at the mouths of the gullies and are spread by wave action along the beaches. Figure 2 shows a 1938 aerial photograph of this portion of the Fairhope coast which indicates that each of the creeks and gullies in the City was providing sand to the beaches.

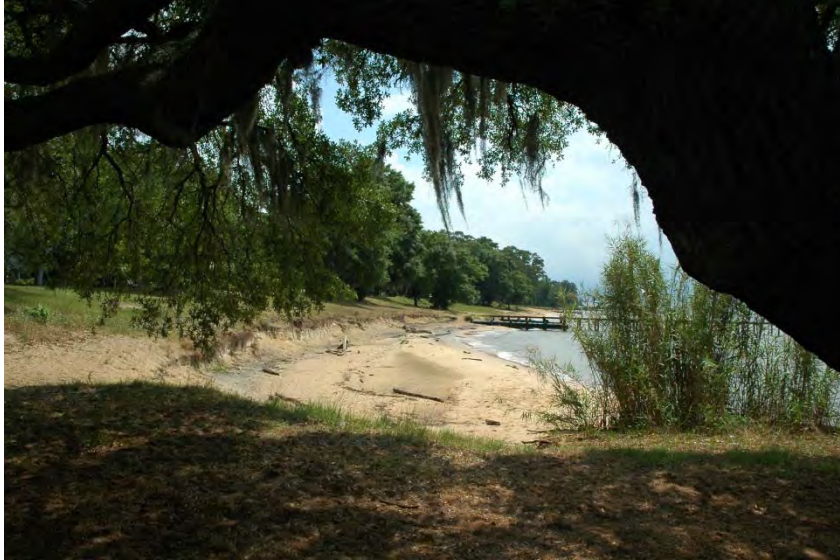
Figure 3: Photograph from June 2004 showing that bluff erosion at the north end of Magnolia Beach Park was problematic in early 2004. This photograph was taken looking south through the overhanging limbs of the large live oak tree which is south of the boat ramp. (Note: In 2004, the roots of that tree in the center of this photograph were exposed by the erosion – see Figure 4).

The photographs in Figures 3 and 4 were taken in June 2004 and show that the erosion problem extends at least that far back in time. Figure 3 shows the eroding bluff taken from under the large live oak tree which still exists just south of the boat ramp. The low-hanging branches have made that tree a popular climbing tree for generations of Fairhope children. Figure 4 shows that the roots of that tree were being exposed by erosion flanking the southeast end of the bulkhead structure around the boat ramp in early summer 2004.

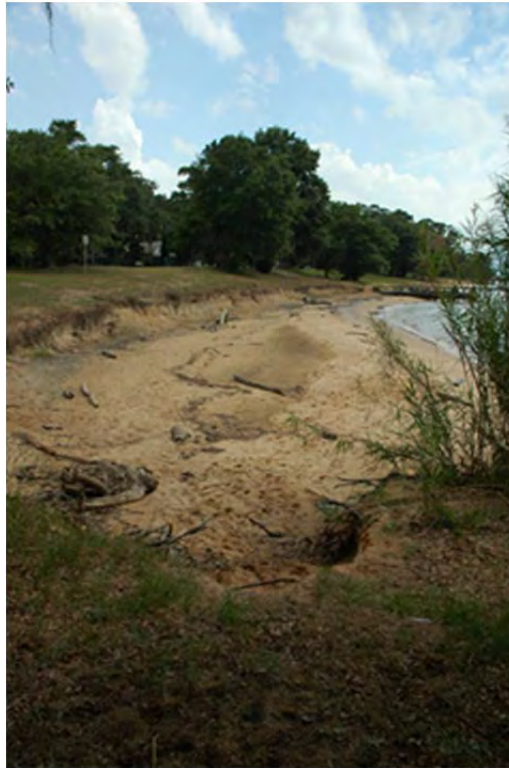
Figure 4: Photograph from June 2004 showing exposed roots of the large live oak tree near the boat ramp. This beloved oak tree still exists today because of the beach nourishments and the timber headland-jetty structure constructed in 2005 to its immediate southwest

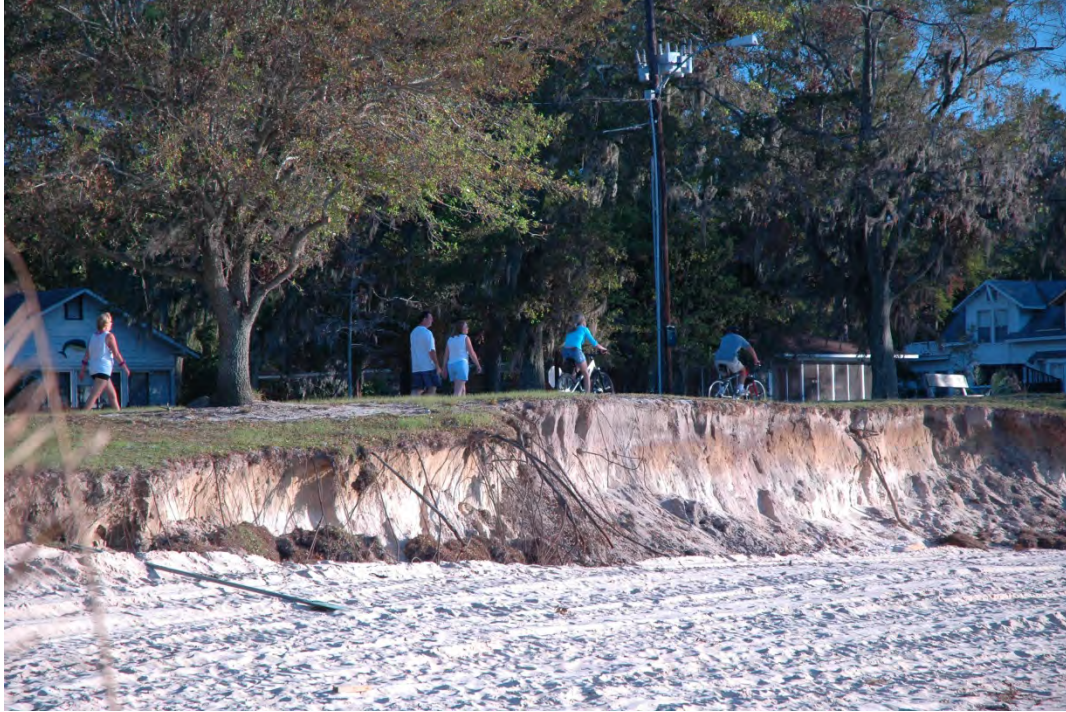
Figure 5: October 2004 photograph shows that some sand (unknown quantity) was mechanically placed on the beaches in the foreground at the northern end of Magnolia Beach Park after bluff erosion exacerbated by Hurricane Ivan (Also: note the small live oak tree on the bluff in the background on the left side of the photograph. That tree was destroyed a year later by bluff erosion caused by Hurricane Katrina)

Hurricane Ivan struck the Alabama coast in September 2004 and caused significant bluff erosion along all of Magnolia Beach Park. Figure 5 is a photograph from October 2004 showing both the bluff erosion as well as indicating that some new sand had been brought in and placed around there as storm damage mitigation. It is worth noting that the smaller live oak tree on the bluff in the background of Figure 4 was subsequently destroyed by the bluff erosion caused by Hurricane Katrina in 2005 and is no longer there.

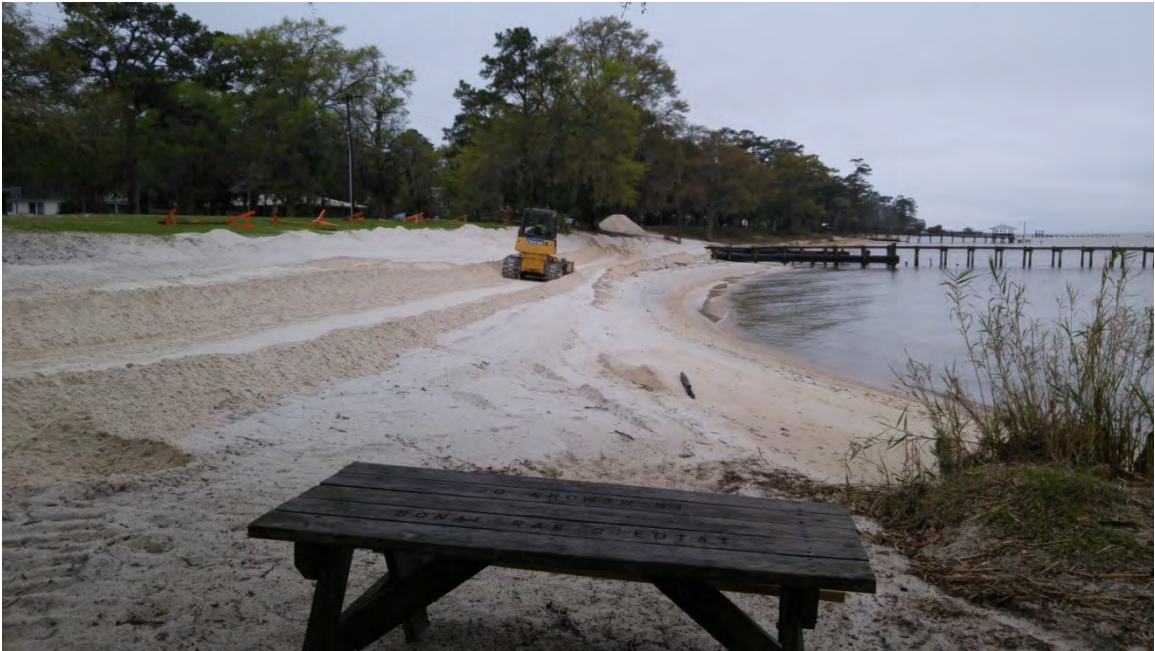
Figure 6: Photograph showing new sand being spread at Magnolia Beach Park in the 2016 beach nourishment (March 2016).

deposit similar to the white sands of the beaches of Gulf Shores. Trucks haul the sand to the beach site where it is spread along the beach as shown in Figure 6.

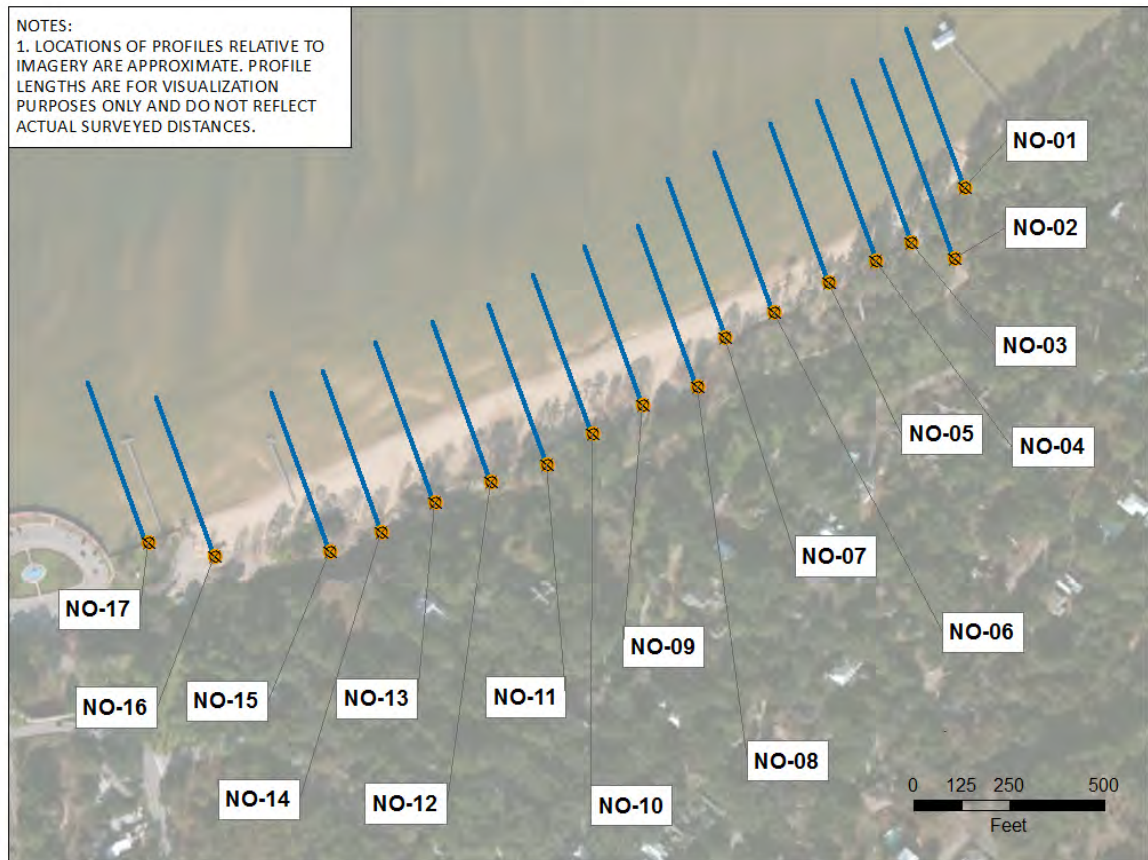
Figure 7: Beach profile locations for North Beach Park.

As part of the development of this beach management plan, 37 beach profiles were established: 20 at Magnolia Beach Park and 17 at North Beach Park. The locations of those profile lines are shown in Figures 7 and 8. Eight of these were re-occupied profiles that were originally established prior to the 2014 beach nourishment project at Magnolia Beach Park and have been repetitively surveyed over the intervening two years. Distances between the beach survey profiles vary from 50 feet to roughly 150 feet, and the profiles were surveyed generally to a distance of 100 feet offshore. All surveys were conducted relative to the mean lower low water (MLLW) tidal datum based on local tidal observations from around Mobile Bay. A separate Beach Profile Data Report has been developed, in conjunction with this management plan report, which documents the profile baseline locations and includes plots of the measured profiles.

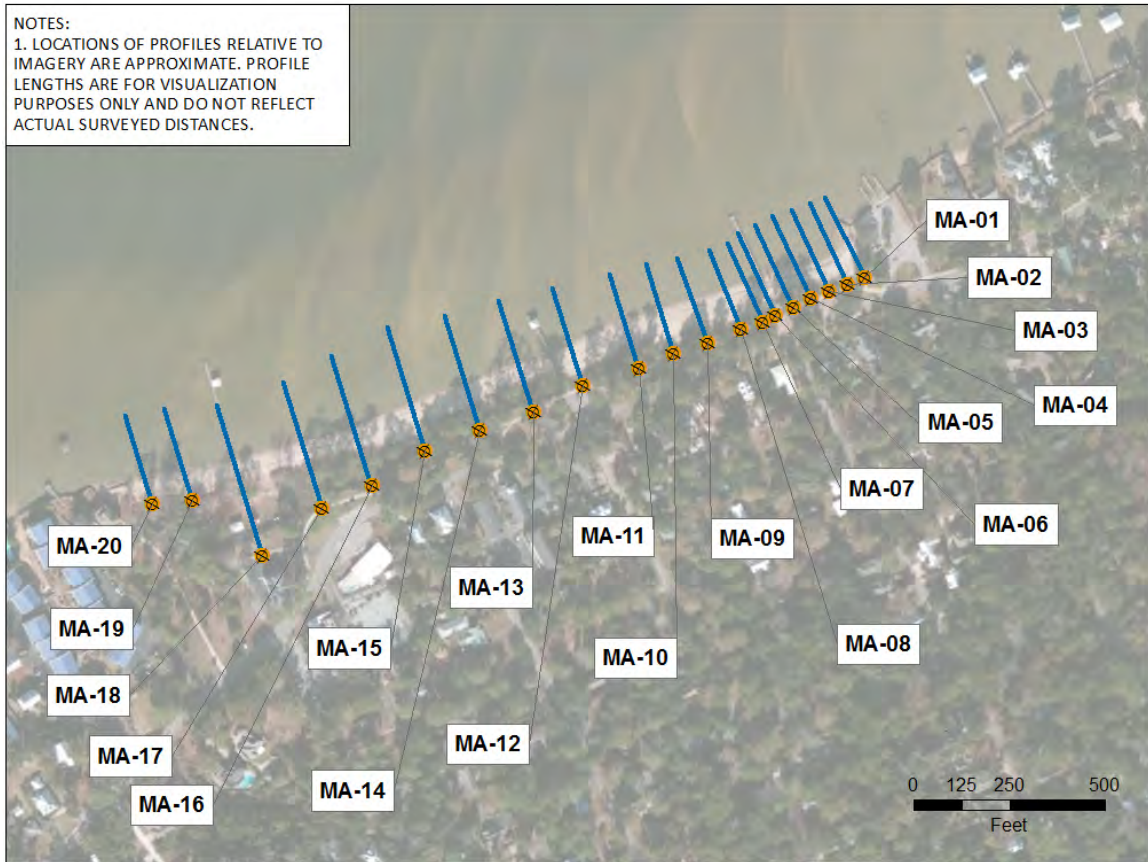
Figure 8: Beach profile locations for Magnolia Beach Park.

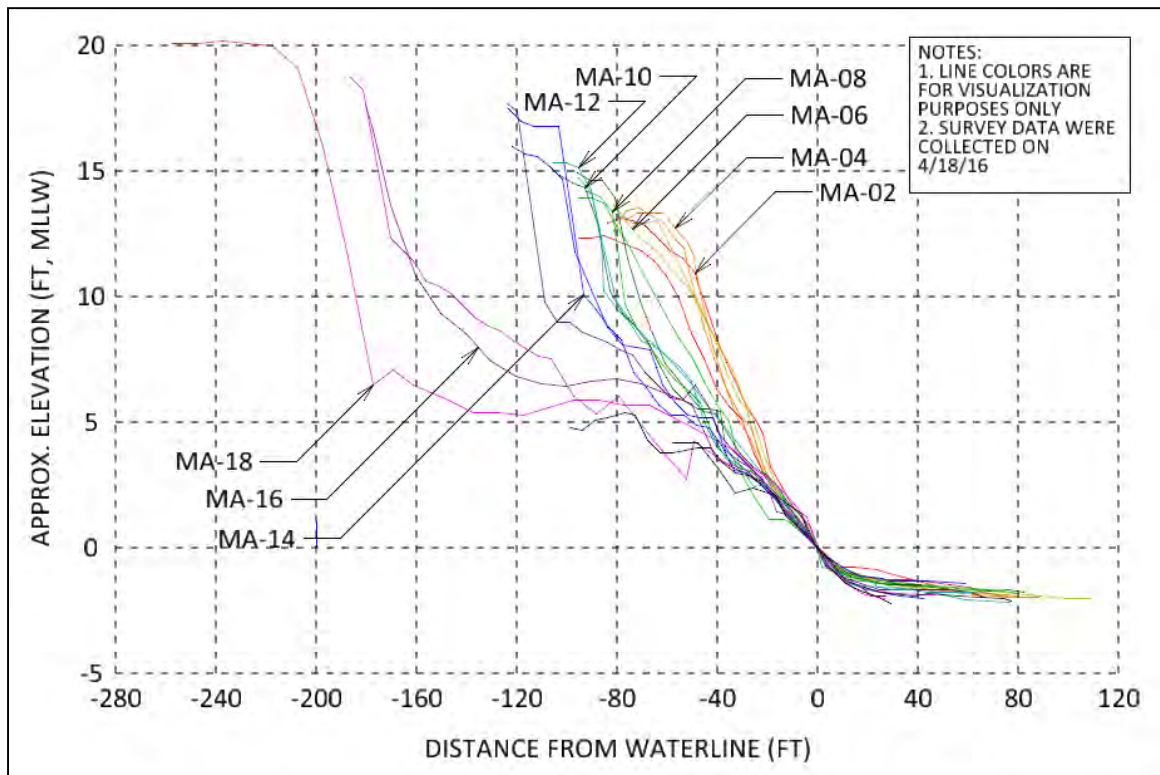
Figure 9: Plot showing all beach profiles for Magnolia Beach Park, relative to the waterline. Note: profiles are adjusted to a common station zero at the waterline.

Analysis of the beach profile surveys provides important context for the recommendations related to shoreline stabilization, beach nourishment, and vegetation plans. An overlay of all the beach profiles from Magnolia Beach Park is shown in Figure 9. The figure overlays the 20 surveyed profiles shifted laterally to match at the waterline in order to illustrate similarities along that part of the beach. Every second profile is identified and the colors of the lines indicate the general area of the profiles from north to south. The northernmost profiles are shown in red, and the southernmost profiles are shown in purple. See Figure 8 for a map of these beach profile locations.

wider. Thus, the implication is that the more southern, stable profile shapes are a reasonable target for all the profiles. This general beach profile shape is emulated in the recommended beach profile template below.

location but the lower portion (below +6 ft MLLW) should be consistent across all profiles because that emulates that healthy beach profiles (see Figure 9).

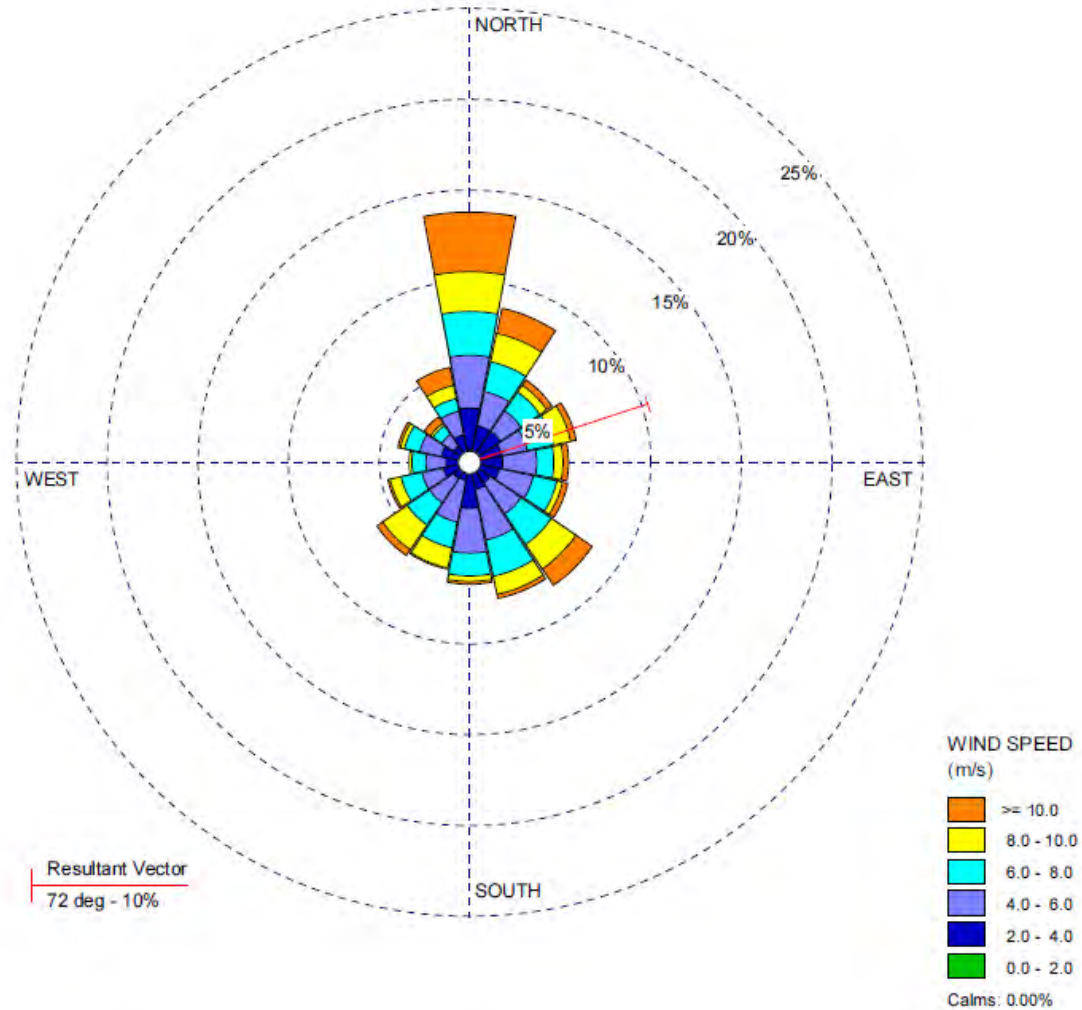
Figure 10: Wind rose plot for 2015 at Middle Bay Lighthouse. The banded colors represent intensities and distributions of wind from each direction.

Figure 10 shows a wind rose plot for the 2015 calendar year. Wind data were collected from the National Buoy Data Center for the station on Middle Bay Lighthouse. The wind rose plot describes the distribution of wind speeds at the lighthouse in various directions and intensities. Of the winds that would have generated waves affecting Fairhope beaches in 2015, southwest and north winds tended to dominate. Monthly or seasonal plots of these data (not shown here) indicate that the southwest winds, which cause northward sand transport, tend to prevail in the late spring and summer months. The north winds, which cause southward sand transport, tend to prevail in the late fall and winter months. This seasonality of winds is well known and controls the erosional signatures on the beaches to some extent.

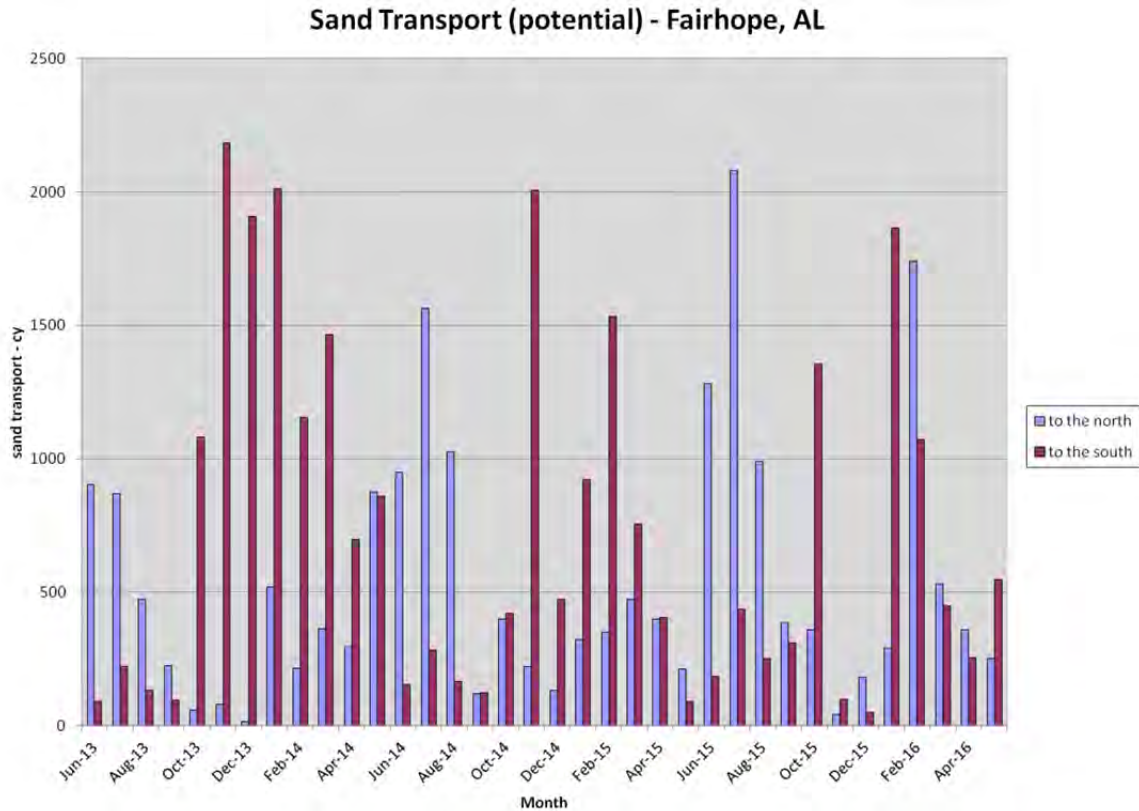
Figure 11: Plot showing monthly potential longshore sand transport along Fairhope's beaches from June 2013 to May 2016. The bars represent the gross volume of sand potentially moved either northward (blue) or southward (purple) in each month of the record. Months where the bars are about equal represent relatively balanced transport.

The longshore sand transport results are shown in Figure 11. The monthly transport estimates are shown as bar graphs that represent northward (blue) and southward (purple) transport for each month. In months when the blue bar is larger than the purple bar, northward transport dominated, and vice-versa. For example, in June 2013, northward transport dominated. Inspection of Figure 11 shows a strong seasonal pattern. For example the months of October 2013 through April 2014 had dominant transport to the south followed by the months of June through August 2014 which had dominant transport to the north. The beach nourishment of 2014 (Table 1) was done in May-June 2014 in response to that winter of very strong southward transport. Thus, it appears that the sand transport modeling results are consistent with the timing of the major erosion events triggering the recent required beach nourishments at the north end of Magnolia Beach Park. Similar triggers, as shown in Figure 11, were the winter months of November 2014 through March 2015 and October 2015 through January 2016. Each of these time periods had dominant southward transport and triggered required beach nourishments (see Table 1).

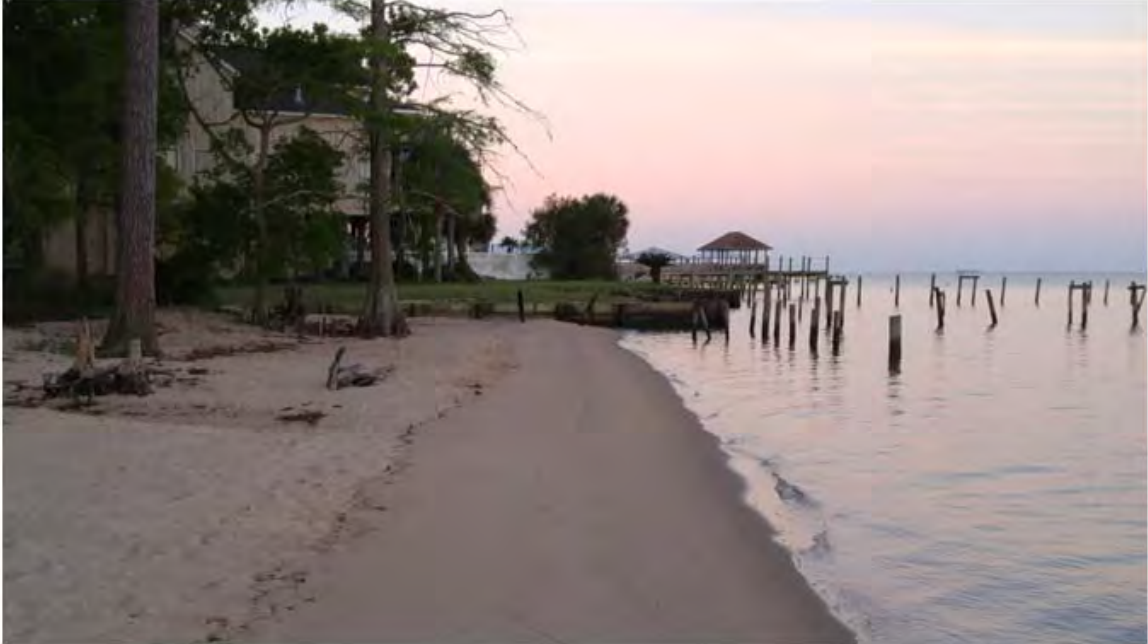
Figure 12: Photograph (facing south) showing winter sand accretion at the southern end of Magnolia Beach Park, near the American Legion (April 2016).

winter/spring) and in Figure 14 (summer). Here the beach at the southern end is eroded, while the beach at the northern end has recovered. Figure 16 shows the wide beach at the northern end from another angle, where the darker native sands have filled in seaward of the new, white sand placed as part of the 2016 nourishment project.

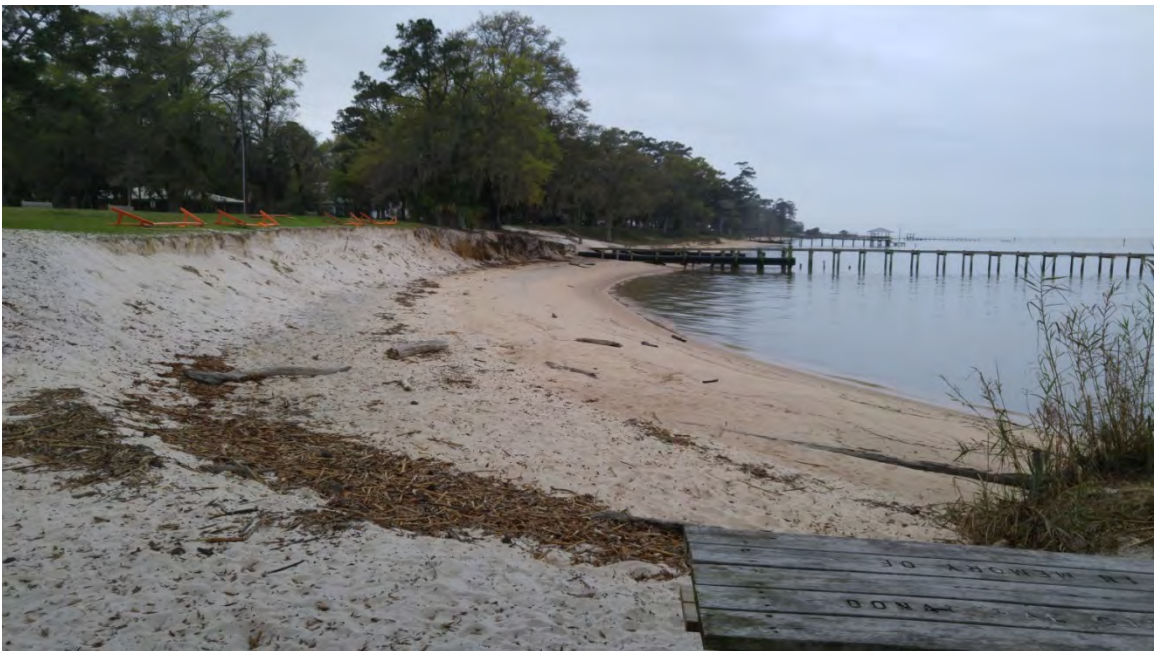
Figure 13: Photograph (facing south) showing winter erosion at the northern end of Magnolia Beach Park, near the boat launch (February 2016).

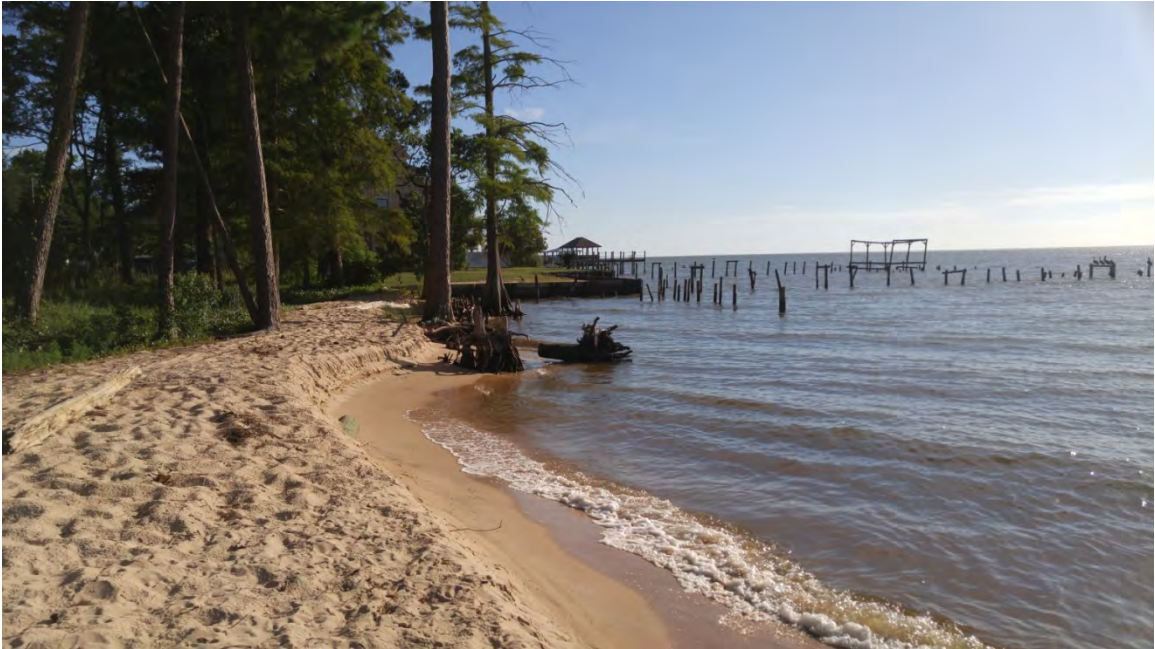
Figure 14: Photograph (facing south) showing summer erosion at the southern end of Magnolia Beach Park, near the American Legion (July 2016).

Figures 14 and 15 show the ends of the Magnolia Beach Park littoral cell conditions in the late spring and summer months, when southerly winds dominate and waves drive sand to the north. Figure 14 shows the erosion of the beach south of the American Legion beach and shows the characteristic curved shoreline consistent with sand transport to the north. Note the very different beach conditions shown in Figure 12 (end of

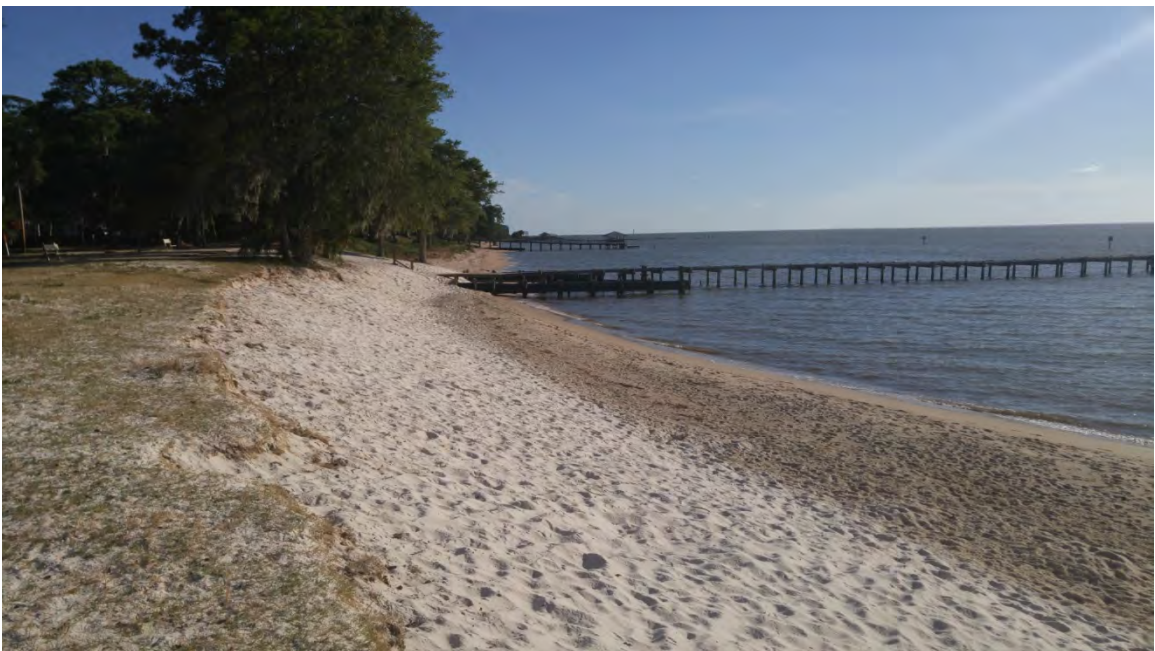
Figure 15: Photograph (facing south) showing summer accretion at the northern end of Magnolia Beach Park, near the boat launch (July 2016).

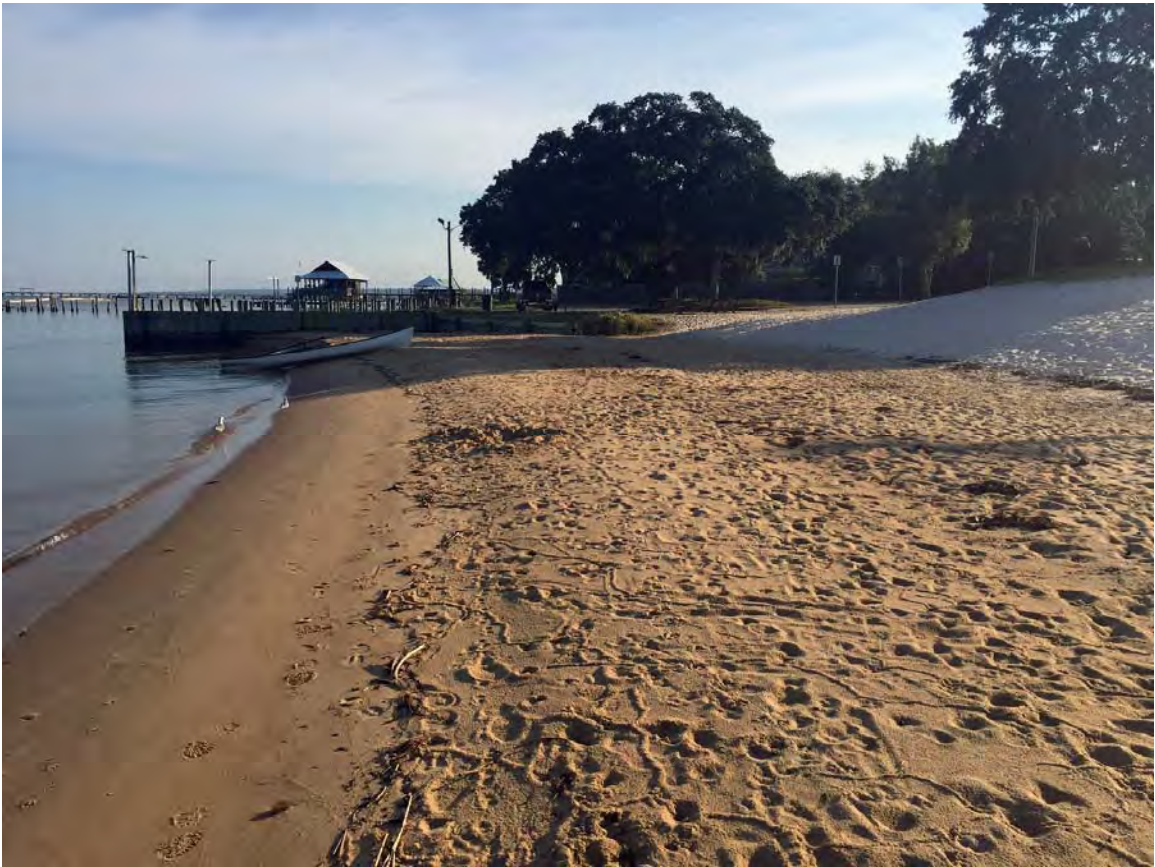
Figure 16: Photograph (facing north) showing summer accretion at the northern end of Magnolia Beach Park, near the boat launch (August 24, 2016).

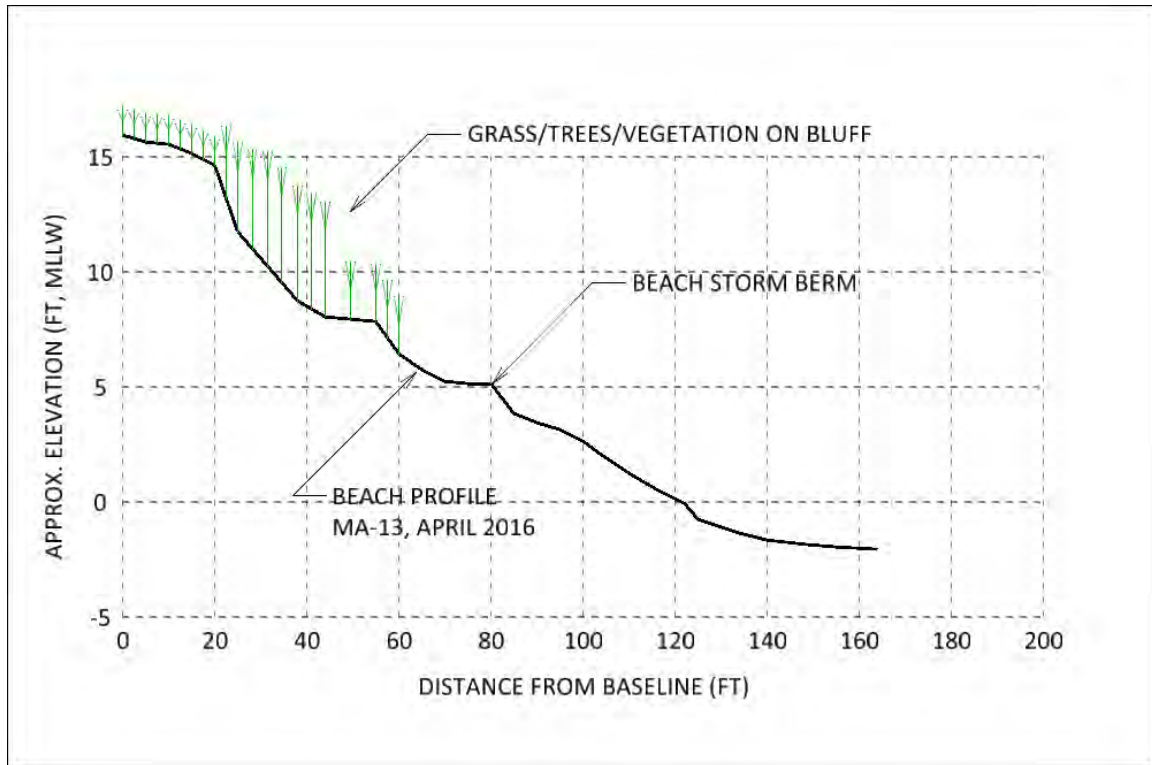
Figure 17: Plot showing existing vegetation near the center of Magnolia Beach Park (i.e. near the dolphin family statue). Here vegetation extends down the bluff and down to the beach face.

In the central part of the Magnolia Beach Park littoral cell, from about Pecan Ave. to Laurel Ave., mature vegetation exists on the bluff that runs parallel to the roadway and stretches to the beach face down to just above +5 ft MLLW in elevation. Above the bluff, grass and trees are prevalent. Notably, wind-blown sand is not a serious problem in these areas. A representative cross-section view of one such area is shown in Figure 17.

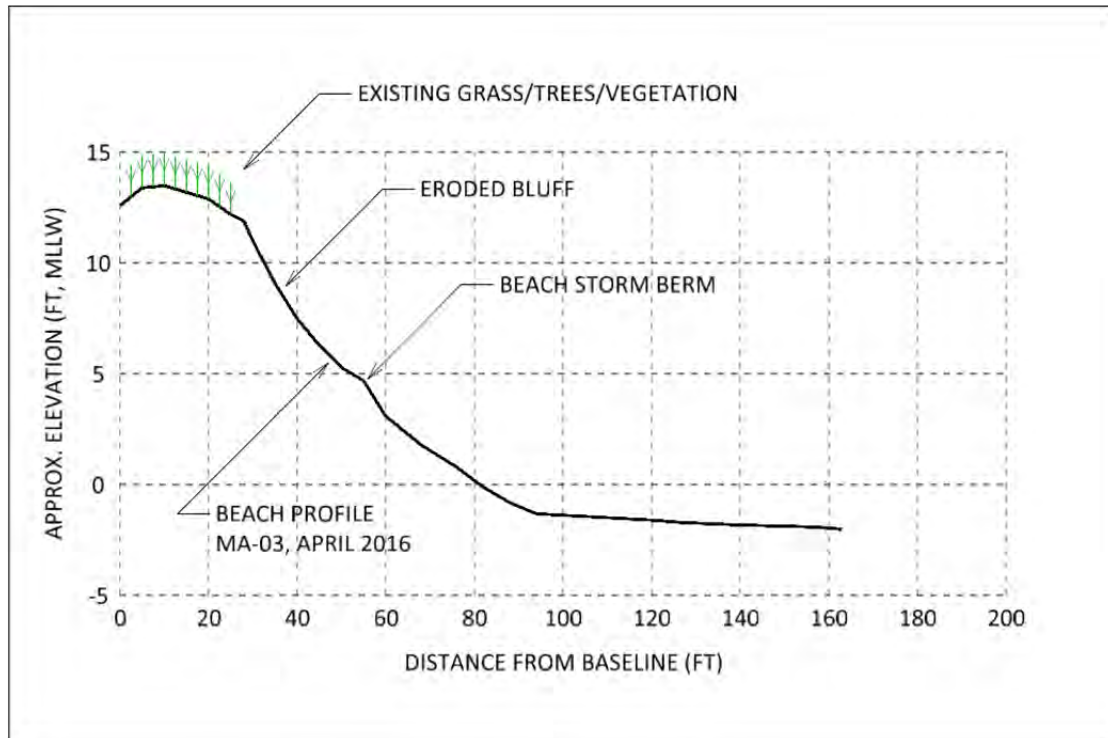
Figure 18: Plot showing existing vegetation at the northern end of Magnolia Beach Park. Here the bluff is actively eroding, and vegetation only survives above the eroding bluff.

At the northern end of Magnolia Beach Park, where the beach has been heavily eroded, little vegetation persists. A representative cross-section view of one such area is shown in Figure 18. The only vegetation is sod grass near the top of the existing bluff which was planted by the City after the 2014 beach nourishment project. Because of the erosive nature of this bluff in the past several years, no other vegetation has naturally colonized below that sod. Note how much narrower the beach profile is between the bluff line and the storm beach berm in the profile shown in Figure 18 (the eroded north end of Magnolia Beach Park) compared to the profile shown in Figure 17. If the beach at the north end could be more permanently stabilized to the west (e.g. recommendation in Figure 19), then a wider bluff could be vegetated which would reduce wind-blown sand problems. Essentially, the southern end situation is a model for the northern end situation if the beach can be stabilized. It should be noted that lack of mature vegetation is common to the beaches at the ends of littoral cells with headlands, where the shoreline is likely to erode and accrete seasonally, preventing the maturation of new growth.

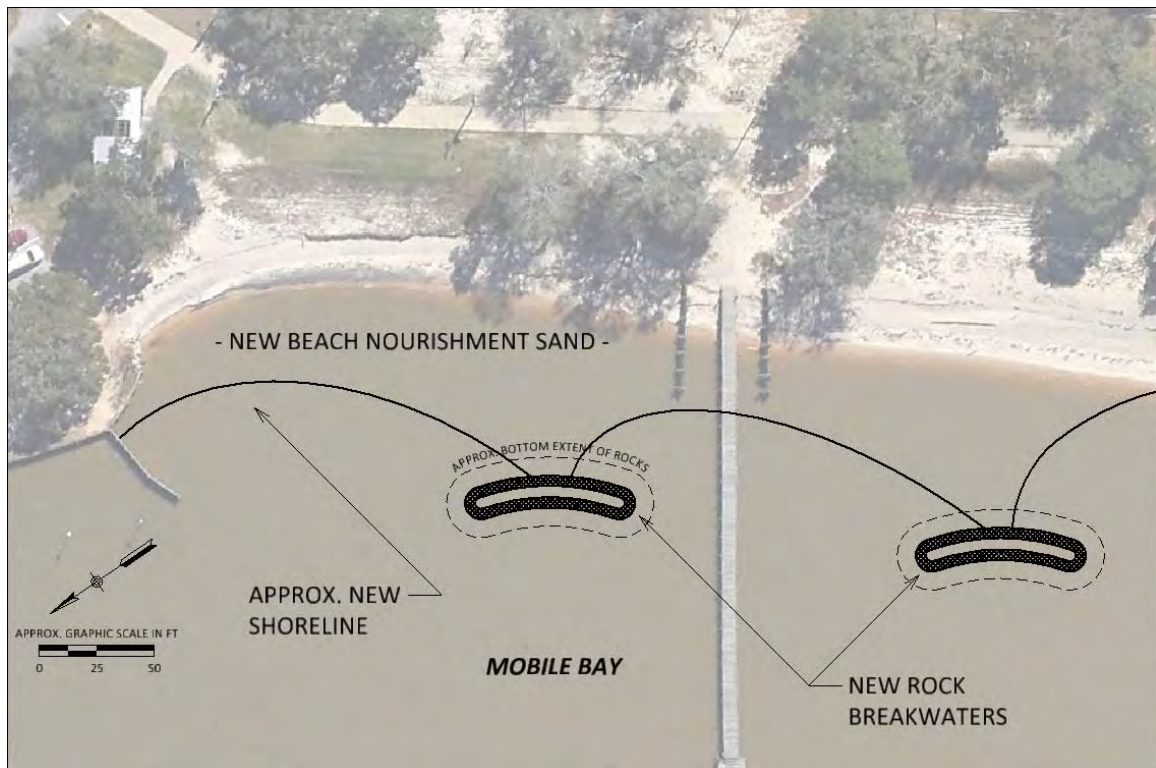
Figure 19: Plan view drawing showing a possible configuration of north Magnolia Beach Park improvements, including the installation of two, new rock breakwaters and the placement of a new beach nourishment project to more permanently stabilize this shoreline

A possible configuration of a proposed plan is shown in Figure 19 that includes the installation of two shore-parallel, rock breakwaters, with the intention of slowing erosion at that part of the beach and retaining the newly placed sand. The primary purpose of the rock breakwaters would be to stabilize a new sand fill in order to protect the small upland bluff in a more permanent configuration – one which would provide a wider beach in the form of small pocket beaches and stable slope up to the bluff elevations which can be vegetated to reduce wind-blown sand. It is envisioned that this project would involve the placement of a new beach nourishment (initially estimated at 3,000 – 4,000 cubic yards of clean, compatible, beach sand) within the northernmost 400-500 feet at Magnolia Beach Park. The rock material and configuration for the breakwaters would be selected based on a coastal engineering analysis of the site conditions and using headland pocket beach principles. There would be significant public outreach needs concerning the aesthetics of such a plan as well as significant coordination with resource agencies in the permit application and evaluation process.

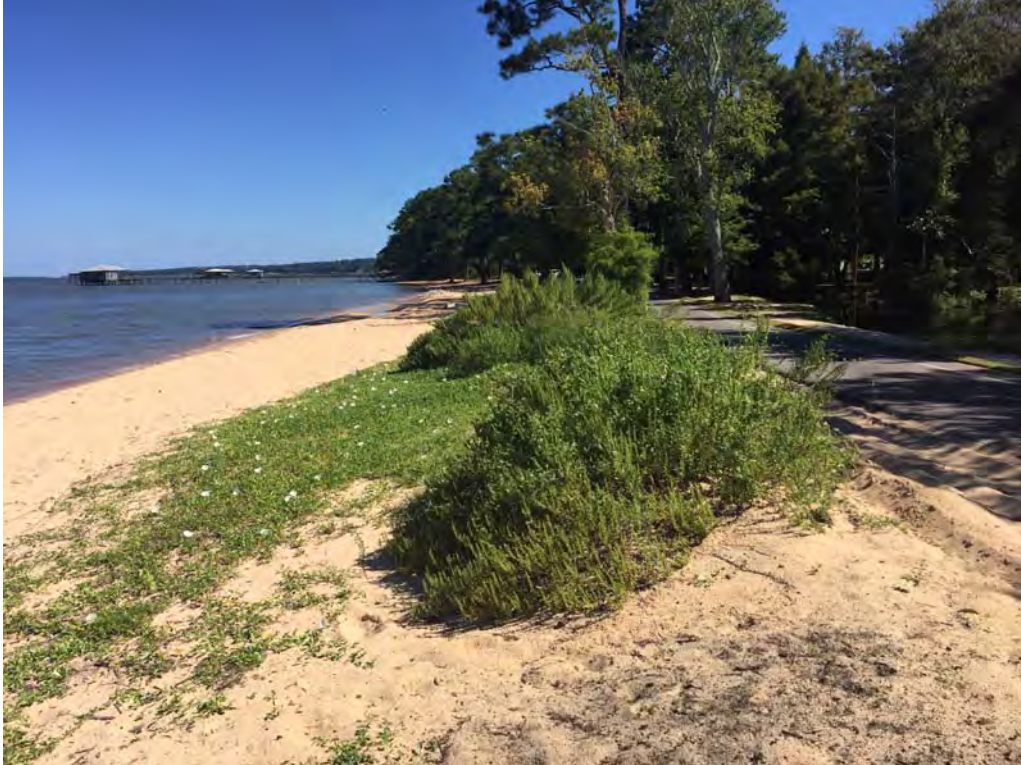
Figure 20: North end of North Beach Park showing narrowness of beach west of the road and vegetation on the dune-like feature.

related to the erosion may begin to be problematic. In particular, there is currently not much distance between the bay and the roadway around the duck pond as shown in Figure 20. At some point in the future, the City may want to consider engineering to address erosion related problems here also.

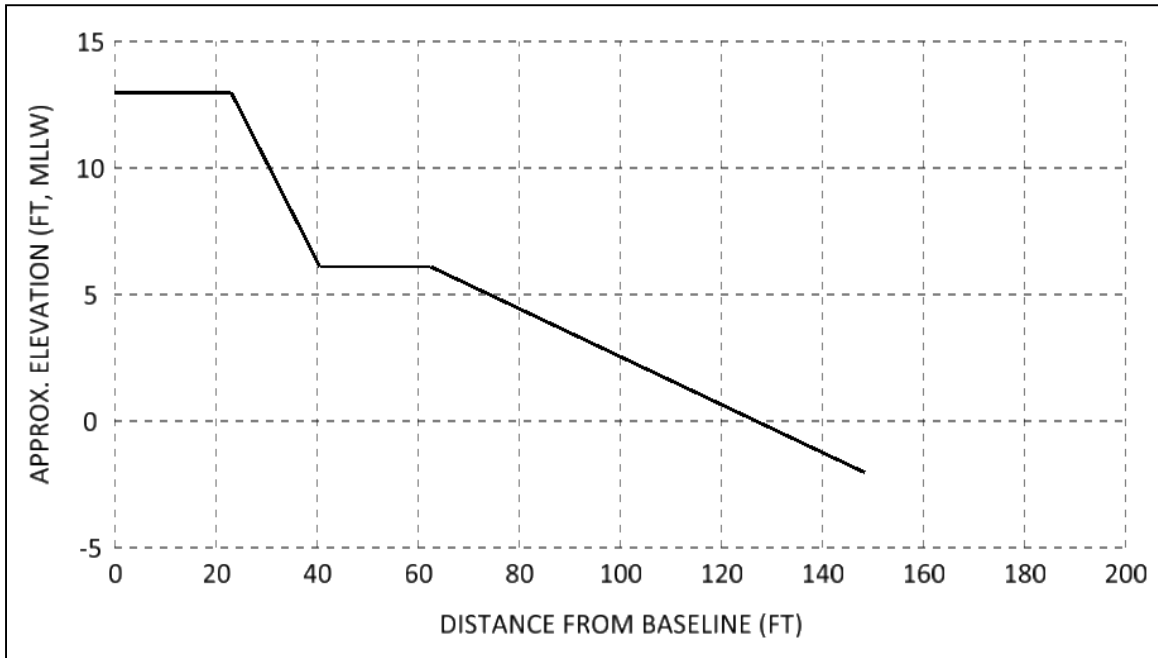
Figure 21: Plot showing an example beach profile template for Magnolia Beach Park.

It is recommended that Fairhope adopt some desired, or target, beach profile template which will serve as the design goal of any beach nourishment projects and the basis for nourishment decisions. A suggested beach template has the following characteristics:

In the event that one of the profiles recede to this level, either as a result of significant erosion during a storm event or due to day-to-day wave action, the City can use that as an indication to implement another round of maintenance beach nourishment project to re-establish the proposed beach template.
