City of Fairhope - Outfall Inventory Bay Outfall Watershed

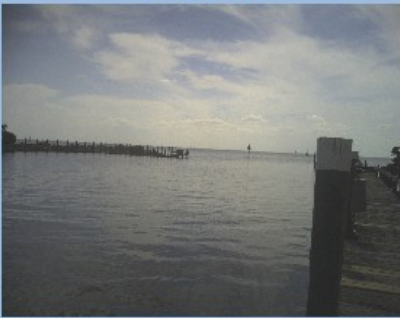
IMG_0013135.jpg

COF MS4 ID	FC-205197-B
Watershed	Fly Creek
Material	Other
Shape_1	Other
Depth	0
Top Width	0
Bottom Width	0
Type	Open Drainage
Category	Bay Outfall
Outfall_No	1
Comment	Outfall to bay, Fly Creek
Flow Description	
Outfall Damage	
Deposits/Stains	
Abnormal Vegetation	
Poor Pool Quality	
Pipe Benthic Growth	
Barrels	
Diameter	0
Submerged in Water	
Submerged With Sediment	
Date Collected	6/21/2012
2012 Photo 1	0013135
2012 Photo 2	<Null>

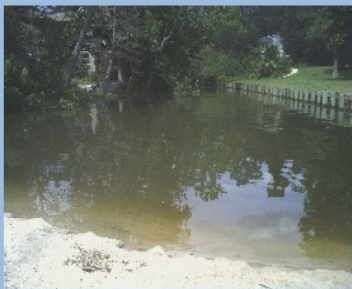
IMG_0013127.jpg

COF MS4 ID	RC-77980-A
Watershed	Rock Creek
Material	Other
Shape_1	Other
Depth	0
Top Width	0
Bottom Width	0
Type	Open Drainage
Category	Bay Outfall
Outfall_No	2
Comment	Rock Creek outfall
Flow Description	
Outfall Damage	
Deposits/Stains	
Abnormal Vegetation	
Poor Pool Quality	
Pipe Benthic Growth	
Barrels	
Diameter	0
Submerged in Water	
Submerged With Sediment	
Date Collected	6/21/2012
2012 Photo 1	0013127
2012 Photo 2	<Null>

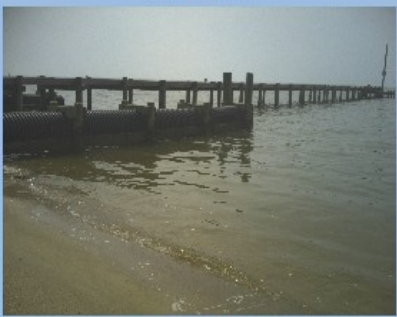
IMG_0019306.jpg

COF MS4 ID	SG-12795-A
Watershed	Stack Gully
Material	HDPE
Shape_1	Circular
Depth	0
Top Width	0
Bottom Width	0
Type	Closed Pipe
Category	Bay Outfall
Outfall_No	3
Comment	Bay outfall
Flow Description	None
Outfall Damage	
Deposits/Stains	
Abnormal Vegetation	
Poor Pool Quality	
Pipe Benthic Growth	
Barrels	1
Diameter	24
Submerged in Water	No
Submerged With Sediment	No
Date Collected	7/3/2012
2012 Photo 1	0019306
2012 Photo 2	<Null>

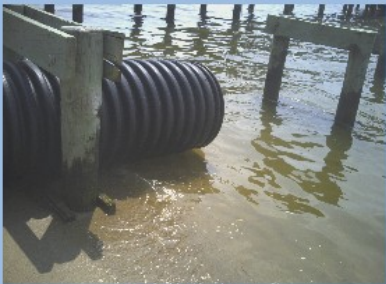
IMG_0019308.jpg

COF MS4 ID	SG-12795-C
Watershed	Stack Gully
Material	HDPE
Shape_1	Circular
Depth	0
Top Width	0
Bottom Width	0
Type	Closed Pipe
Category	Bay Outfall
Outfall_No	5
Comment	Bay outfall
Flow Description	None
Outfall Damage	
Deposits/Stains	
Abnormal Vegetation	
Poor Pool Quality	
Pipe Benthic Growth	
Barrels	1
Diameter	24
Submerged in Water	No
Submerged With Sediment	No
Date Collected	7/3/2012
2012 Photo 1	0019308
2012 Photo 2	<Null>

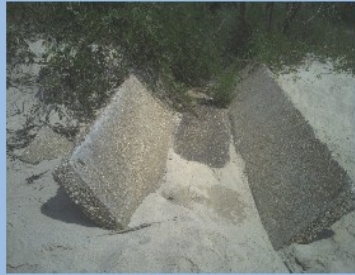
IMG_0019309.jpg

COF MS4 ID	SG-64364-A
Watershed	Stack Gully
Material	Concrete
Shape_1	Trapezoid
Depth	2
Top Width	6
Bottom Width	2
Type	Open Drainage
Category	Bay Outfall
Outfall_No	8
Comment	Bay outfall
Flow Description	None
Outfall Damage	
Deposits/Stains	
Abnormal Vegetation	
Poor Pool Quality	
Pipe Benthic Growth	
Barrels	
Diameter	0
Submerged in Water	
Submerged With Sediment	
Date Collected	7/3/2012
2012 Photo 1	0019309
2012 Photo 2	<Null>

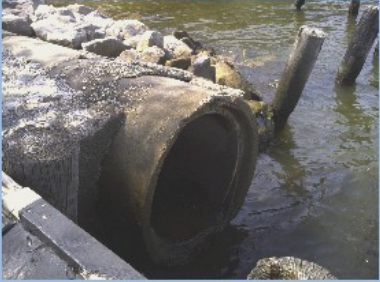
IMG_00004.jpg

COF MS4 ID	SG-12788-A
Watershed	Stack Gully
Material	RCP
Shape_1	Circular
Depth	0
Top Width	0
Bottom Width	0
Type	Closed Pipe
Category	Major Bay Outfall
Outfall_No	11
Comment	
Flow Description	Trickle
Outfall Damage	Spalling_Cracking_Ch
Deposits/Stains	
Abnormal Vegetation	
Poor Pool Quality	
Pipe Benthic Growth	Green
Barrels	1
Diameter	36
Submerged in Water	No
Submerged With Sediment	No
Date Collected	6/14/2012
2012 Photo 1	00004
2012 Photo 2	<Null>

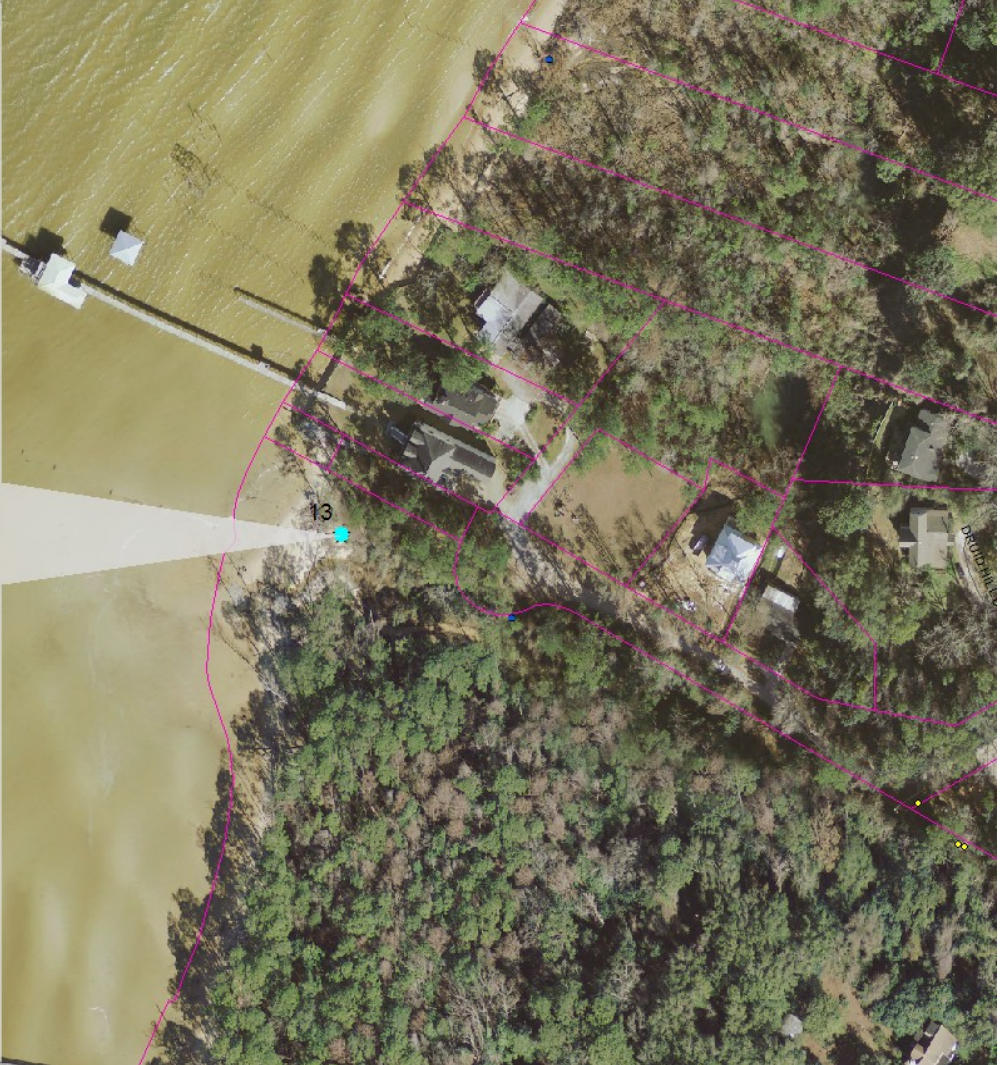
IMG_0015219.jpg

COF MS4 ID	BMG-40542-C
Watershed	Big Mouth Gully
Material	Earthen
Shape_1	Other
Depth	3
Top Width	0
Bottom Width	0
Type	Open Drainage
Category	Major Bay Outfall
Outfall_No	13
Comment	Gulley discharge to bay
Flow Description	Substantial
Outfall Damage	
Deposits/Stains	
Abnormal Vegetation	
Poor Pool Quality	
Pipe Benthic Growth	
Barrels	
Diameter	0
Submerged in Water	
Submerged With Sediment	
Date Collected	7/2/2012
2012 Photo 1	0015219
2012 Photo 2	0016220

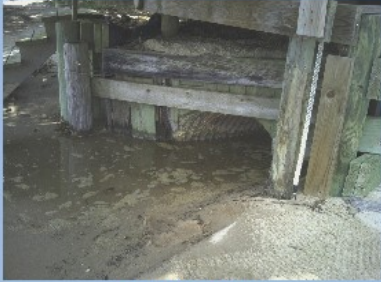
IMG_0013126.jpg

COF MS4 ID	RC-59793-A
Watershed	Rock Creek
Material	CMP
Shape_1	Circular
Depth	0
Top Width	0
Bottom Width	0
Type	Closed Pipe
Category	Bay Outfall
Outfall_No	
Comment	Bay outfall
Flow Description	Trickle
Outfall Damage	
Deposits/Stains	
Abnormal Vegetation	
Poor Pool Quality	
Pipe Benthic Growth	
Barrels	1
Diameter	24
Submerged in Water	Partially
Submerged With Sediment	Partially
Date Collected	6/21/2012
2012 Photo 1	0013126
2012 Photo 2	<Null>

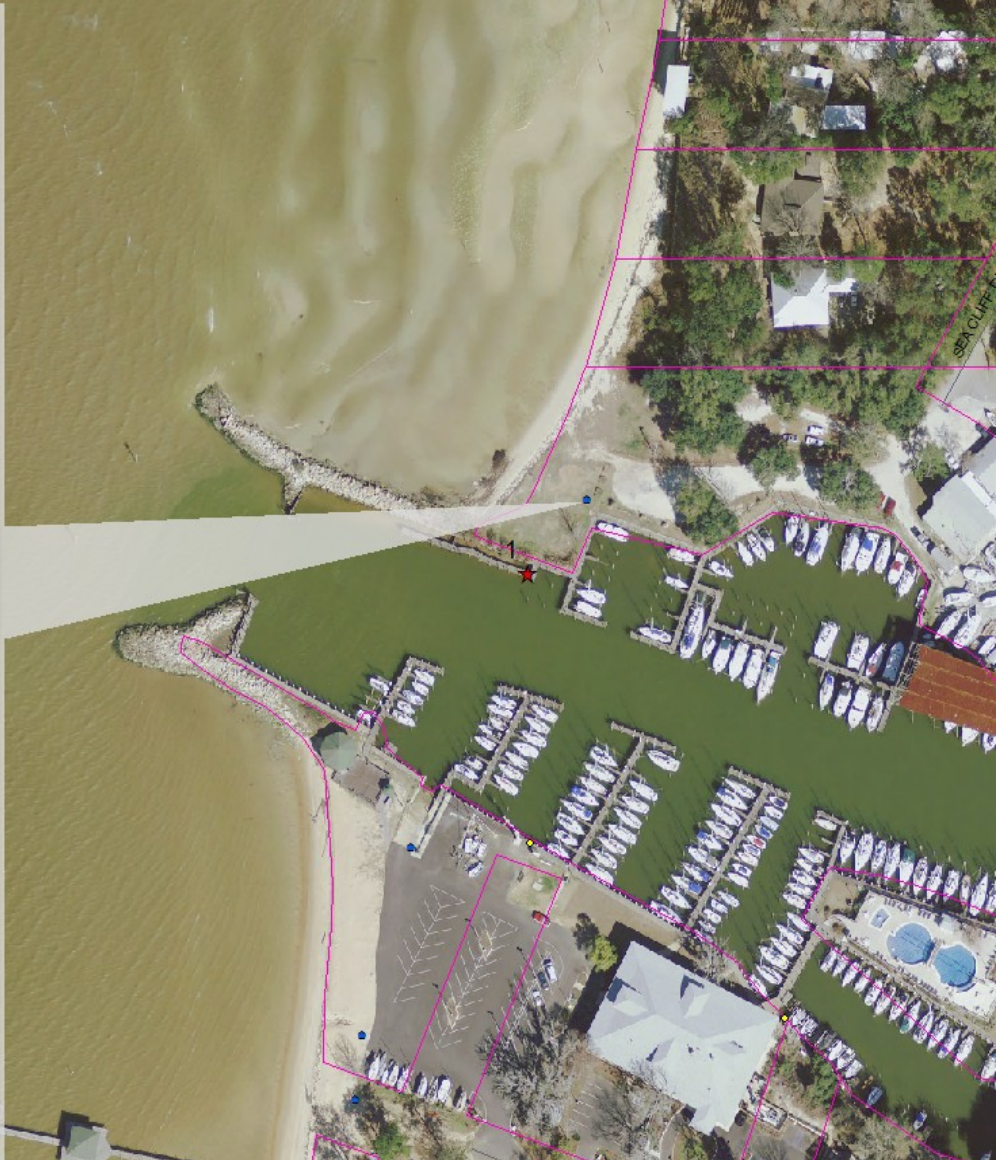
IMG_0013133.jpg

COF MS4 ID	FC-205197-A
Watershed	Fly Creek
Material	Other
Shape_1	Other
Depth	0
Top Width	5
Bottom Width	5
Type	Open Drainage
Category	
Outfall_No	<Null>
Comment	Overland flow from parking
Flow Description	None
Outfall Damage	
Deposits/Stains	
Abnormal Vegetation	
Poor Pool Quality	
Pipe Benthic Growth	
Barrels	
Diameter	0
Submerged in Water	
Submerged With Sediment	
Date Collected	6/21/2012
2012 Photo 1	0013133
2012 Photo 2	0014134

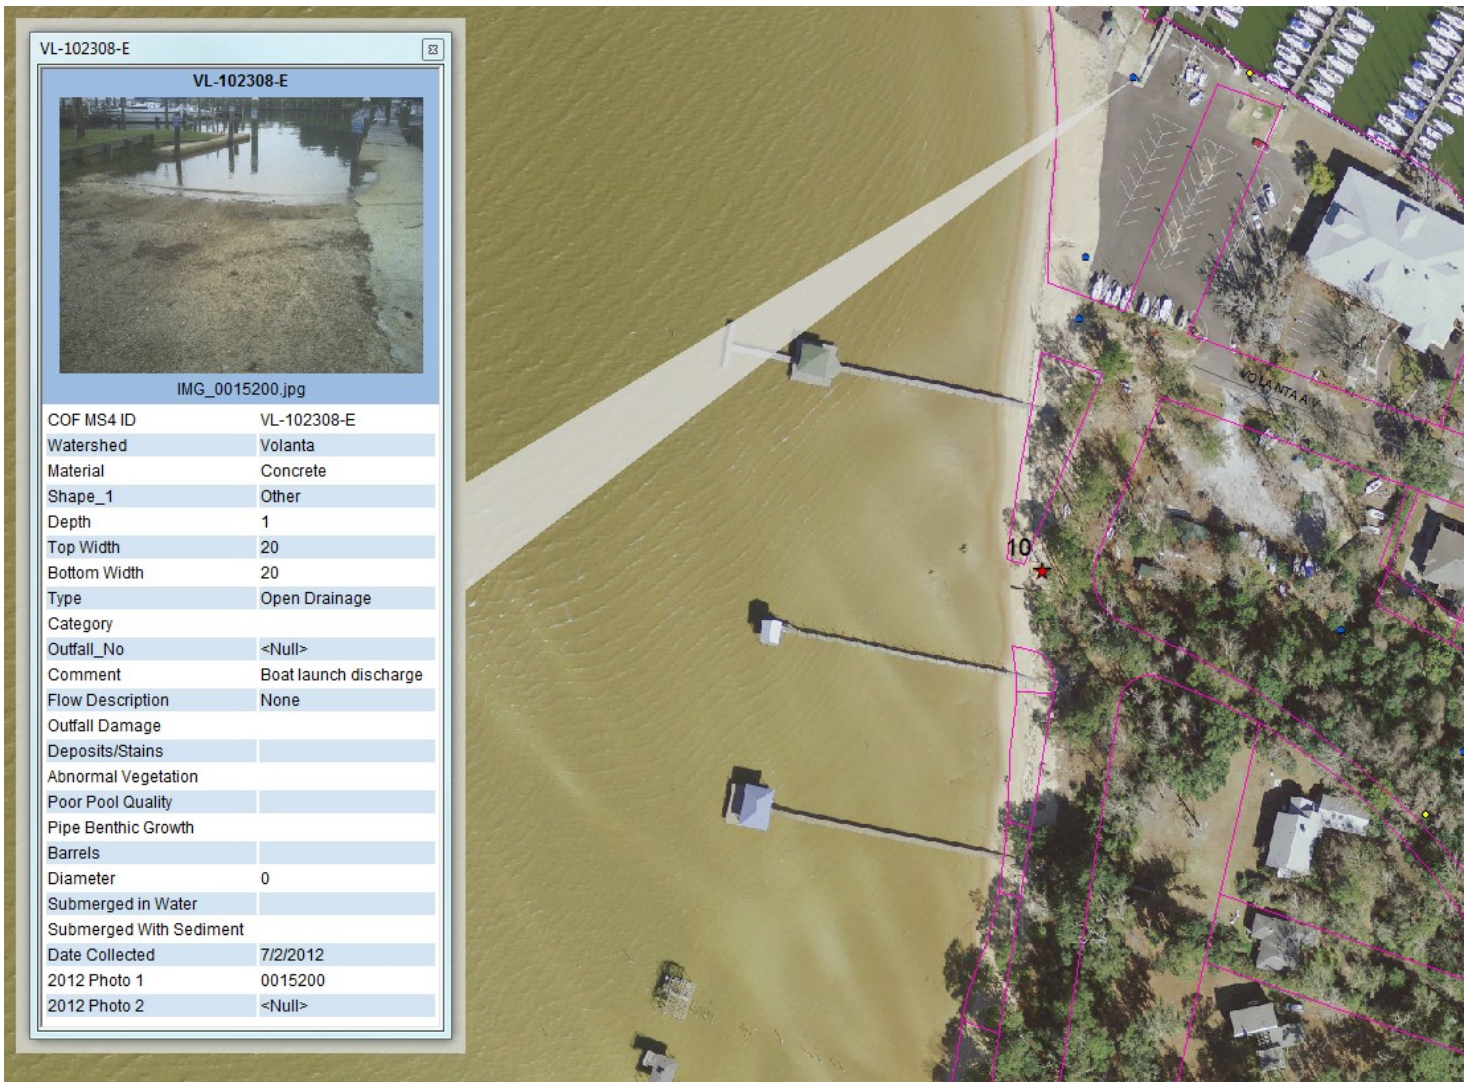
IMG_0015200.jpg

COF MS4 ID	VL-102308-E
Watershed	Volanta
Material	Concrete
Shape_1	Other
Depth	1
Top Width	20
Bottom Width	20
Type	Open Drainage
Category	
Outfall_No	<Null>
Comment	Boat launch discharge
Flow Description	None
Outfall Damage	
Deposits/Stains	
Abnormal Vegetation	
Poor Pool Quality	
Pipe Benthic Growth	
Barrels	
Diameter	0
Submerged in Water	
Submerged With Sediment	
Date Collected	7/2/2012
2012 Photo 1	0015200
2012 Photo 2	<Null>

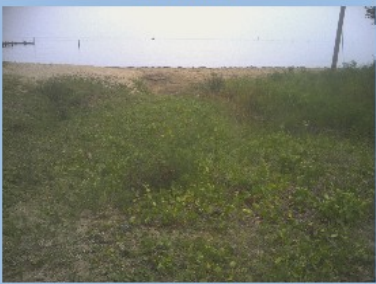
IMG_0015197.jpg

COF MS4 ID	VL-102308-C
Watershed	Volanta
Material	Earthen
Shape_1	Other
Depth	2
Top Width	20
Bottom Width	2
Type	Open Drainage
Category	
Outfall_No	<Null>
Comment	Volanta Street discharge
Flow Description	None
Outfall Damage	
Deposits/Stains	
Abnormal Vegetation	
Poor Pool Quality	
Pipe Benthic Growth	
Barrels	
Diameter	0
Submerged in Water	
Submerged With Sediment	
Date Collected	7/2/2012
2012 Photo 1	0015196
2012 Photo 2	0016198

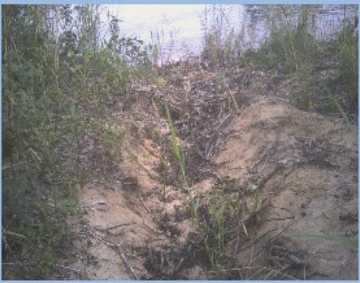
IMG_0015214.jpg

COF MS4 ID	BMG-69776-A
Watershed	Big Mouth Gully
Material	Earthen
Shape_1	Other
Depth	2
Top Width	5
Bottom Width	2
Type	Open Drainage
Category	
Outfall_No	<Null>
Comment	
Flow Description	None
Outfall Damage	
Deposits/Stains	
Abnormal Vegetation	
Poor Pool Quality	
Pipe Benthic Growth	
Barrels	
Diameter	0
Submerged in Water	
Submerged With Sediment	
Date Collected	7/2/2012
2012 Photo 1	0015214
2012 Photo 2	<Null>

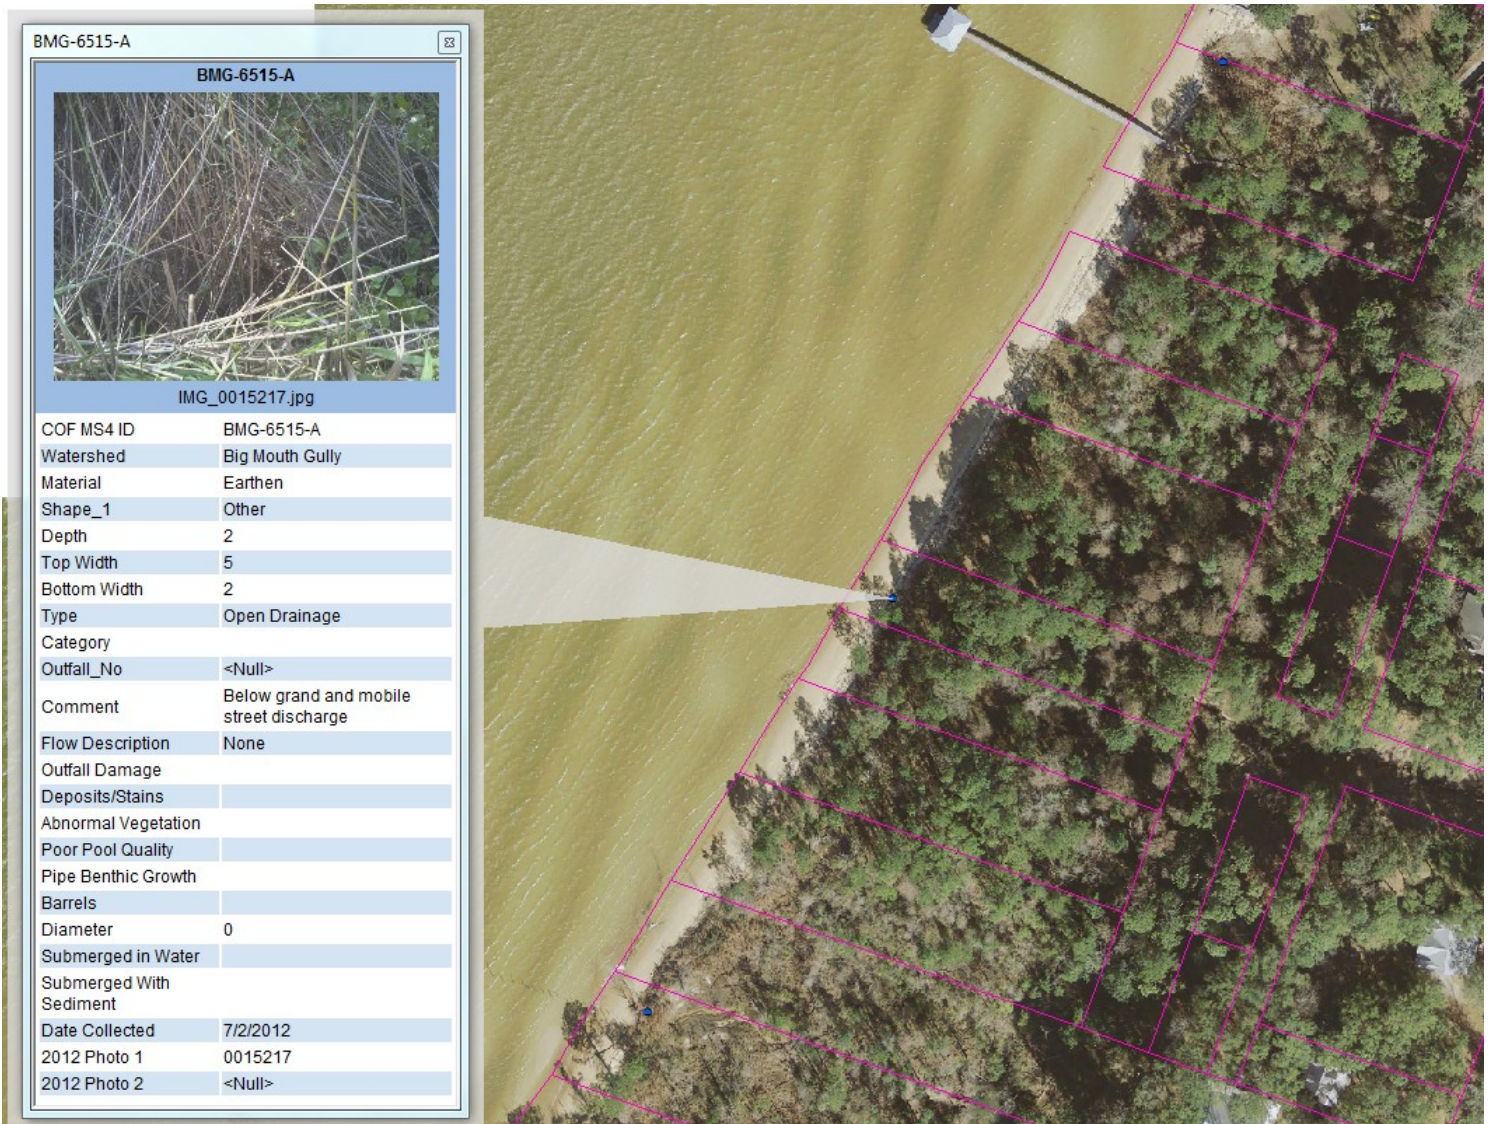
COF MS4 ID	BMG-6515-A
Watershed	Big Mouth Gully
Material	Earthen
Shape_1	Other
Depth	2
Top Width	5
Bottom Width	2
Type	Open Drainage
Category	
Outfall_No	<Null>
Comment	Below grand and mobile street discharge
Flow Description	None
Outfall Damage	
Deposits/Stains	
Abnormal Vegetation	
Poor Pool Quality	
Pipe Benthic Growth	
Barrels	
Diameter	0
Submerged in Water	
Submerged With Sediment	
Date Collected	7/2/2012
2012 Photo 1	0015217
2012 Photo 2	<Null>

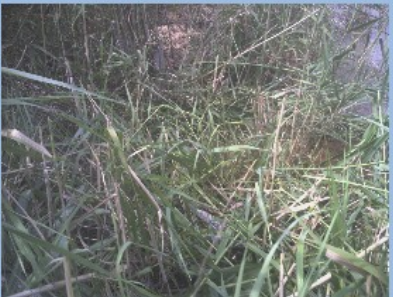
IMG_0015218.jpg

COF MS4 ID	BMG-10058-A
Watershed	Big Mouth Gully
Material	Earthen
Shape_1	Other
Depth	0
Top Width	0
Bottom Width	0
Type	Open Drainage
Category	
Outfall_No	<Null>
Comment	Gulley discharge
Flow Description	Moderate
Outfall Damage	
Deposits/Stains	
Abnormal Vegetation	
Poor Pool Quality	
Pipe Benthic Growth	
Barrels	
Diameter	0
Submerged in Water	
Submerged With Sediment	
Date Collected	7/2/2012
2012 Photo 1	0015218
2012 Photo 2	<Null>

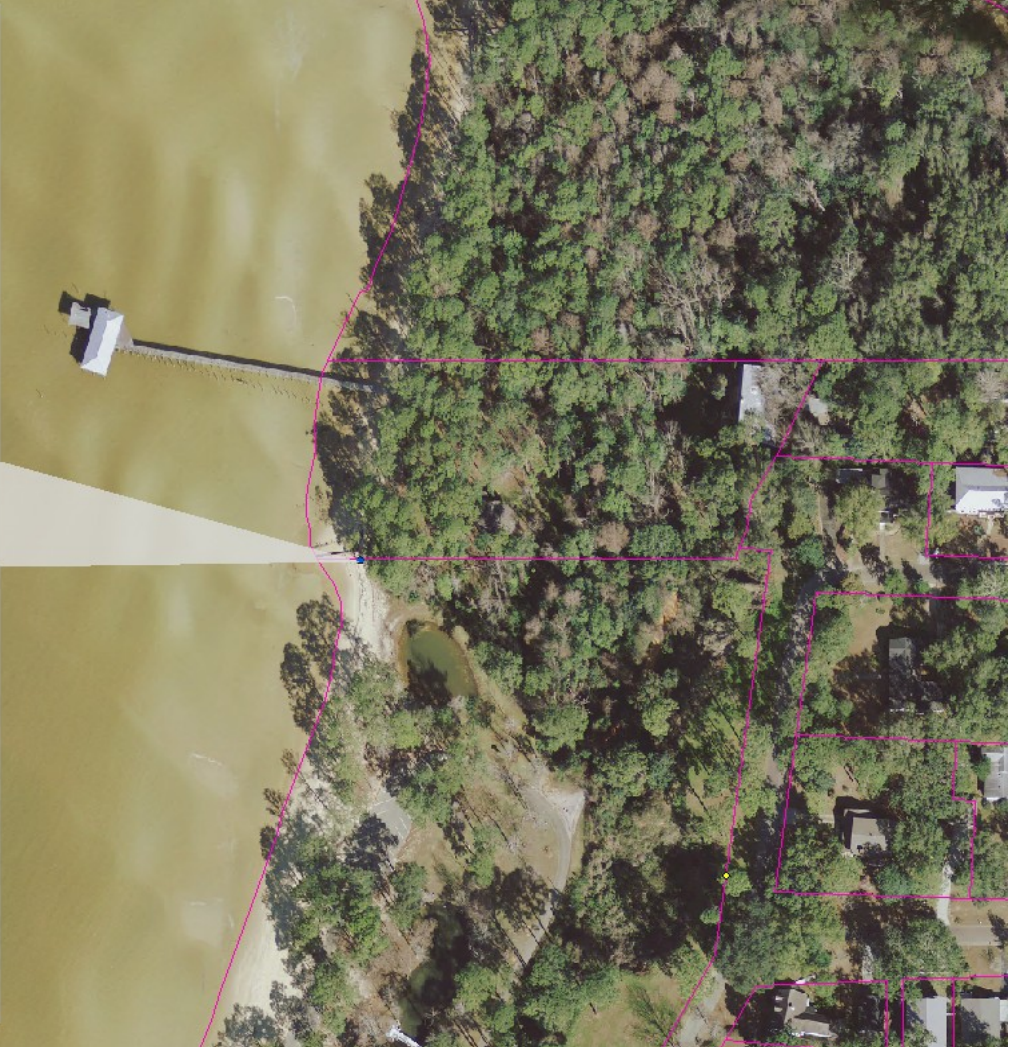
COF MS4 ID	BMG-64360-C
Watershed	Big Mouth Gully
Material	Earthen
Shape_1	Trapezoid
Depth	3
Top Width	6
Bottom Width	3
Type	Open Drainage
Category	
Outfall_No	<Null>
Comment	
Flow Description	Trickle
Outfall Damage	
Deposits/Stains	
Abnormal Vegetation	
Poor Pool Quality	
Pipe Benthic Growth	
Barrels	
Diameter	0
Submerged in Water	
Submerged With Sediment	
Date Collected	7/2/2012
2012 Photo 1	0016250
2012 Photo 2	<Null>

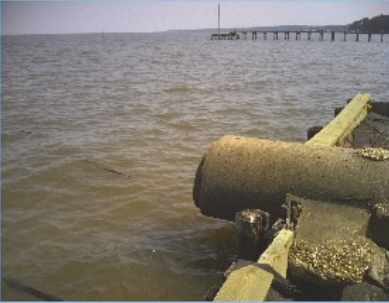
IMG_00003.jpg

COF MS4 ID	SG-64362-C
Watershed	Stack Gully
Material	RCP
Shape_1	Arch
Depth	0
Top Width	0
Bottom Width	0
Type	Closed Pipe
Category	
Outfall_No	<Null>
Comment	
Flow Description	None
Outfall Damage	
Deposits/Stains	
Abnormal Vegetation	
Poor Pool Quality	
Pipe Benthic Growth	
Barrels	1
Diameter	0
Submerged in Water	No
Submerged With Sediment	No
Date Collected	6/14/2012
2012 Photo 1	00003
2012 Photo 2	<Null>

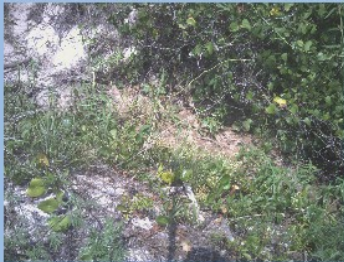
IMG_0019310.jpg

COF MS4 ID	TG-64364-A
Watershed	Tatumville Gully
Material	Earthen
Shape_1	Trapezoid
Depth	2
Top Width	8
Bottom Width	4
Type	Open Drainage
Category	
Outfall_No	<Null>
Comment	Open ditch bay outfall
Flow Description	None
Outfall Damage	
Deposits/Stains	
Abnormal Vegetation	
Poor Pool Quality	
Pipe Benthic Growth	
Barrels	
Diameter	0
Submerged in Water	
Submerged With Sediment	
Date Collected	7/3/2012
2012 Photo 1	0019310
2012 Photo 2	<Null>
