# City of Fairhope - Outfall Inventory Pensacola Worm Branch Watershed

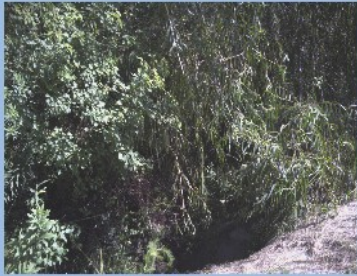
IMG\_0051694.jpg

COF MS4 ID	PWB-14734-A
Watershed	Pensacola Worm Branch
Material	RCP
Shape_1	Circular
Depth	0
Top Width	0
Bottom Width	0
Type	Closed Pipe
Category	Private
Outfall_No	<Null>
Comment	Private retention discharge
Flow Description	Trickle
Outfall Damage	
Deposits/Stains	
Abnormal Vegetation	
Poor Pool Quality	
Pipe Benthic Growth	
Barrels	1
Diameter	36
Submerged in Water	No
Submerged With Sediment	No
Date Collected	8/24/2012
2012 Photo 1	0051694
2012 Photo 2	<Null>

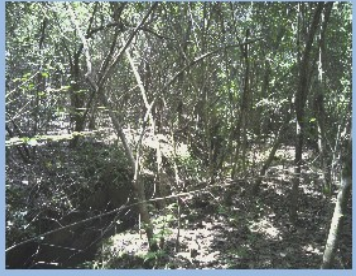
IMG\_0051699.jpg

COF MS4 ID	PWB-269693-C
Watershed	Pensacola Worm Branch
Material	Earthen
Shape_1	Other
Depth	3
Top Width	3
Bottom Width	2
Type	Open Drainage
Category	
Outfall_No	<Null>
Comment	Ditch downstream from discharge
Flow Description	Trickle
Outfall Damage	
Deposits/Stains	
Abnormal Vegetation	
Poor Pool Quality	
Pipe Benthic Growth	
Barrels	0
Diameter	0
Submerged in Water	0
Submerged With Sediment	0
Date Collected	8/24/2012
2012 Photo 1	0051699
2012 Photo 2	0052700

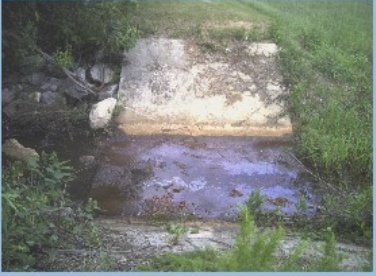
IMG\_0015171.jpg

COF MS4 ID	PWB-270376-A
Watershed	Pensacola Worm Branch
Material	
Shape_1	Trapezoid
Depth	3
Top Width	16
Bottom Width	5
Type	Open Drainage
Category	Private
Outfall_No	<Null>
Comment	Private retention discharge
Flow Description	Trickle
Outfall Damage	
Deposits/Stains	
Abnormal Vegetation	
Poor Pool Quality	Oil_Sheen
Pipe Benthic Growth	Orange
Barrels	
Diameter	0
Submerged in Water	
Submerged With Sediment	
Date Collected	6/22/2012
2012 Photo 1	0015171
2012 Photo 2	0016172

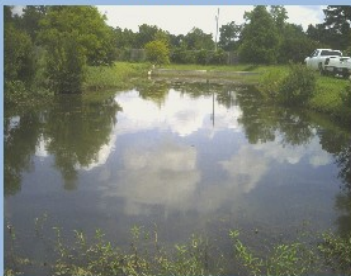
IMG\_0015176.jpg

COF MS4 ID	PWB-281003-B
Watershed	Pensacola Worm Branch
Material	Earthen
Shape_1	Other
Depth	0
Top Width	0
Bottom Width	0
Type	Open Drainage
Category	Private
Outfall_No	<Null>
Comment	Private retention
Flow Description	
Outfall Damage	
Deposits/Stains	
Abnormal Vegetation	
Poor Pool Quality	
Pipe Benthic Growth	
Barrels	
Diameter	0
Submerged in Water	
Submerged With Sediment	
Date Collected	6/22/2012
2012 Photo 1	0015176
2012 Photo 2	0016177
