City of Fairhope - Outfall Inventory Waterhole Branch Watershed

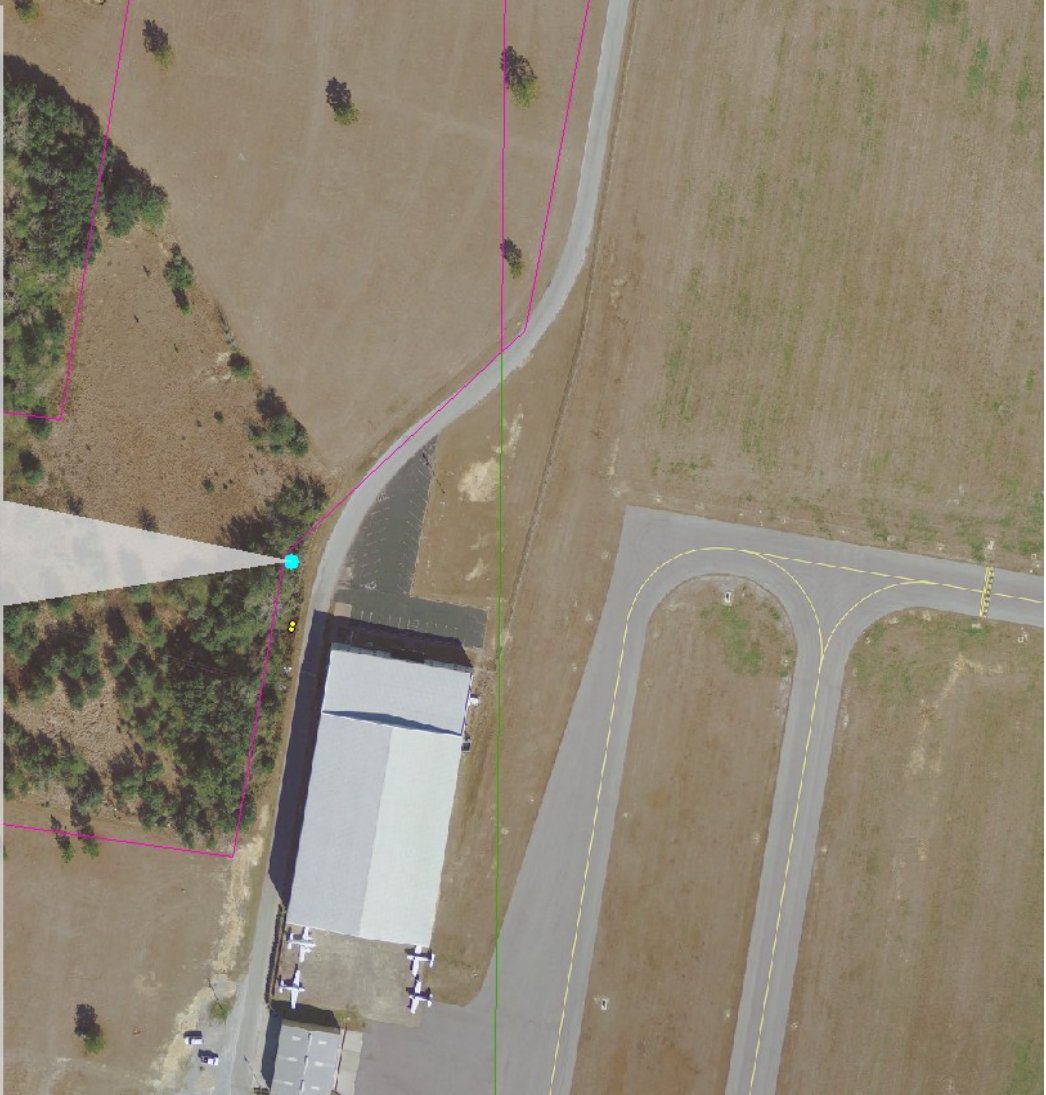
COF MS4 ID	WB-12786-A
Watershed	Waterhole Branch
Material	Concrete
Shape_1	Trapezoid
Depth	1
Top Width	12
Bottom Width	5
Type	Open Drainage
Category	
Outfall_No	<Null>
Comment	From airport taxiway
Flow Description	None
Outfall Damage	
Deposits/Stains	
Abnormal Vegetation	
Poor Pool Quality	
Pipe Benthic Growth	
Barrels	0
Diameter	0
Submerged in Water	0
Submerged With Sediment	0
Date Collected	8/8/2012
2012 Photo 1	0041544
2012 Photo 2	0042545

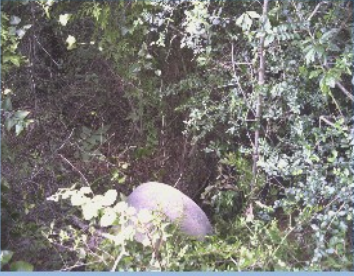
COF MS4 ID	WB-226620-A
Watershed	Waterhole Branch
Material	RCP
Shape_1	Circular
Depth	<Null>
Top Width	<Null>
Bottom Width	<Null>
Type	Closed Pipe
Category	
Outfall_No	<Null>
Comment	5' drop off pipe discharge in hole.
Flow Description	None
Outfall Damage	
Deposits/Stains	
Abnormal Vegetation	
Poor Pool Quality	
Pipe Benthic Growth	
Barrels	1
Diameter	18
Submerged in Water	No
Submerged With Sediment	No
Date Collected	8/8/2012
2012 Photo 1	0036536
2012 Photo 2	0038537

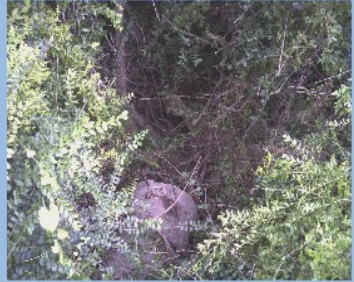
COF MS4 ID	WB-226620-B
Watershed	Waterhole Branch
Material	RCP
Shape_1	Circular
Depth	<Null>
Top Width	<Null>
Bottom Width	<Null>
Type	Closed Pipe
Category	
Outfall_No	<Null>
Comment	From road at airport
Flow Description	None
Outfall Damage	Spalling_Cracking_Ch
Deposits/Stains	
Abnormal Vegetation	
Poor Pool Quality	
Pipe Benthic Growth	
Barrels	1
Diameter	15
Submerged in Water	No
Submerged With Sediment	No
Date Collected	8/8/2012
2012 Photo 1	0040541
2012 Photo 2	<Null>

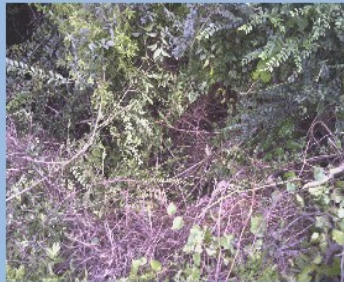
WB-226620-C	
WB-226620-C

IMG_0040540.jpg	
COF MS4 ID	WB-226620-C
Watershed	Waterhole Branch
Material	RCP
Shape_1	Circular
Depth	<Null>
Top Width	<Null>
Bottom Width	<Null>
Type	Closed Pipe
Category	
Outfall_No	<Null>
Comment	From road at airport
Flow Description	None
Outfall Damage	Spalling_Cracking_Ch
Deposits/Stains	
Abnormal Vegetation	
Poor Pool Quality	
Pipe Benthic Growth	
Barrels	1
Diameter	18
Submerged in Water	
Submerged With Sediment	No
Date Collected	8/8/2012
2012 Photo 1	0040540
2012 Photo 2	<Null>

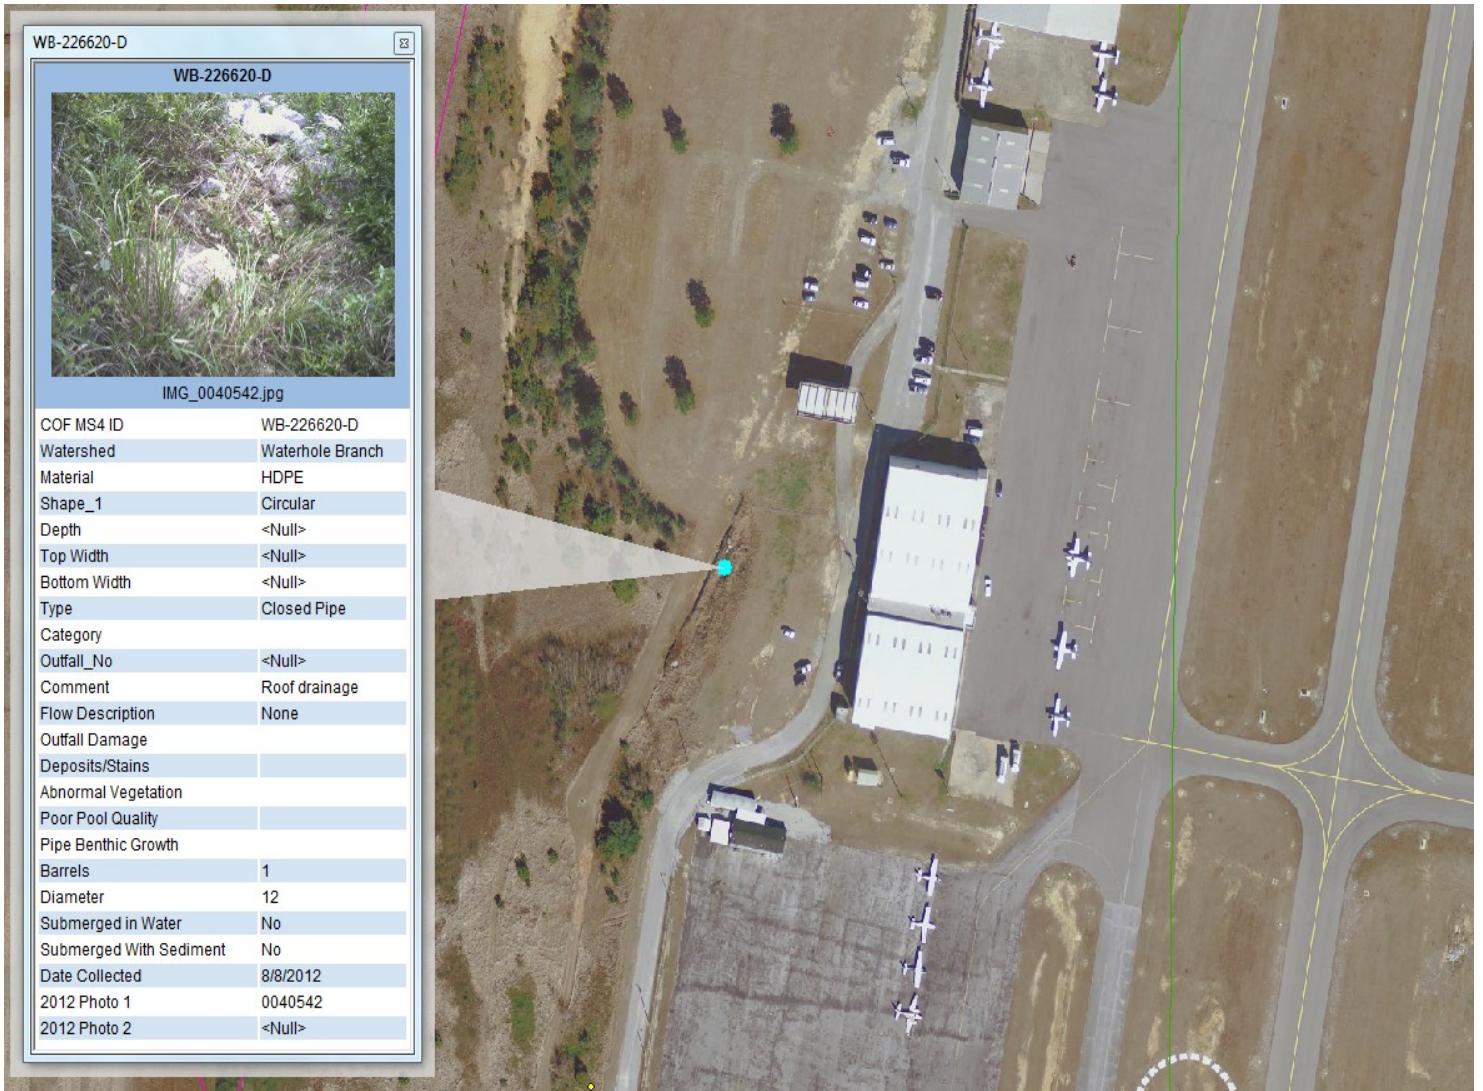
COF MS4 ID	WB-226620-D
Watershed	Waterhole Branch
Material	HDPE
Shape_1	Circular
Depth	<Null>
Top Width	<Null>
Bottom Width	<Null>
Type	Closed Pipe
Category	
Outfall_No	<Null>
Comment	Roof drainage
Flow Description	None
Outfall Damage	
Deposits/Stains	
Abnormal Vegetation	
Poor Pool Quality	
Pipe Benthic Growth	
Barrels	1
Diameter	12
Submerged in Water	No
Submerged With Sediment	No
Date Collected	8/8/2012
2012 Photo 1	0040542
2012 Photo 2	<Null>

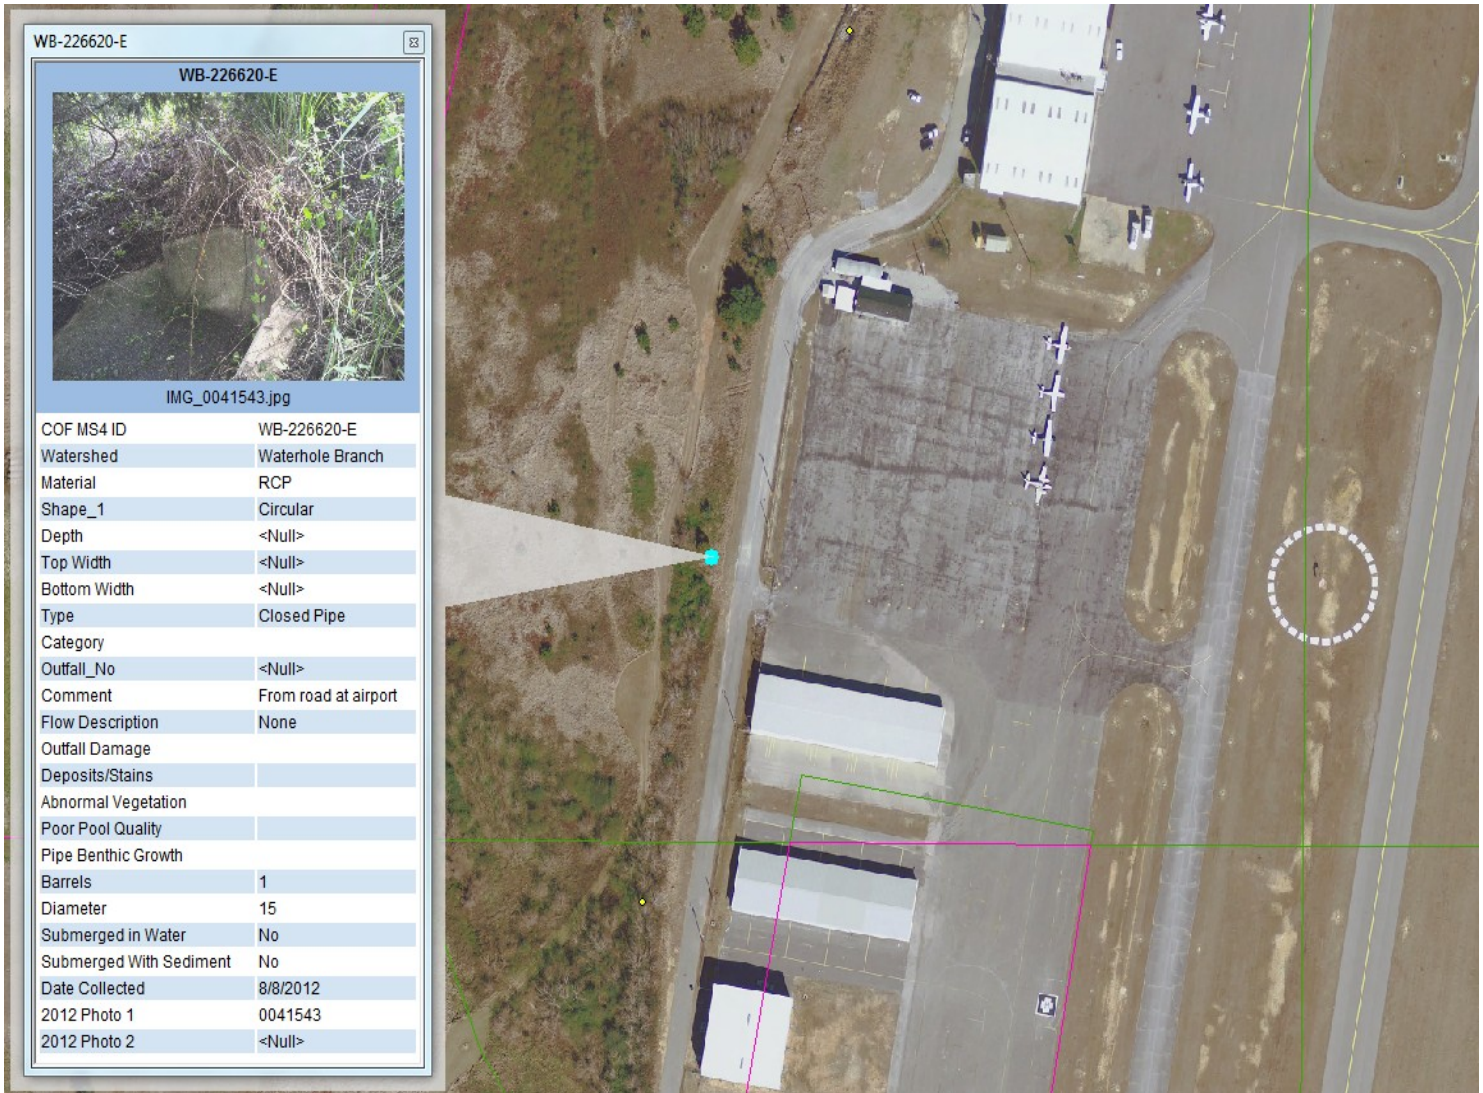
COF MS4 ID	WB-226620-E
Watershed	Waterhole Branch
Material	RCP
Shape_1	Circular
Depth	<Null>
Top Width	<Null>
Bottom Width	<Null>
Type	Closed Pipe
Category	
Outfall_No	<Null>
Comment	From road at airport
Flow Description	None
Outfall Damage	
Deposits/Stains	
Abnormal Vegetation	
Poor Pool Quality	
Pipe Benthic Growth	
Barrels	1
Diameter	15
Submerged in Water	No
Submerged With Sediment	No
Date Collected	8/8/2012
2012 Photo 1	0041543
2012 Photo 2	<Null>

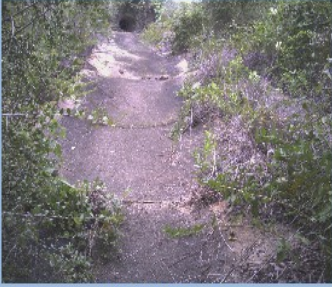
COF MS4 ID	WB-226622-A
Watershed	Waterhole Branch
Material	Concrete
Shape_1	Trapezoid
Depth	1
Top Width	8
Bottom Width	3
Type	Open Drainage
Category	
Outfall_No	<Null>
Comment	Flume from airport
Flow Description	
Outfall Damage	
Deposits/Stains	
Abnormal Vegetation	Excessive
Poor Pool Quality	
Pipe Benthic Growth	
Barrels	0
Diameter	0
Submerged in Water	0
Submerged With Sediment	0
Date Collected	8/8/2012
2012 Photo 1	0041546
2012 Photo 2	<Null>

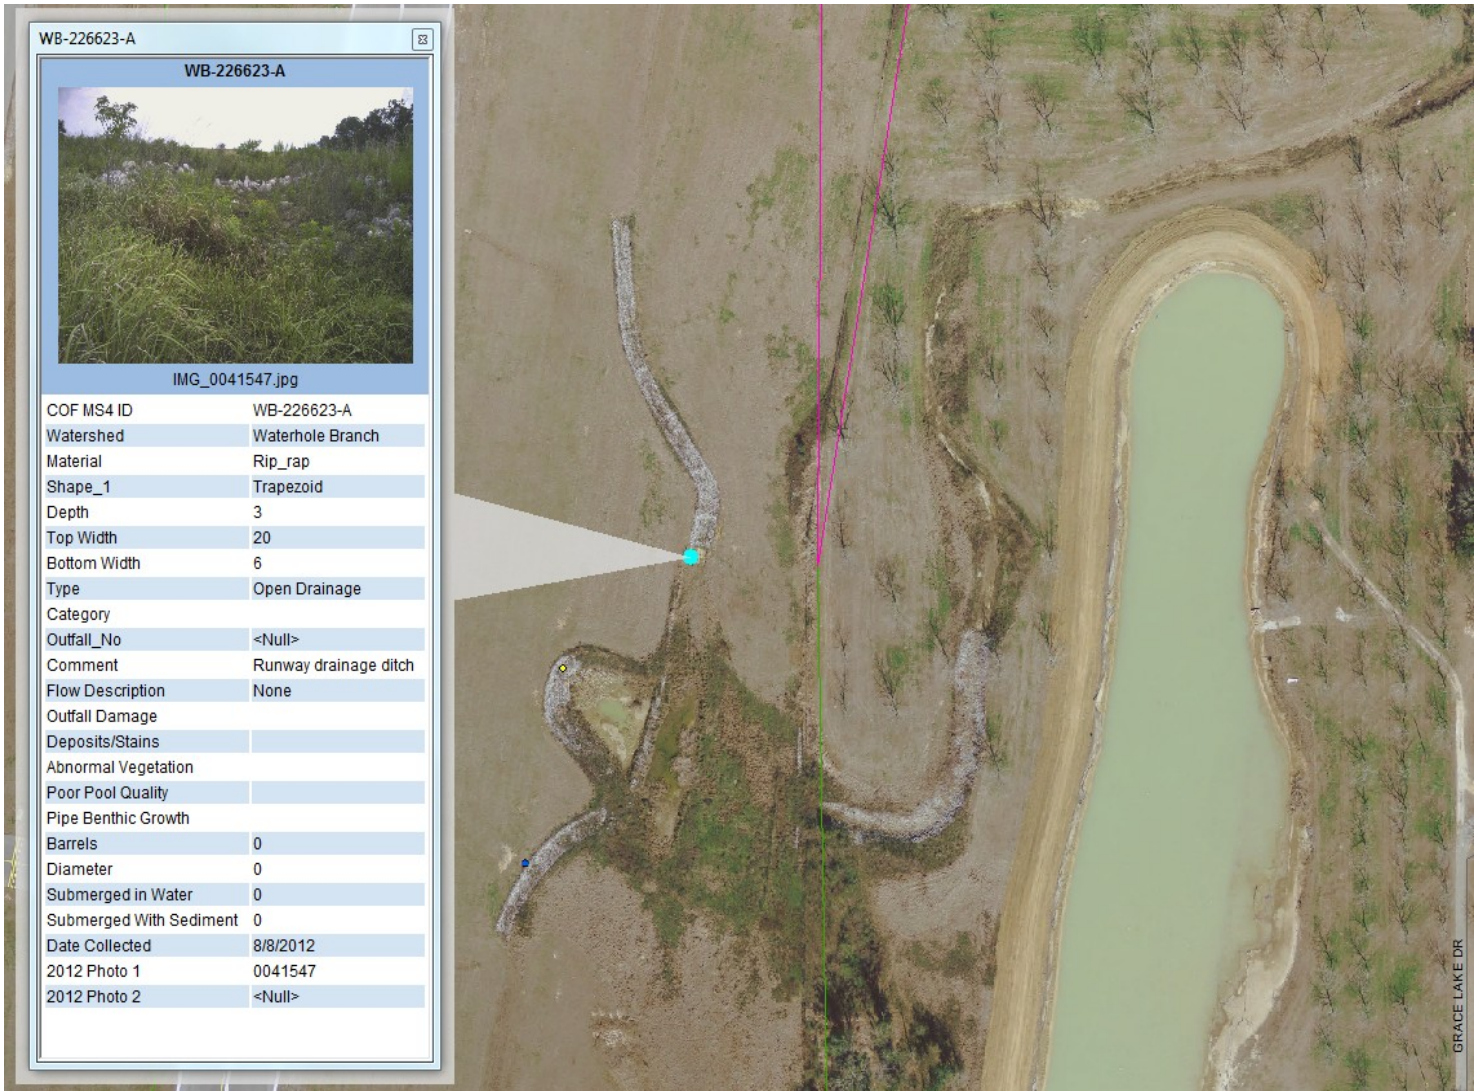
WB-226623-A	
COF MS4 ID	WB-226623-A
Watershed	Waterhole Branch
Material	Rip_rap
Shape_1	Trapezoid
Depth	3
Top Width	20
Bottom Width	6
Type	Open Drainage
Category	
Outfall_No	<Null>
Comment	Runway drainage ditch
Flow Description	None
Outfall Damage	
Deposits/Stains	
Abnormal Vegetation	
Poor Pool Quality	
Pipe Benthic Growth	
Barrels	0
Diameter	0
Submerged in Water	0
Submerged With Sediment	0
Date Collected	8/8/2012
2012 Photo 1	0041547
2012 Photo 2	<Null>

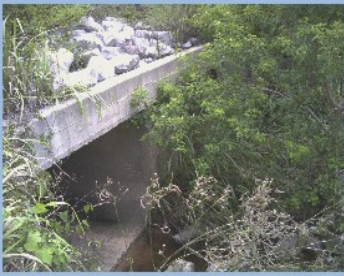
WB-226623-B x

COF MS4 ID	WB-226623-B
Watershed	Waterhole Branch
Material	RCP
Shape_1	Box
Depth	<Null>
Top Width	<Null>
Bottom Width	<Null>
Type	Closed Pipe
Category	
Outfall_No	<Null>
Comment	4x6 box under runway stilling basin downstream
Flow Description	None
Outfall Damage	
Deposits/Stains	
Abnormal Vegetation	
Poor Pool Quality	
Pipe Benthic Growth	
Barrels	2
Diameter	72
Submerged in Water	No
Submerged With Sediment	No
Date Collected	8/8/2012
2012 Photo 1	0041548
2012 Photo 2	0042549

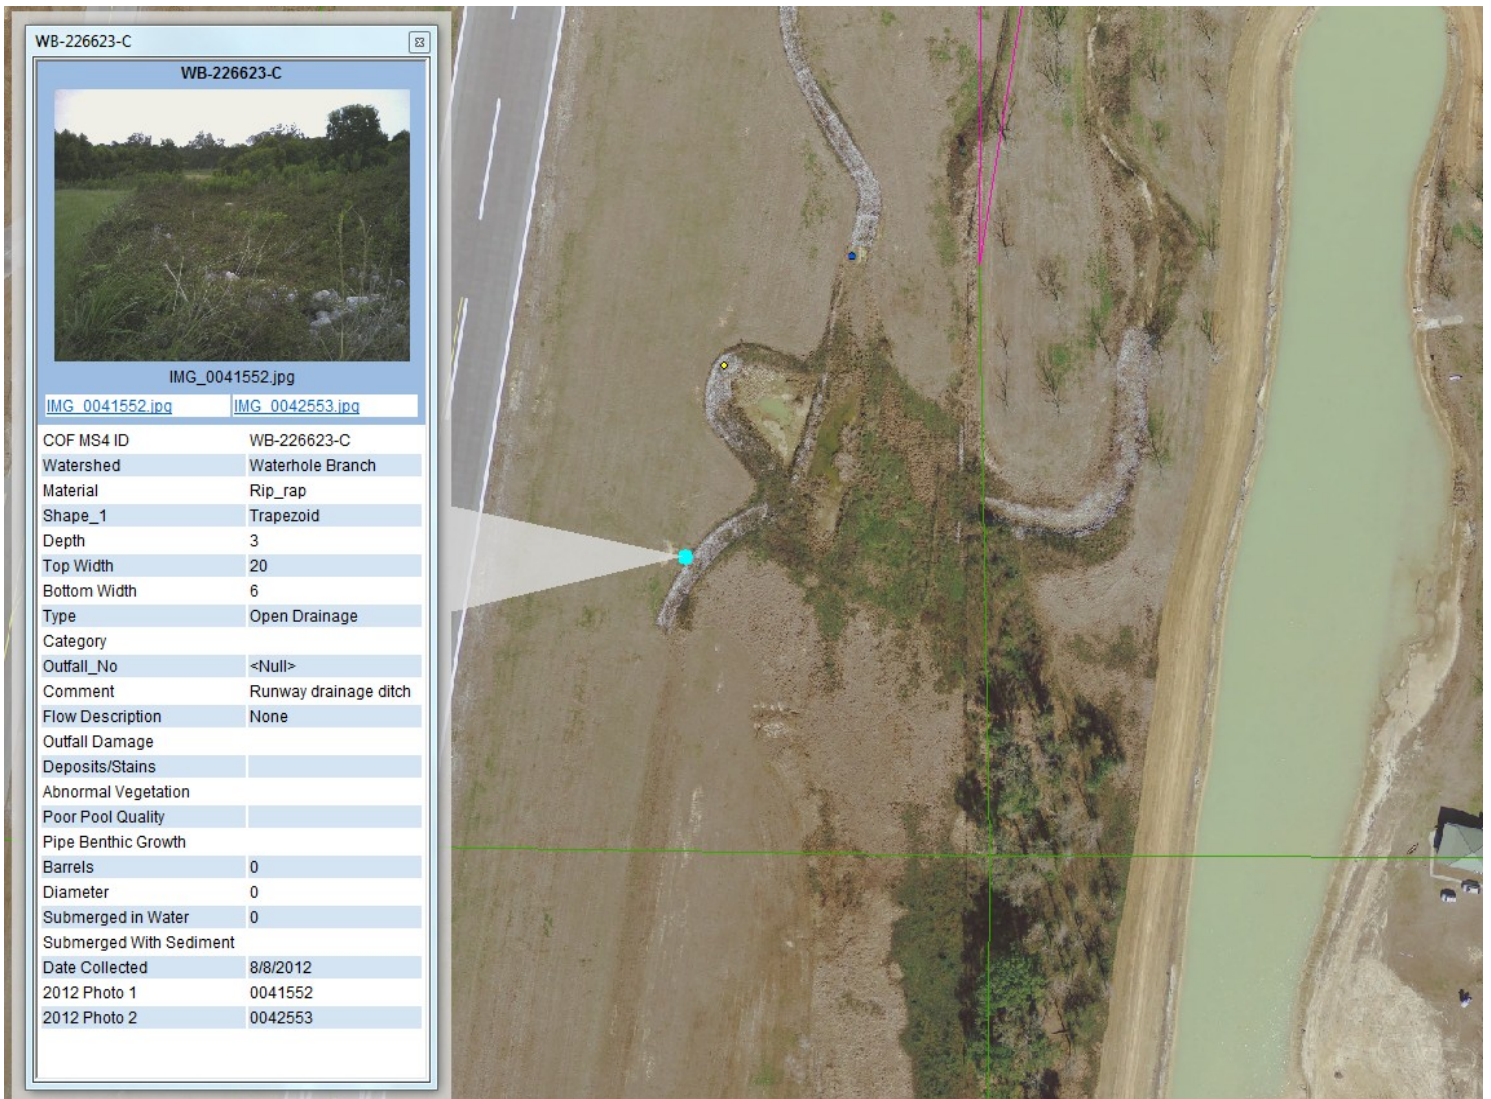
COF MS4 ID	WB-226623-C
Watershed	Waterhole Branch
Material	Rip_rap
Shape_1	Trapezoid
Depth	3
Top Width	20
Bottom Width	6
Type	Open Drainage
Category	
Outfall_No	<Null>
Comment	Runway drainage ditch
Flow Description	None
Outfall Damage	
Deposits/Stains	
Abnormal Vegetation	
Poor Pool Quality	
Pipe Benthic Growth	
Barrels	0
Diameter	0
Submerged in Water	0
Submerged With Sediment	
Date Collected	8/8/2012
2012 Photo 1	0041552
2012 Photo 2	0042553

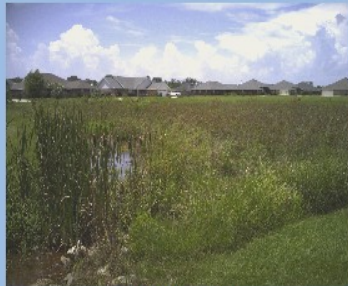
COF MS4 ID	WB-243146-A
Watershed	Waterhole Branch
Material	Earthen
Shape_1	Other
Depth	0
Top Width	0
Bottom Width	0
Type	Open Drainage
Category	Private
Outfall_No	<Null>
Comment	Private retention pond
Flow Description	
Outfall Damage	
Deposits/Stains	
Abnormal Vegetation	Excessive
Poor Pool Quality	Excessive_Alg
Pipe Benthic Growth	
Barrels	
Diameter	0
Submerged in Water	
Submerged With Sediment	
Date Collected	7/27/2012
2012 Photo 1	0035490
2012 Photo 2	<Null>

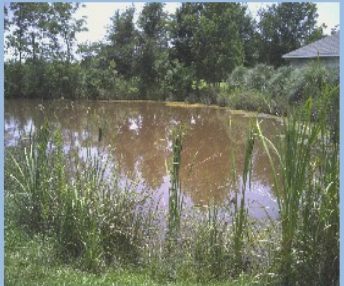
COF MS4 ID	WB-243149-A
Watershed	Waterhole Branch
Material	Earthen
Shape_1	Other
Depth	0
Top Width	0
Bottom Width	0
Type	Open Drainage
Category	Private
Outfall_No	<Null>
Comment	Private retention pond
Flow Description	
Outfall Damage	
Deposits/Stains	
Abnormal Vegetation	
Poor Pool Quality	
Pipe Benthic Growth	
Barrels	
Diameter	0
Submerged in Water	
Submerged With Sediment	
Date Collected	7/27/2012
2012 Photo 1	0035489
2012 Photo 2	<Null>

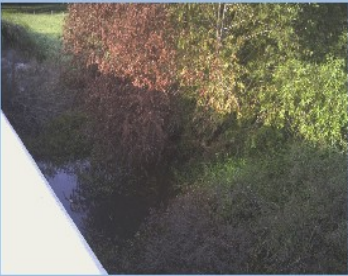
WB-2496-A 23

COF MS4 ID	WB-2496-A
Watershed	Waterhole Branch
Material	Earthen
Shape_1	Other
Depth	3
Top Width	20
Bottom Width	5
Type	Open Drainage
Category	
Outfall_No	<Null>
Comment	Waterhole Branch crossing with road
Flow Description	None
Outfall Damage	
Deposits/Stains	
Abnormal Vegetation	
Poor Pool Quality	
Pipe Benthic Growth	
Barrels	0
Diameter	0
Submerged in Water	0
Submerged With Sediment	
Date Collected	8/8/2012
2012 Photo 1	0035493
2012 Photo 2	0036494
