City of Fairhope – Outfall Inventory Stack Gully Watershed

SG-12773-A

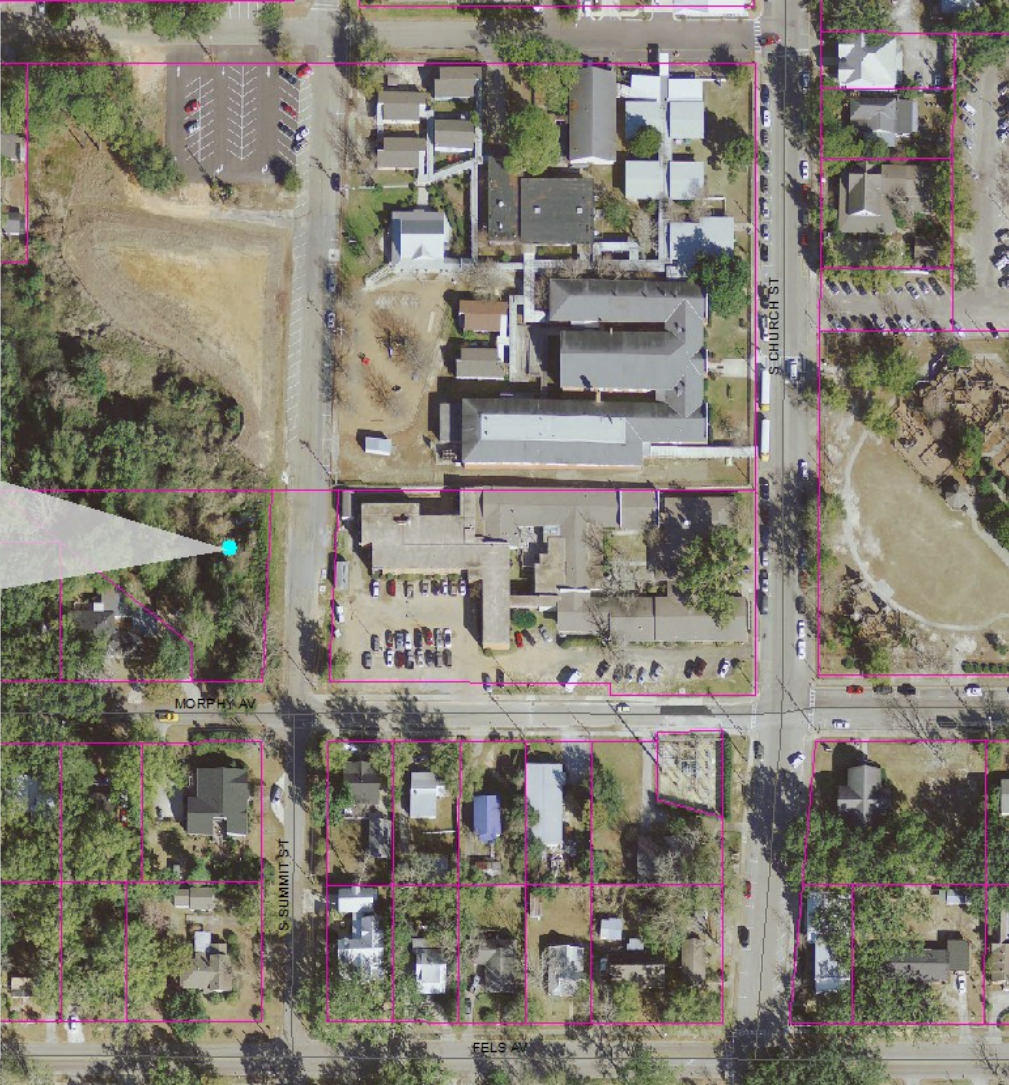
COF MS4 ID	SG-12788-A
Watershed	Stack Gully
Material	RCP
Shape_1	Circular
Depth	0
Top Width	0
Bottom Width	0
Type	Closed Pipe
Category	Major Bay Outfall
Outfall_No	11
Comment	
Flow Description	Trickle
Outfall Damage	Spalling_Cracking_Ch
Deposits/Stains	
Abnormal Vegetation	
Poor Pool Quality	
Pipe Benthic Growth	Green
Barrels	1
Diameter	36
Submerged in Water	No
Submerged With Sediment	No
Date Collected	6/14/2012
2012 Photo 1	00004
2012 Photo 2	<Null>

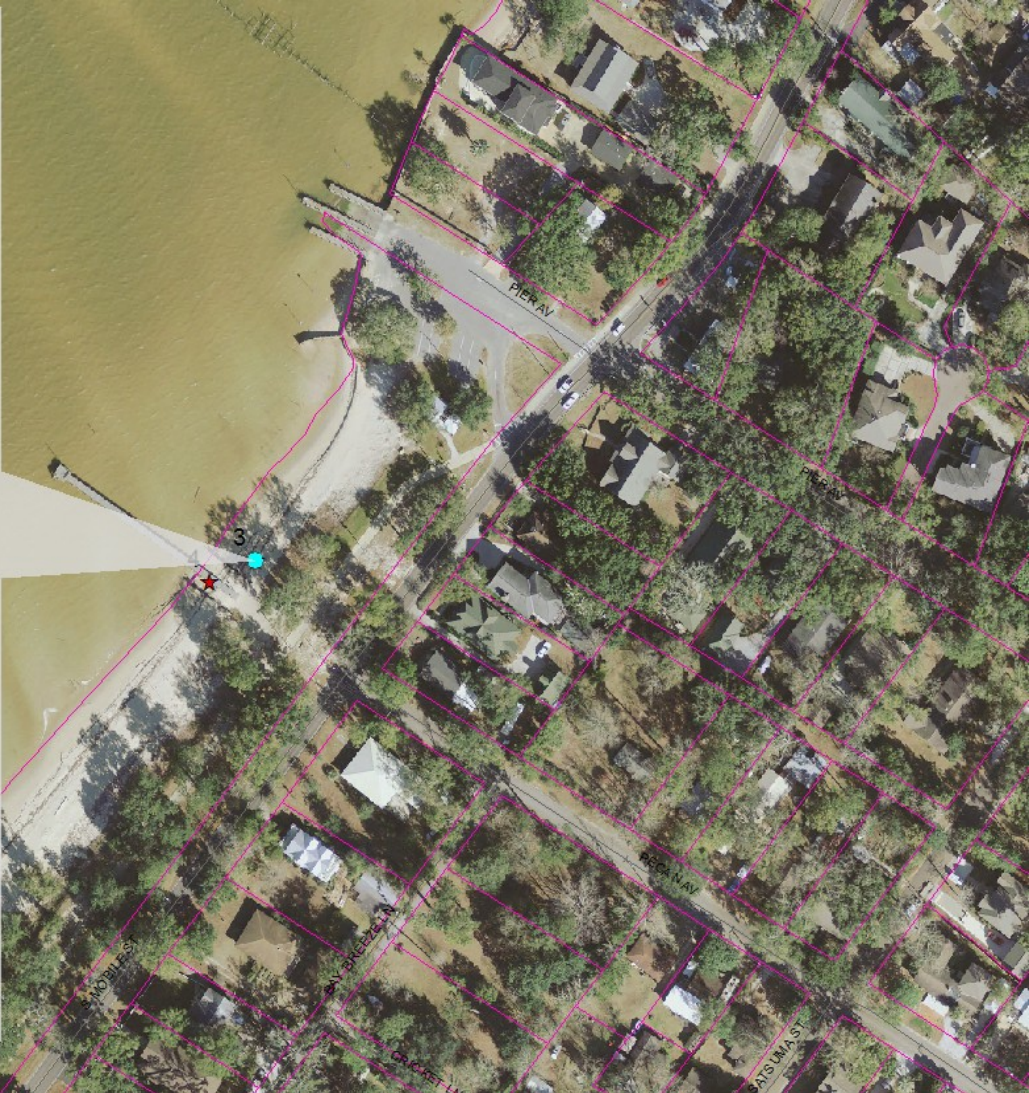
COF MS4 ID	SG-12795-B
Watershed	Stack Gully
Material	HDPE
Shape_1	Circular
Depth	0
Top Width	0
Bottom Width	0
Type	Closed Pipe
Category	Bay Outfall
Outfall_No	4
Comment	Bay outfall
Flow Description	Trickle
Outfall Damage	
Deposits/Stains	
Abnormal Vegetation	
Poor Pool Quality	
Pipe Benthic Growth	
Barrels	1
Diameter	24
Submerged in Water	Partially
Submerged With Sediment	No
Date Collected	7/3/2012
2012 Photo 1	0019307
2012 Photo 2	<Null>

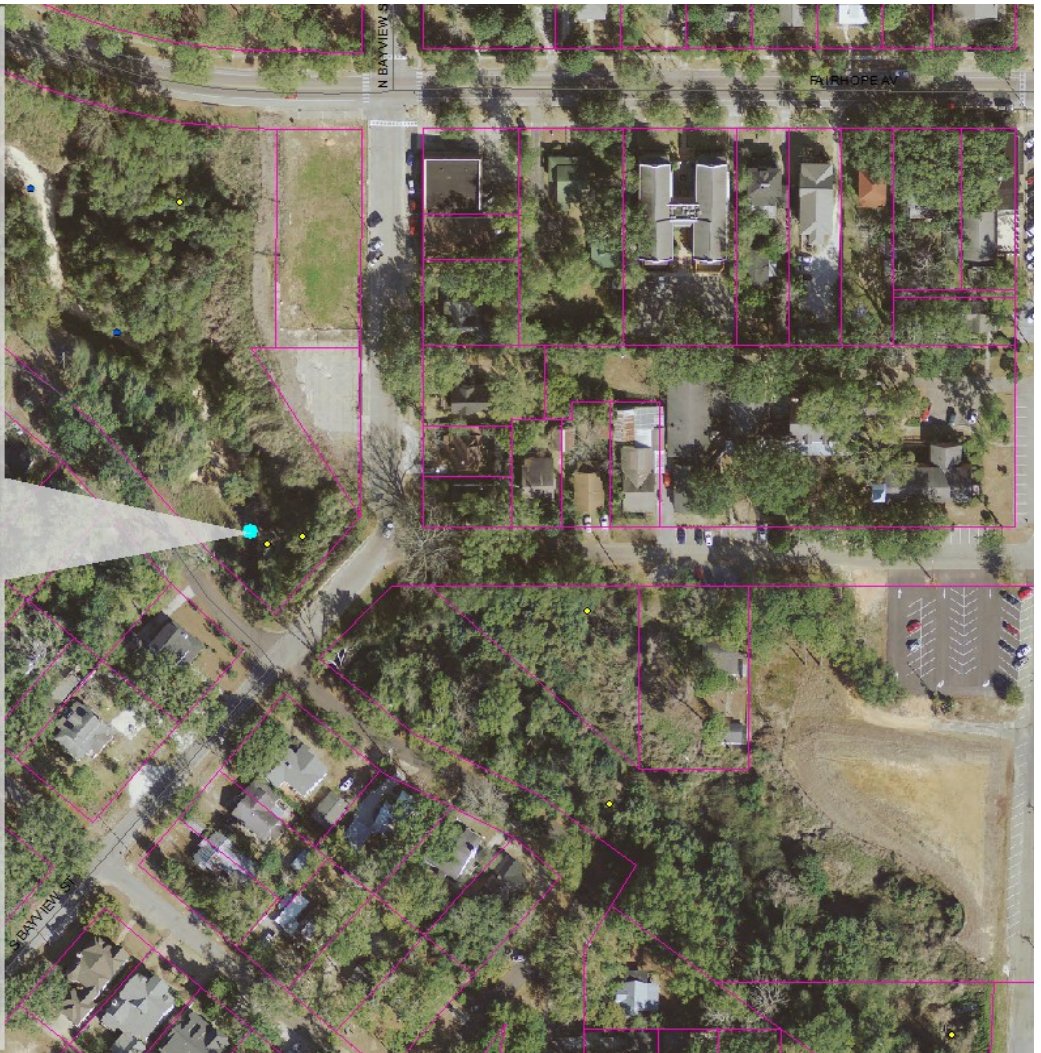
COF MS4 ID	SG-64356-B
Watershed	Stack Gully
Material	Rip_rap
Shape_1	Other
Depth	0
Top Width	0
Bottom Width	0
Type	Open Drainage
Category	
Outfall_No	<Null>
Comment	Gabion sidewall
Flow Description	None
Outfall Damage	
Deposits/Stains	
Abnormal Vegetation	
Poor Pool Quality	
Pipe Benthic Growth	
Barrels	
Diameter	0
Submerged in Water	
Submerged With Sediment	
Date Collected	7/9/2012
2012 Photo 1	0027373
2012 Photo 2	<Null>

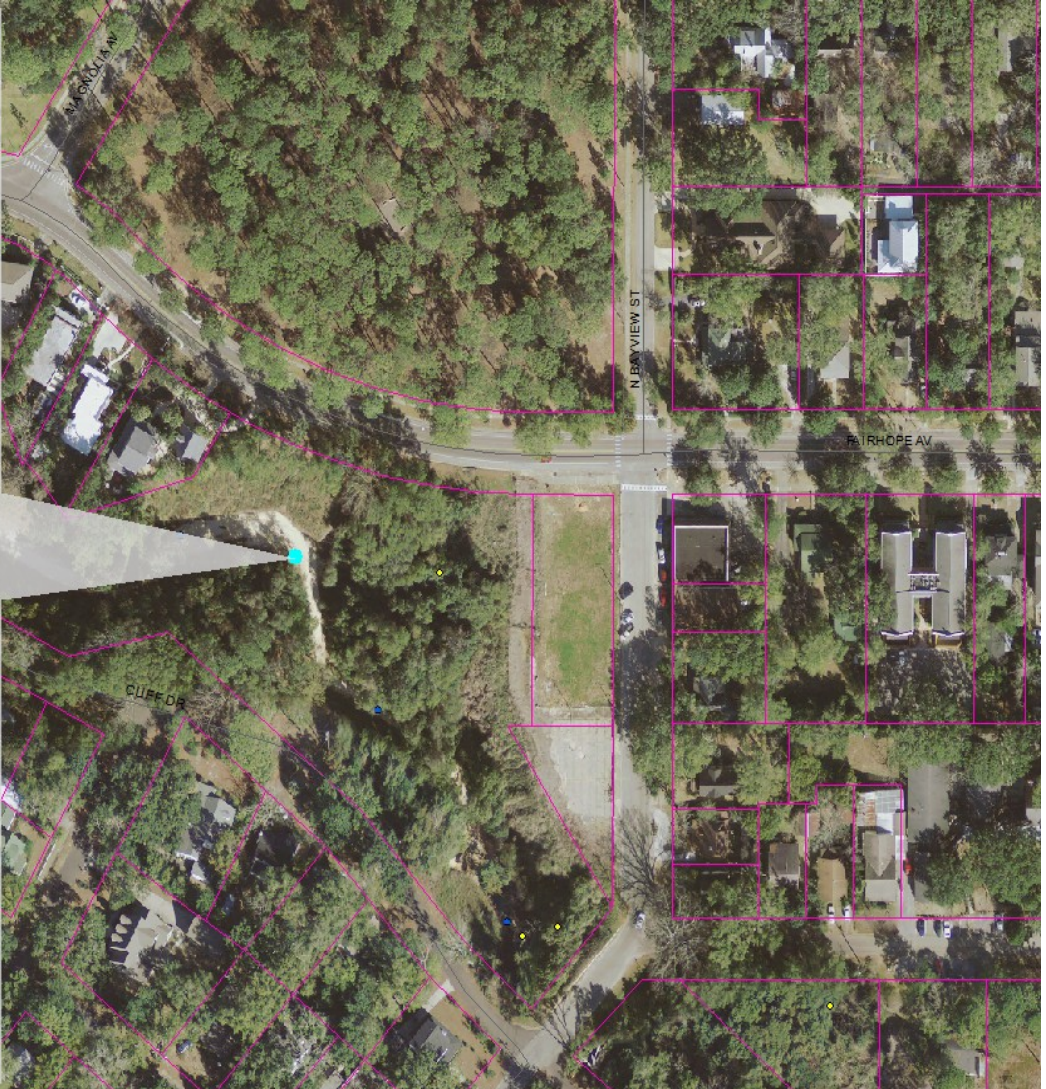
COF MS4 ID	SG-64356-D
Watershed	Stack Gully
Material	Rip_rap
Shape_1	Other
Depth	0
Top Width	0
Bottom Width	0
Type	Open Drainage
Category	
Outfall_No	<Null>
Comment	Gabion sidewall end of
Flow Description	
Outfall Damage	
Deposits/Stains	Flow_line
Abnormal Vegetation	
Poor Pool Quality	
Pipe Benthic Growth	
Barrels	
Diameter	0
Submerged in Water	
Submerged With Sediment	
Date Collected	7/9/2012
2012 Photo 1	0028377
2012 Photo 2	<Null>

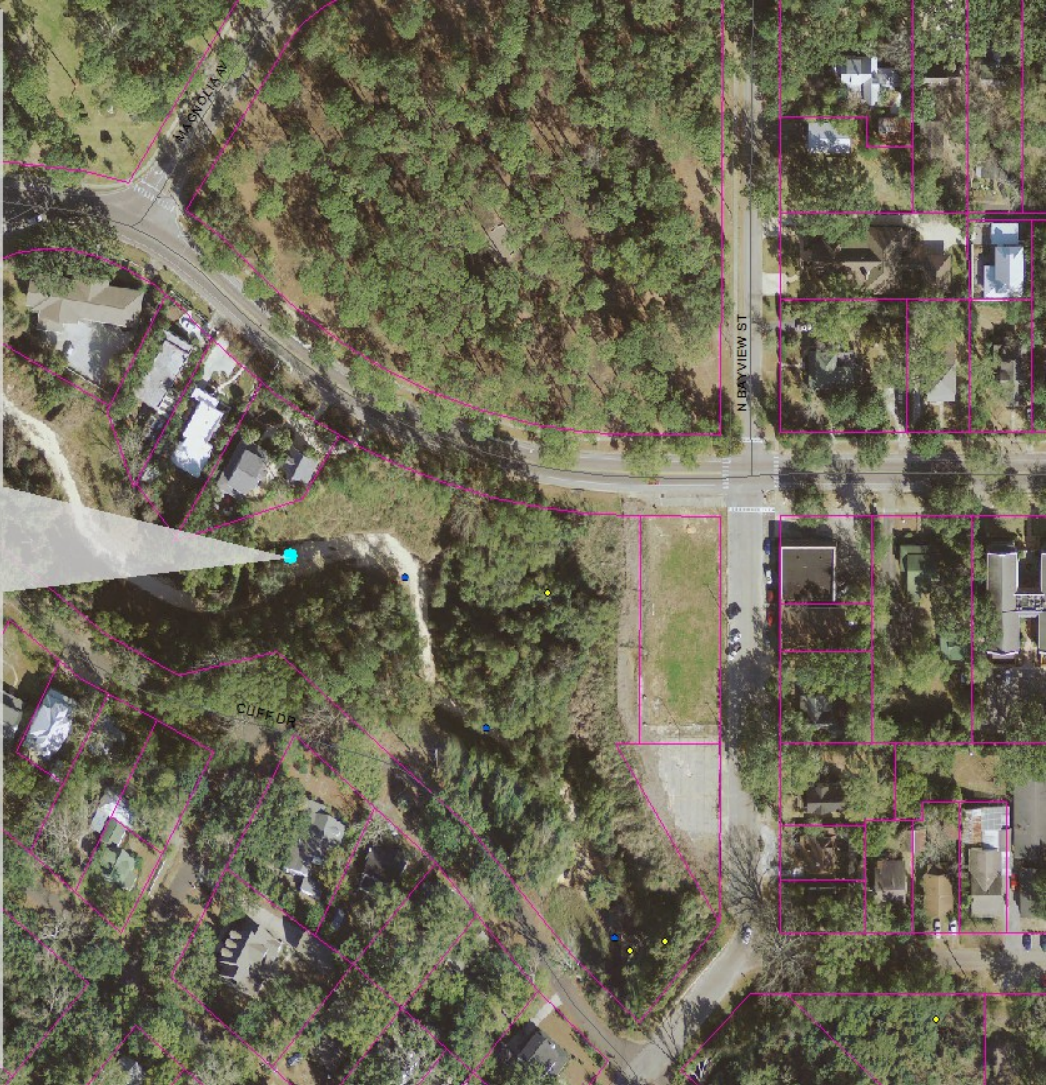
COF MS4 ID	SG-64356-E
Watershed	Stack Gully
Material	HDPE
Shape_1	Circular
Depth	0
Top Width	0
Bottom Width	0
Type	Closed Pipe
Category	
Outfall_No	<Null>
Comment	Into drop structure
Flow Description	None
Outfall Damage	
Deposits/Stains	
Abnormal Vegetation	
Poor Pool Quality	
Pipe Benthic Growth	
Barrels	1
Diameter	12
Submerged in Water	No
Submerged With Sediment	No
Date Collected	7/9/2012
2012 Photo 1	0028382
2012 Photo 2	<Null>
