City of Fairhope - Outfall Inventory Volanta Watershed

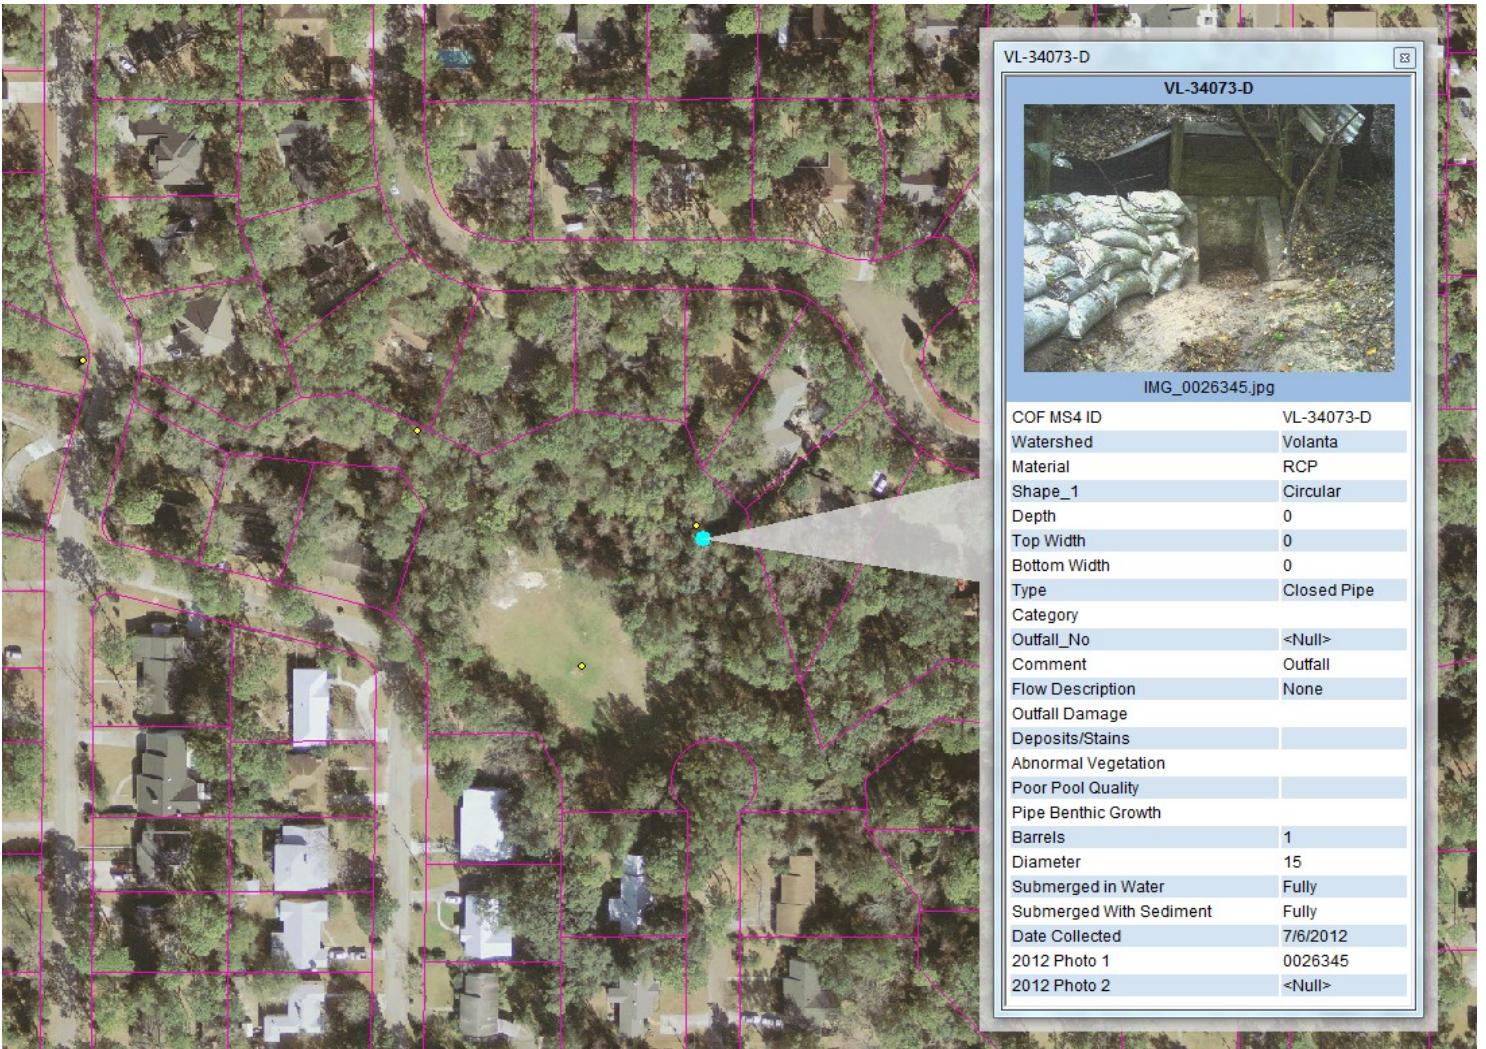
COF MS4 ID	VL-34073-D
Watershed	Volanta
Material	RCP
Shape_1	Circular
Depth	0
Top Width	0
Bottom Width	0
Type	Closed Pipe
Category	
Outfall_No	<Null>
Comment	Outfall
Flow Description	None
Outfall Damage	
Deposits/Stains	
Abnormal Vegetation	
Poor Pool Quality	
Pipe Benthic Growth	
Barrels	1
Diameter	15
Submerged in Water	Fully
Submerged With Sediment	Fully
Date Collected	7/6/2012
2012 Photo 1	0026345
2012 Photo 2	<Null>

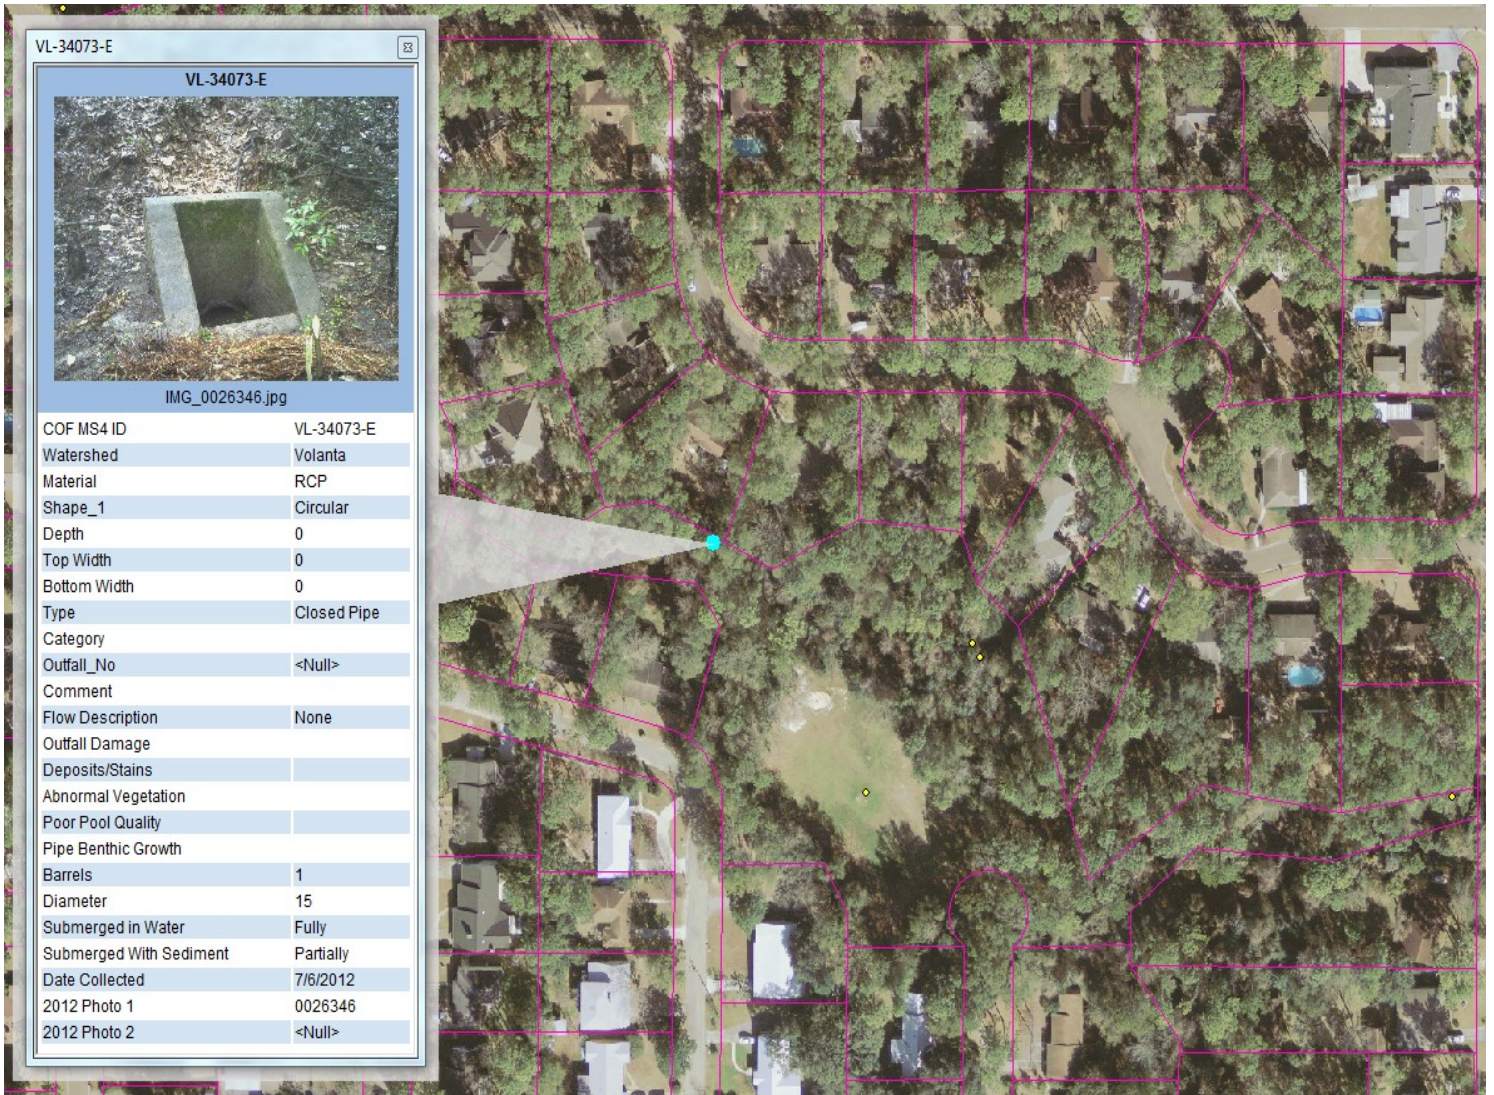
COF MS4 ID	VL-34073-E
Watershed	Volanta
Material	RCP
Shape_1	Circular
Depth	0
Top Width	0
Bottom Width	0
Type	Closed Pipe
Category	
Outfall_No	<Null>
Comment	
Flow Description	None
Outfall Damage	
Deposits/Stains	
Abnormal Vegetation	
Poor Pool Quality	
Pipe Benthic Growth	
Barrels	1
Diameter	15
Submerged in Water	Fully
Submerged With Sediment	Partially
Date Collected	7/6/2012
2012 Photo 1	0026346
2012 Photo 2	<Null>

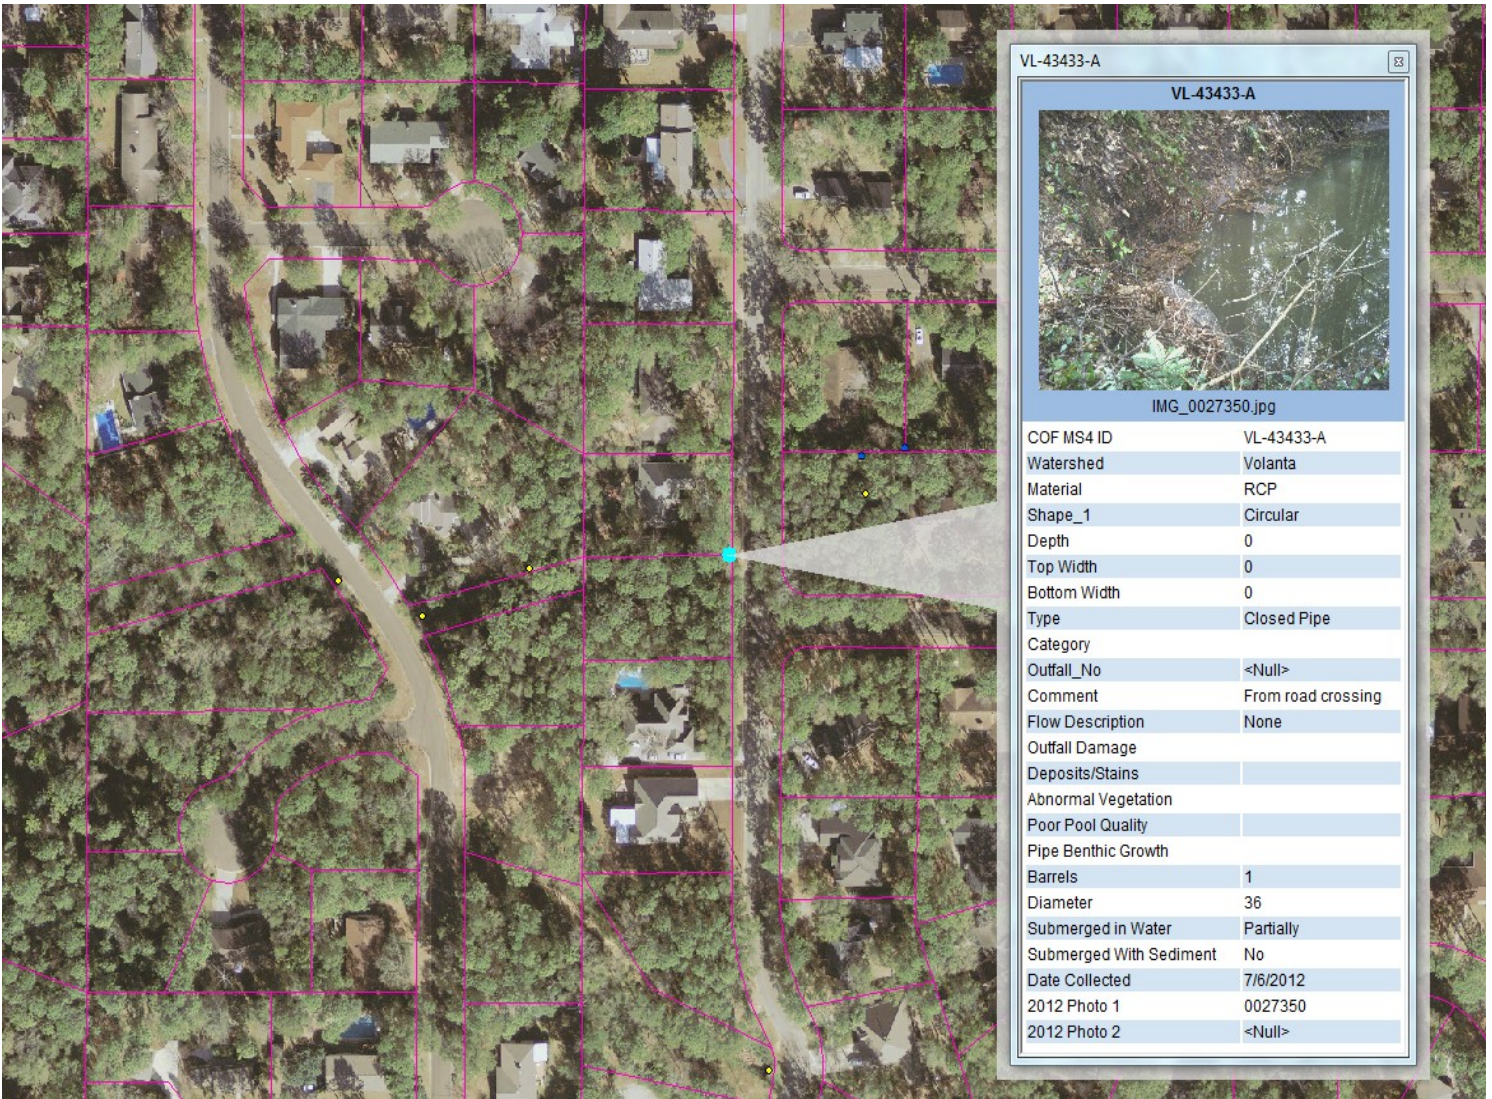
COF MS4 ID	VL-43433-A
Watershed	Volanta
Material	RCP
Shape_1	Circular
Depth	0
Top Width	0
Bottom Width	0
Type	Closed Pipe
Category	
Outfall_No	<Null>
Comment	From road crossing
Flow Description	None
Outfall Damage	
Deposits/Stains	
Abnormal Vegetation	
Poor Pool Quality	
Pipe Benthic Growth	
Barrels	1
Diameter	36
Submerged in Water	Partially
Submerged With Sediment	No
Date Collected	7/6/2012
2012 Photo 1	0027350
2012 Photo 2	<Null>

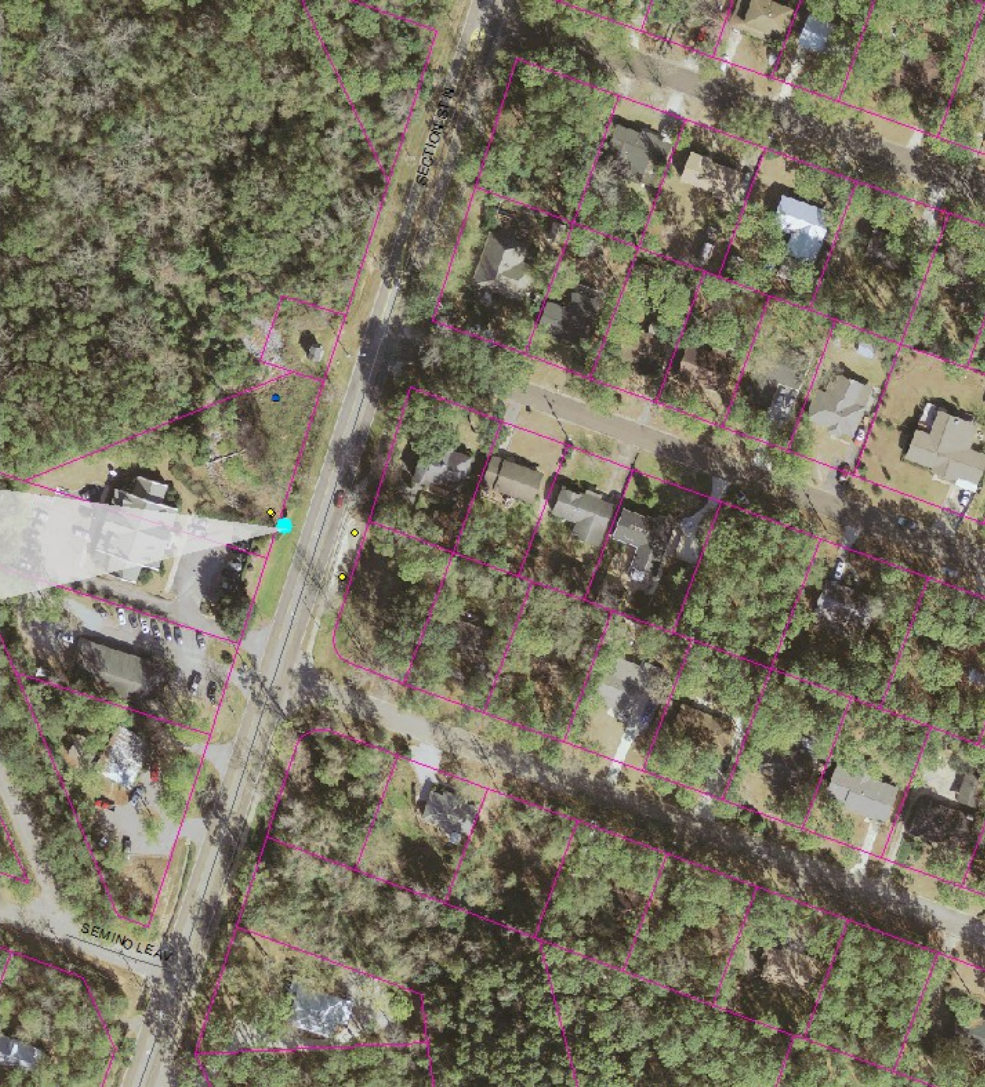
COF MS4 ID	VL-47625-A
Watershed	Volanta
Material	HDPE
Shape_1	Circular
Depth	0
Top Width	0
Bottom Width	0
Type	Closed Pipe
Category	
Outfall_No	<Null>
Comment	
Flow Description	None
Outfall Damage	
Deposits/Stains	
Abnormal Vegetation	
Poor Pool Quality	
Pipe Benthic Growth	Orange
Barrels	1
Diameter	24
Submerged in Water	No
Submerged With Sediment	No
Date Collected	7/6/2012
2012 Photo 1	0027360
2012 Photo 2	<Null>

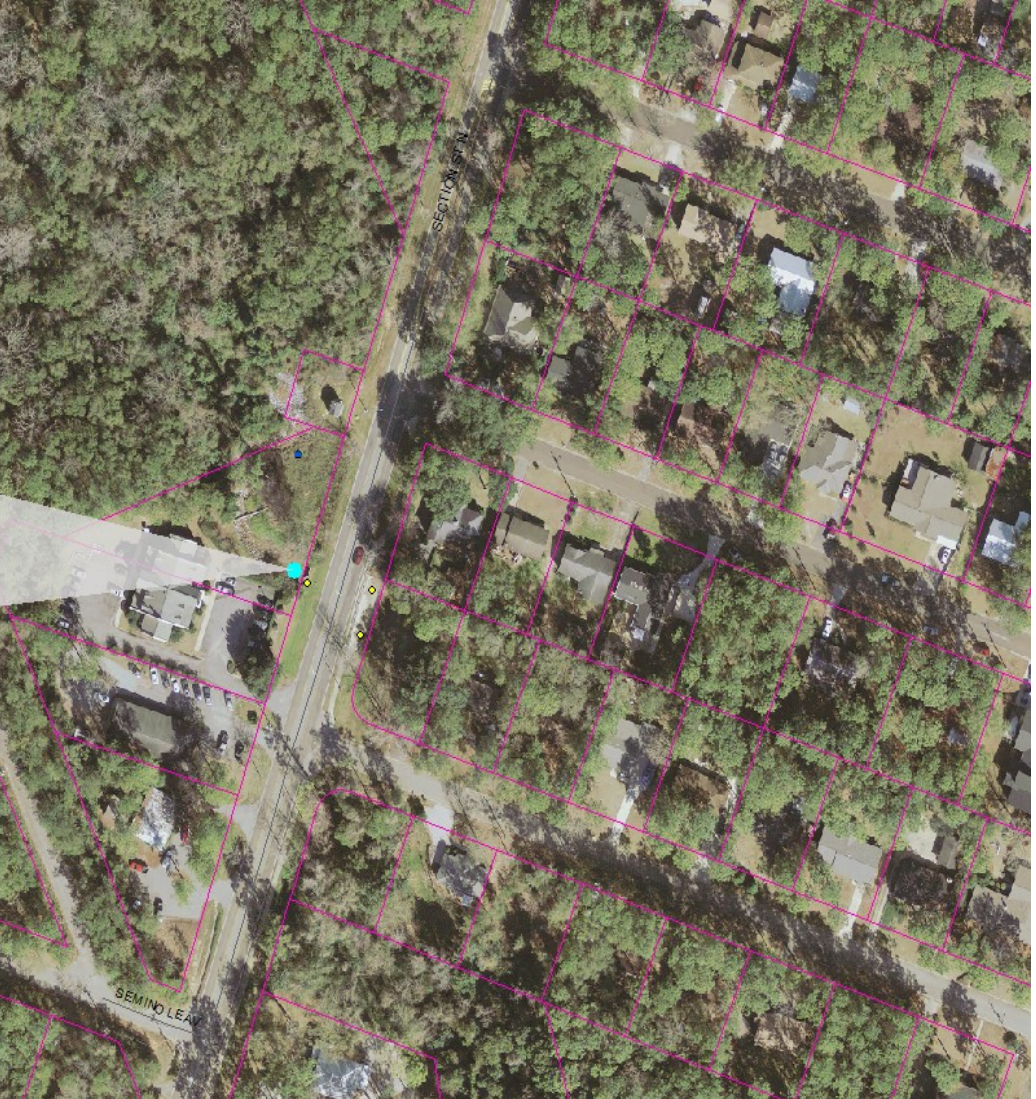
COF MS4 ID	VL-47625-B
Watershed	Volanta
Material	RCP
Shape_1	Circular
Depth	0
Top Width	0
Bottom Width	0
Type	Closed Pipe
Category	
Outfall_No	<Null>
Comment	Parking discharge
Flow Description	None
Outfall Damage	
Deposits/Stains	
Abnormal Vegetation	
Poor Pool Quality	
Pipe Benthic Growth	
Barrels	1
Diameter	24
Submerged in Water	No
Submerged With Sediment	Partially
Date Collected	7/6/2012
2012 Photo 1	0027361
2012 Photo 2	<Null>

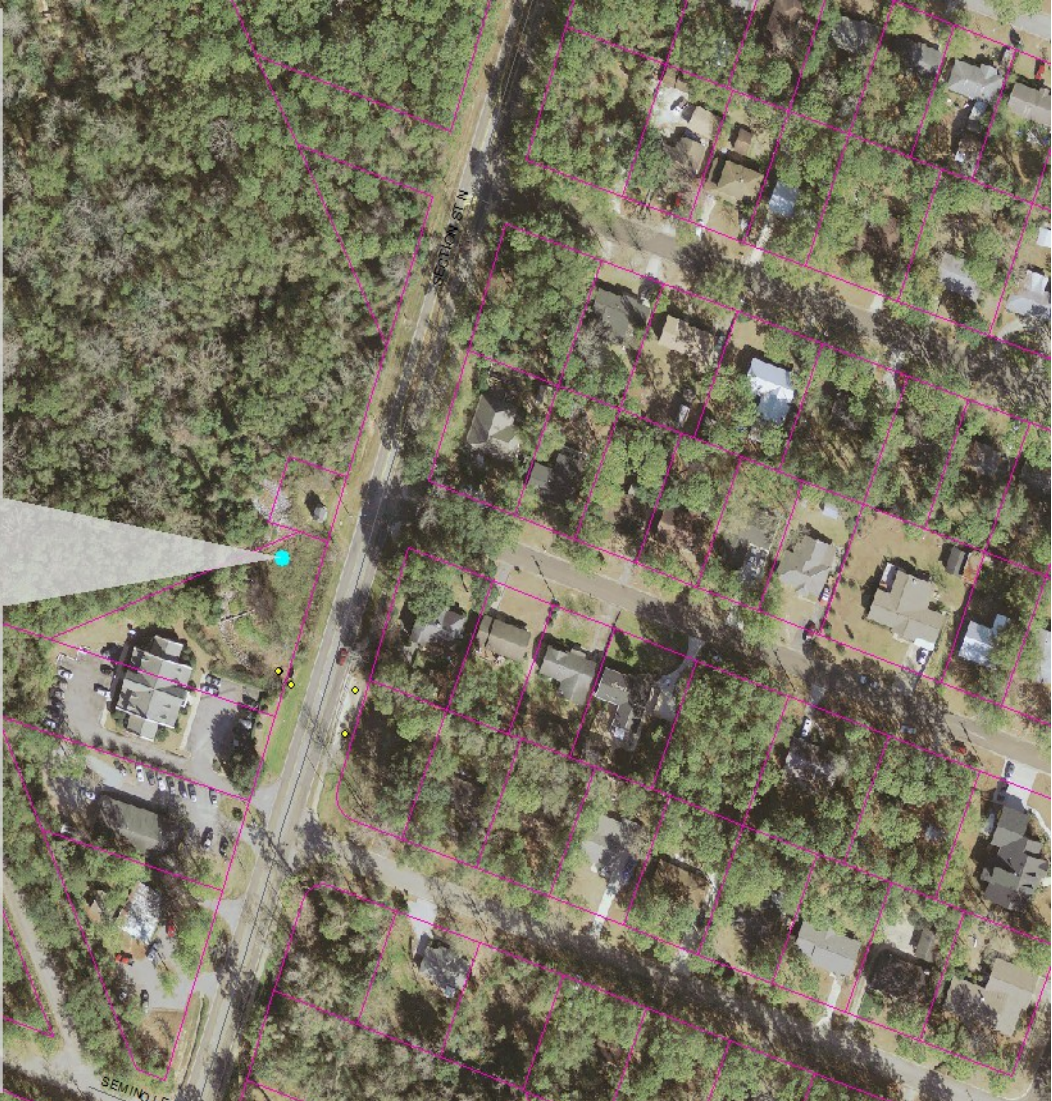
COF MS4 ID	VL-47625-D
Watershed	Volanta
Material	Rip_rap
Shape_1	Trapezoid
Depth	4
Top Width	20
Bottom Width	10
Type	Open Drainage
Category	
Outfall_No	<Null>
Comment	Armored ditch
Flow Description	None
Outfall Damage	
Deposits/Stains	
Abnormal Vegetation	
Poor Pool Quality	
Pipe Benthic Growth	
Barrels	
Diameter	0
Submerged in Water	
Submerged With Sediment	
Date Collected	7/6/2012
2012 Photo 1	0027363
2012 Photo 2	0028364

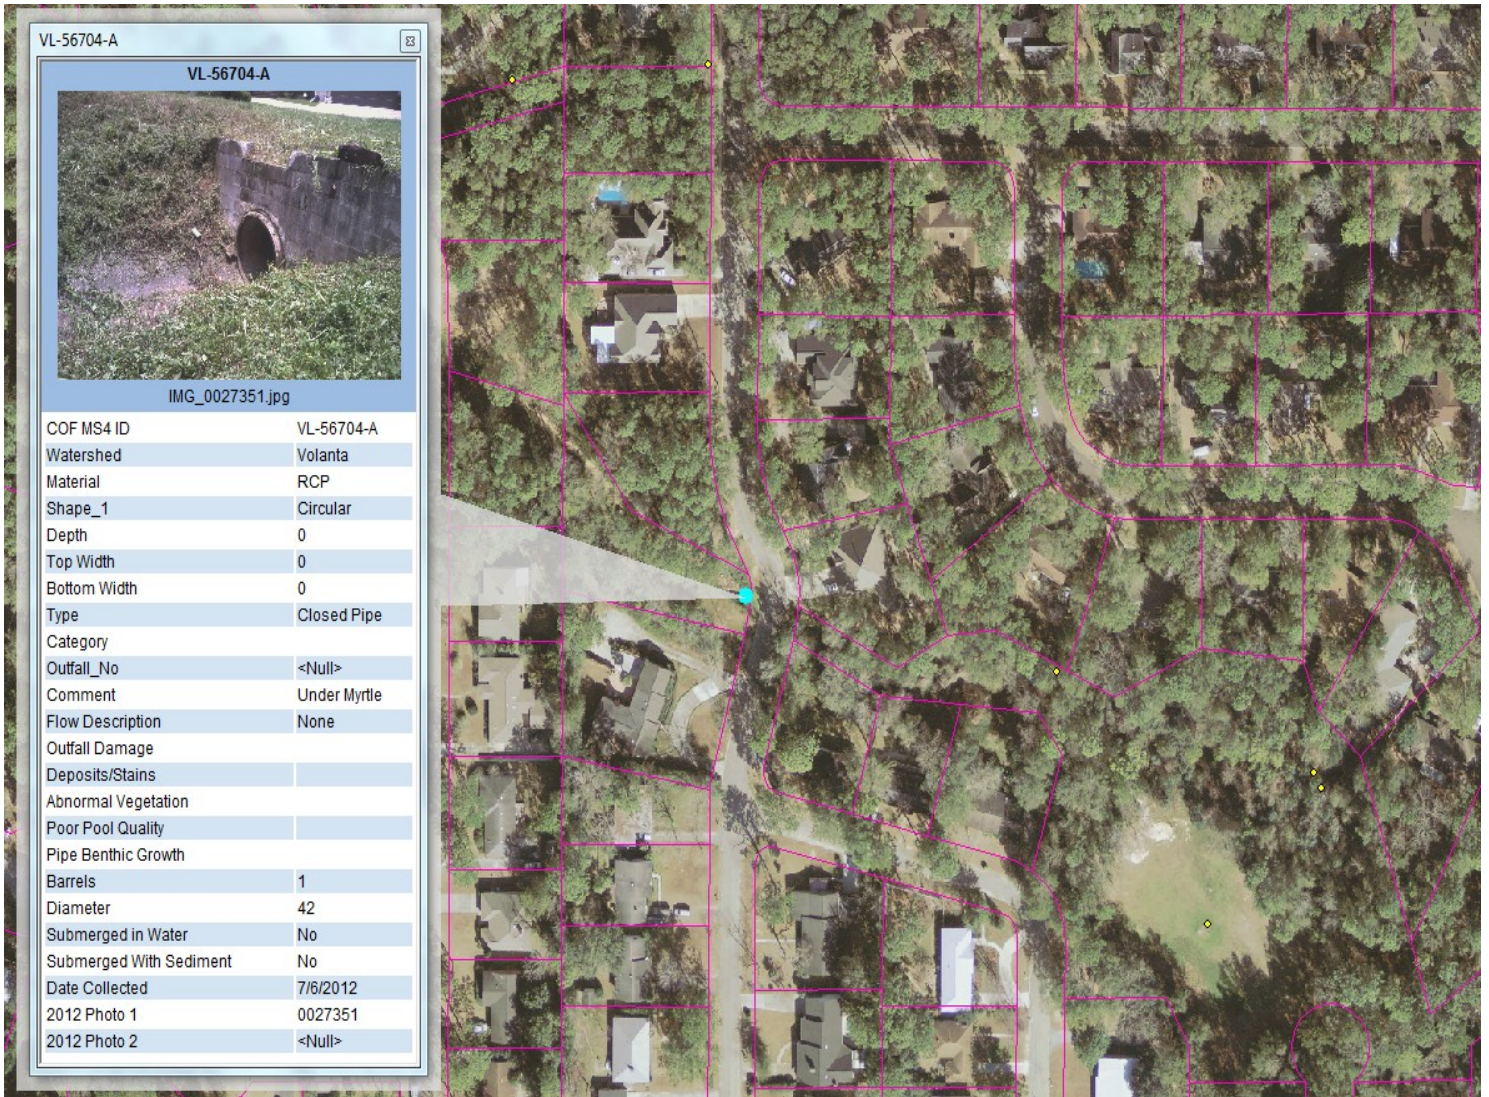
COF MS4 ID	VL-56704-A
Watershed	Volanta
Material	RCP
Shape_1	Circular
Depth	0
Top Width	0
Bottom Width	0
Type	Closed Pipe
Category	
Outfall_No	<Null>
Comment	Under Myrtle
Flow Description	None
Outfall Damage	
Deposits/Stains	
Abnormal Vegetation	
Poor Pool Quality	
Pipe Benthic Growth	
Barrels	1
Diameter	42
Submerged in Water	No
Submerged With Sediment	No
Date Collected	7/6/2012
2012 Photo 1	0027351
2012 Photo 2	<Null>

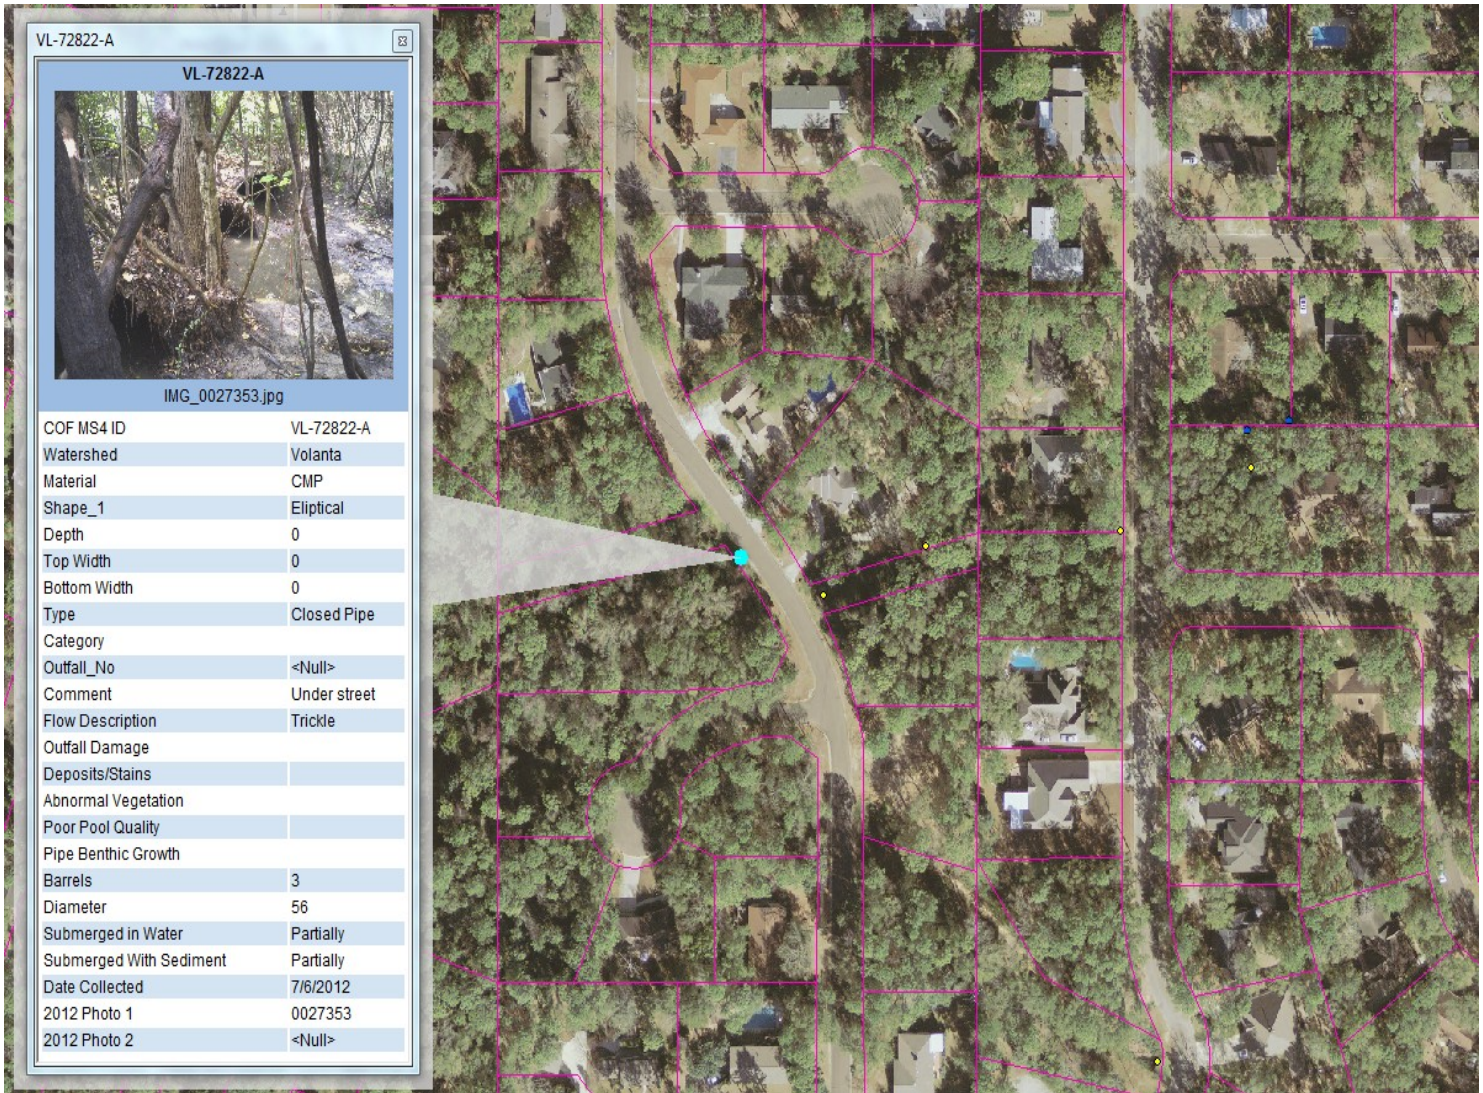
COF MS4 ID	VL-72822-A
Watershed	Volanta
Material	CMP
Shape_1	Elliptical
Depth	0
Top Width	0
Bottom Width	0
Type	Closed Pipe
Category	
Outfall_No	<Null>
Comment	Under street
Flow Description	Trickle
Outfall Damage	
Deposits/Stains	
Abnormal Vegetation	
Poor Pool Quality	
Pipe Benthic Growth	
Barrels	3
Diameter	56
Submerged in Water	Partially
Submerged With Sediment	Partially
Date Collected	7/6/2012
2012 Photo 1	0027353
2012 Photo 2	<Null>
