ADDENDUM NO 01

CITY OF FAIRHOPE

Bid No. 011-13

TROYER BOOTHE ROAD IMPROVEMENTS

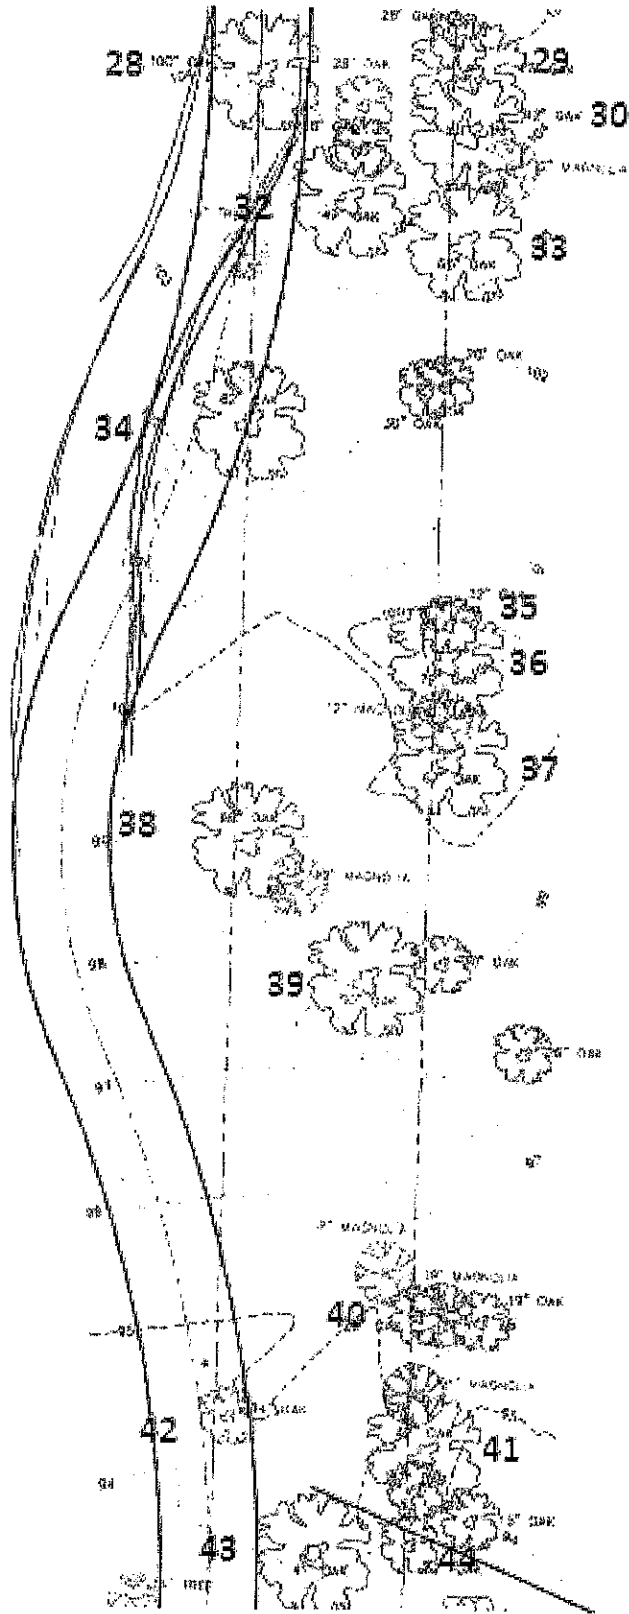
Appendix B – Survey

FAIRHOPE SINGLE TAX CORPORATION
PROPOSED BOOTH ROAD EXTENSION
ALTERNATE 12
